2022 Sanitary Sewer Reconstruction

Phase 1

Project # 2022-017963

# Sewer CCTV Observations

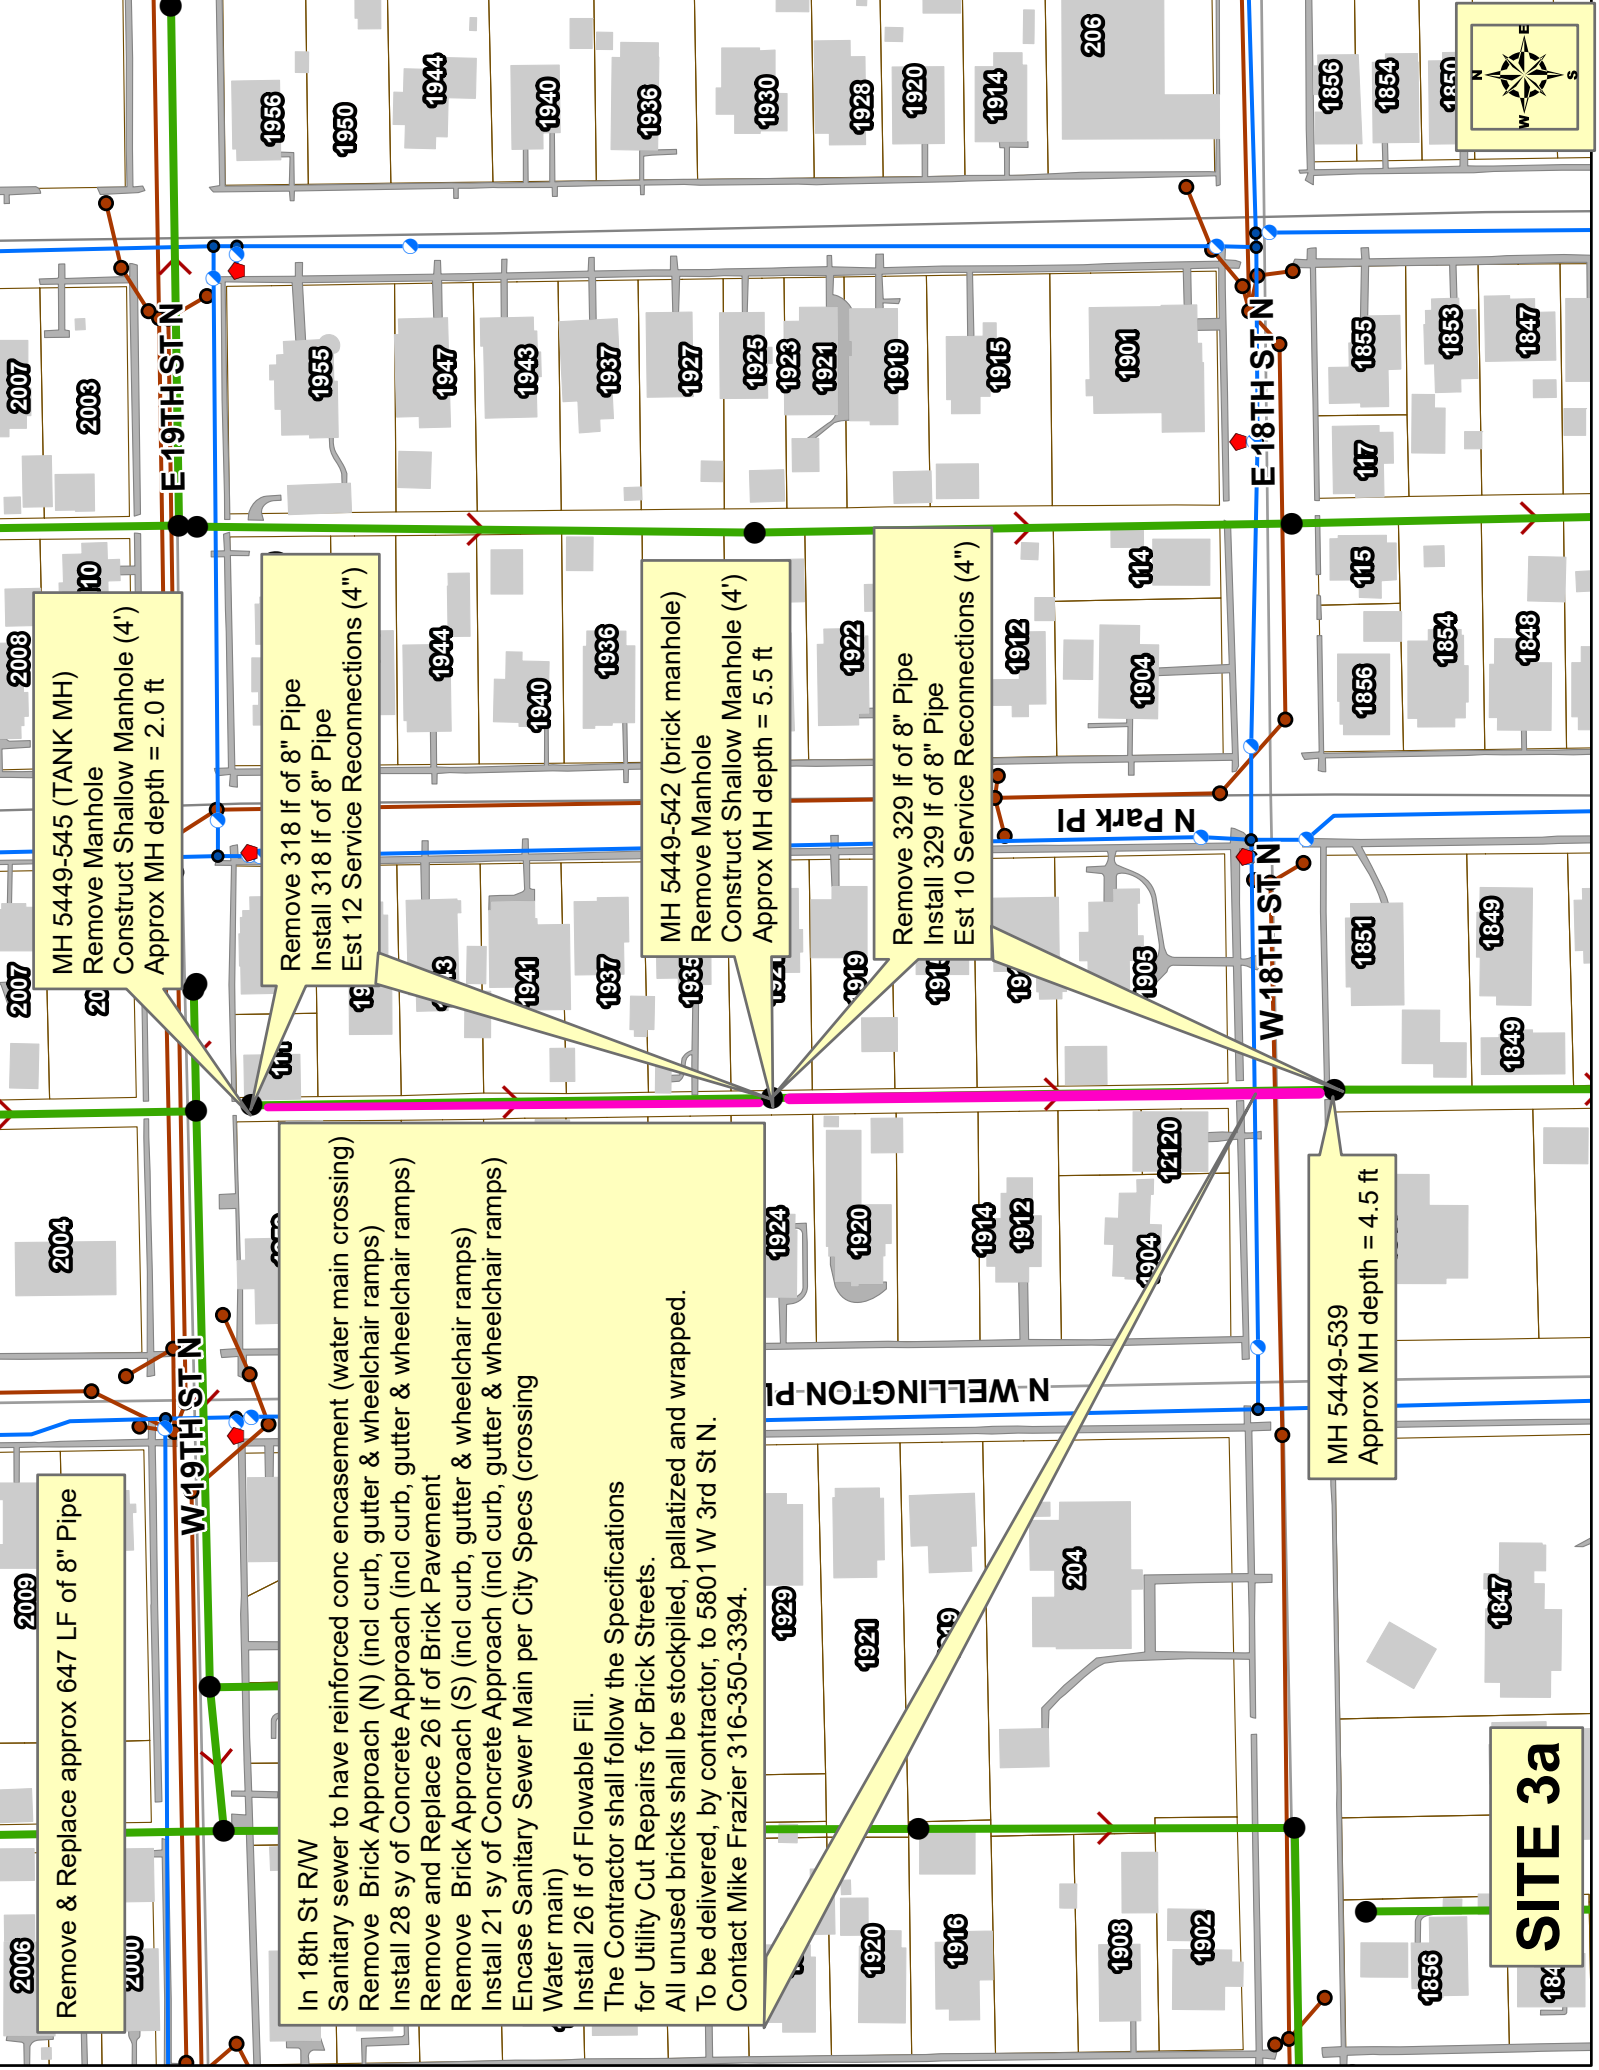
SITE 3a

MH 5449-545 (TANK MH)  
Remove Manhole  
Construct Shallow Manhole (4')  
Approx MH depth = 2.0 ft

MH 5449-542 (brick manhole)  
Remove Manhole  
Construct Shallow Manhole (4')  
Approx MH depth = 5.5 ft

MH 5449-539  
Approx MH depth = 4.5 ft

Remove & Replace approx 647 LF of 8" Pipe

In 18th St RW  
Sanitary sewer to have reinforced conc encasement (water main crossing)  
Remove Brick Approach (N) (incl curb, gutter & wheelchair ramps)  
Install 28 sy of Concrete Approach (incl curb, gutter & wheelchair ramps)  
Remove and Replace 26 lf of Brick Pavement  
Remove Brick Approach (S) (incl curb, gutter & wheelchair ramps)  
Install 21 sy of Concrete Approach (incl curb, gutter & wheelchair ramps)  
Encase Sanitary Sewer Main per City Specs (crossing Water main)  
Install 26 lf of Flowable Fill.  
The Contractor shall follow the Specifications for Utility Cut Repairs for Brick Streets.  
All unused bricks shall be stockpiled, palletized and wrapped.  
To be delivered, by contractor, to 5801 W 3rd St N.  
Contact Mike Frazier 316-350-3394.

Remove 318 lf of 8" Pipe  
Install 318 lf of 8" Pipe  
Est 12 Service Reconnections (4")

Remove 329 lf of 8" Pipe  
Install 329 lf of 8" Pipe  
Est 10 Service Reconnections (4")

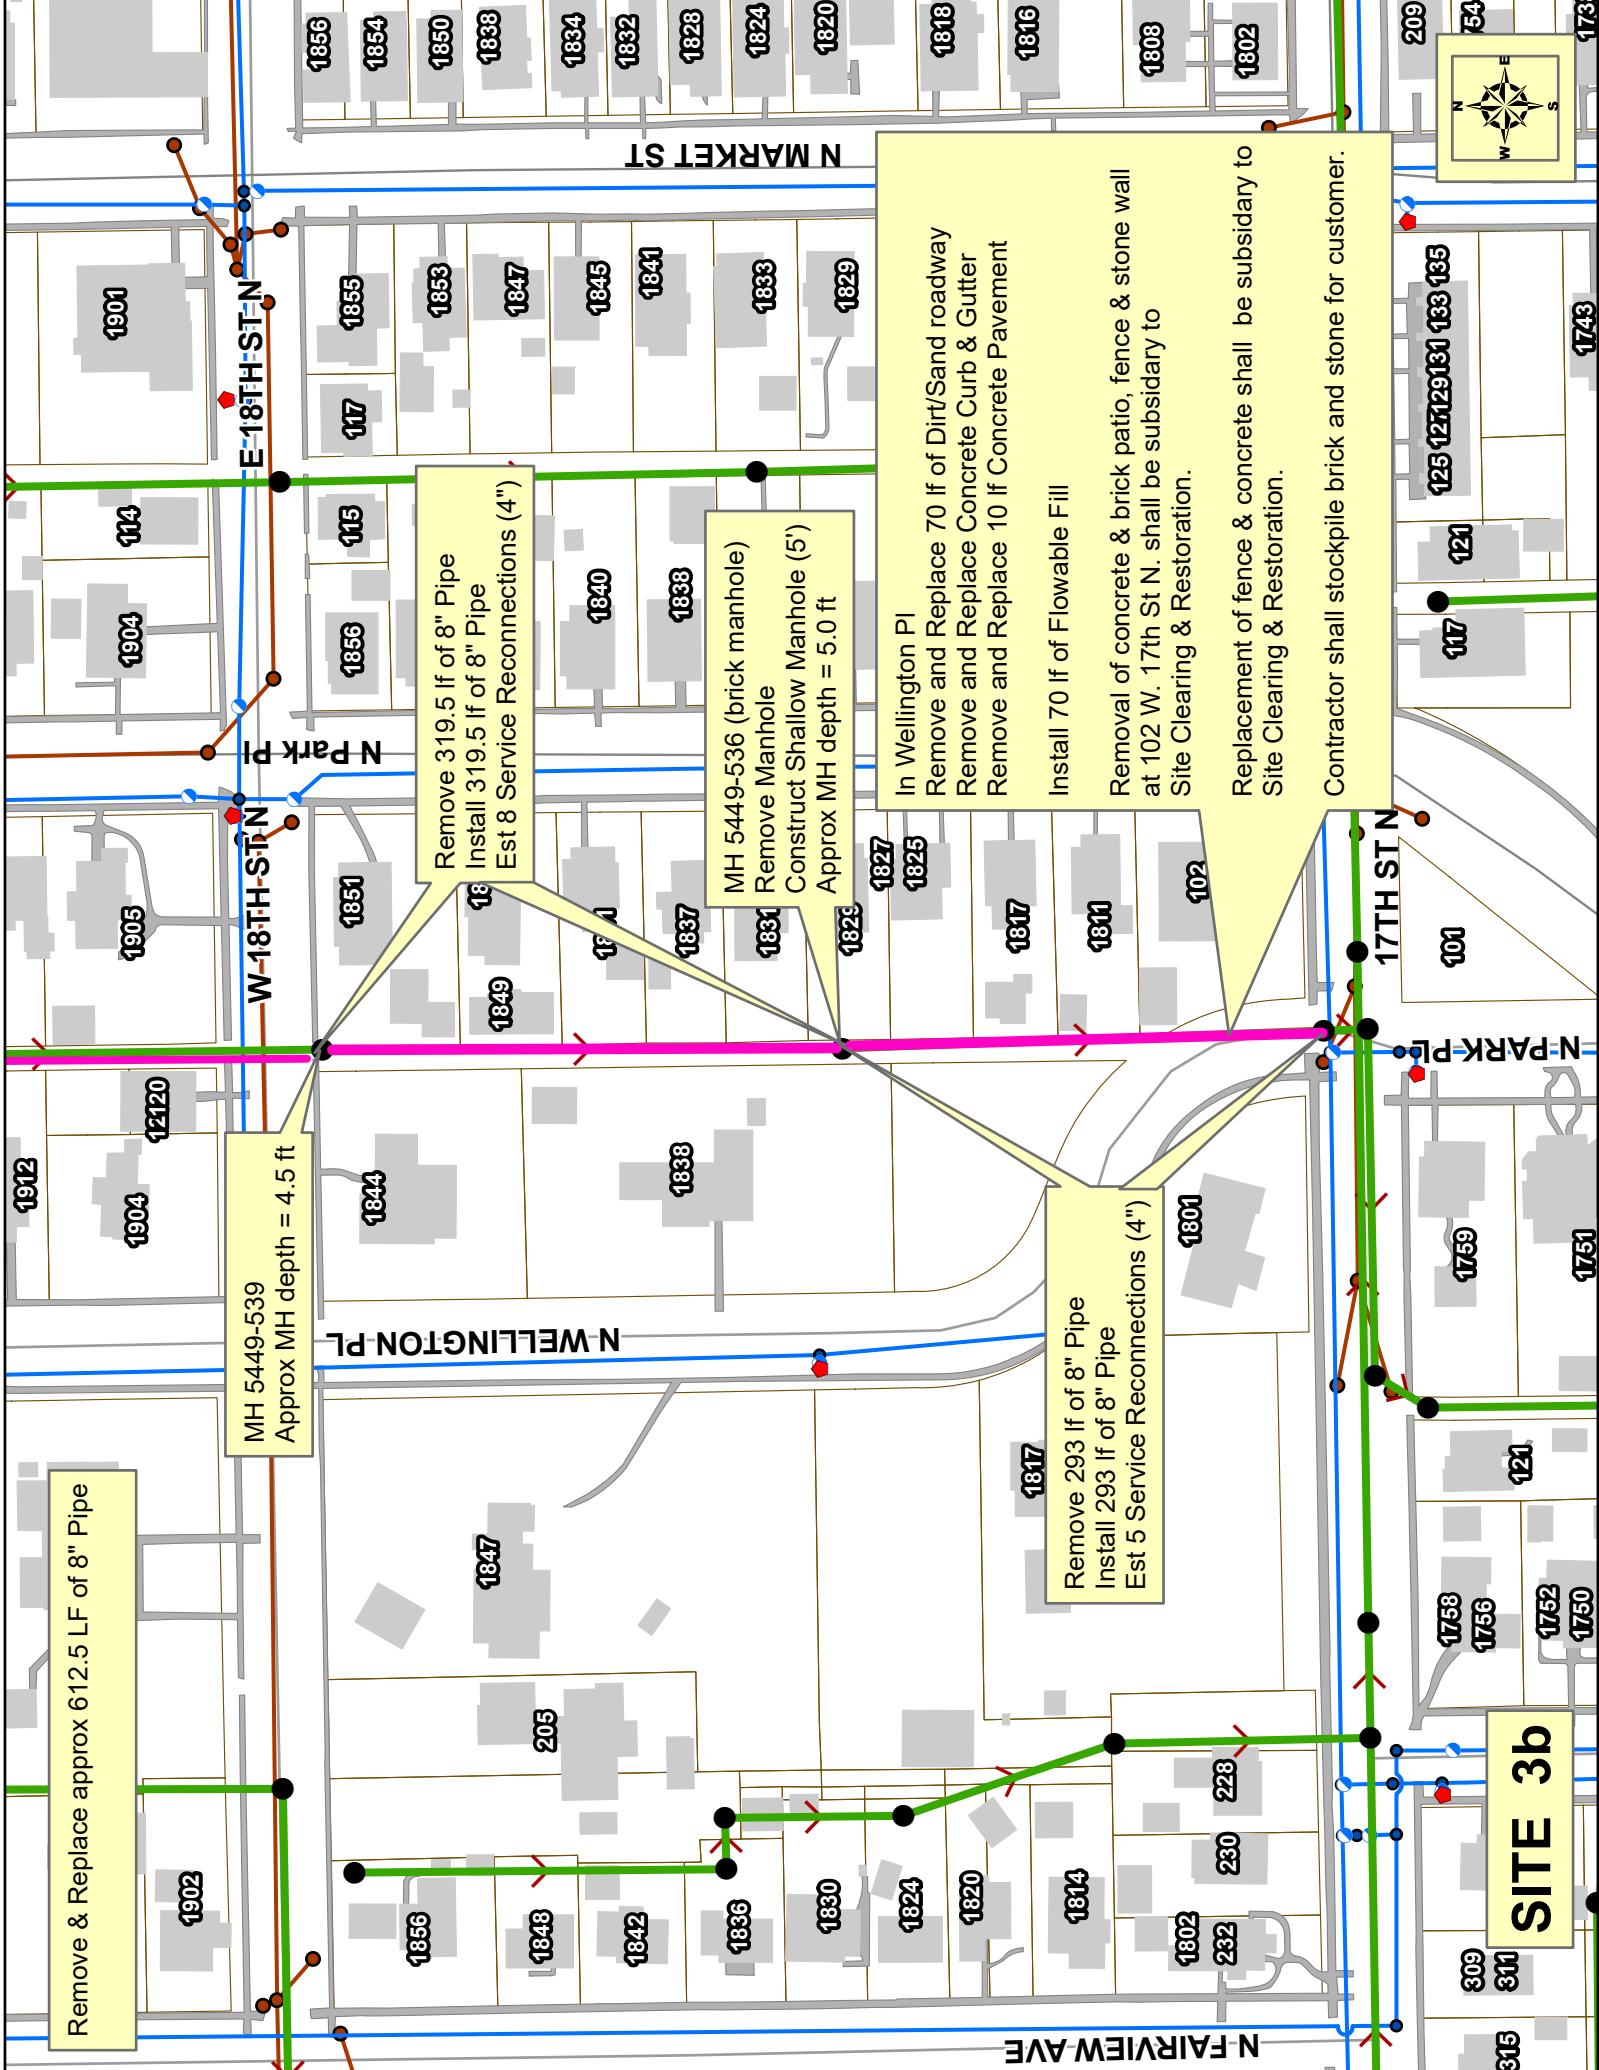
**SITE 3b**

MH 5449-539  
Approx MH depth = 4.5 ft

MH 5449-536 (brick manhole)  
Remove Manhole  
Construct Shallow Manhole (5')  
Approx MH depth = 5.0 ft

Remove & Replace approx 612.5 LF of 8" Pipe

Remove 319.5 lf of 8" Pipe  
Install 319.5 lf of 8" Pipe  
Est 8 Service Reconections (4")

Remove 293 lf of 8" Pipe  
Install 293 lf of 8" Pipe  
Est 5 Service Reconections (4")

In Wellington Pl  
Remove and Replace 70 lf of Dirt/Sand roadway  
Remove and Replace Concrete Curb & Gutter  
Remove and Replace 10 lf Concrete Pavement  
Install 70 lf of Flowable Fill  
Removal of concrete & brick patio, fence & stone wall at 102 W. 17th St N. shall be subsidiary to Site Clearing & Restoration.  
Replacement of fence & concrete shall be subsidiary to Site Clearing & Restoration.  
Contractor shall stockpile brick and stone for customer.
