Install 369 lf of 8" Cured-in-Place Liner

Television Inspection Master Report

US Manhole: 5845-364 2158 S GLENDALE AVE Date Insp: 9/7/2005 Basin: E01A
DS Manhole: 5845-363 2188 S GLENDALE ST Dir Televised: Downstream To Upstream

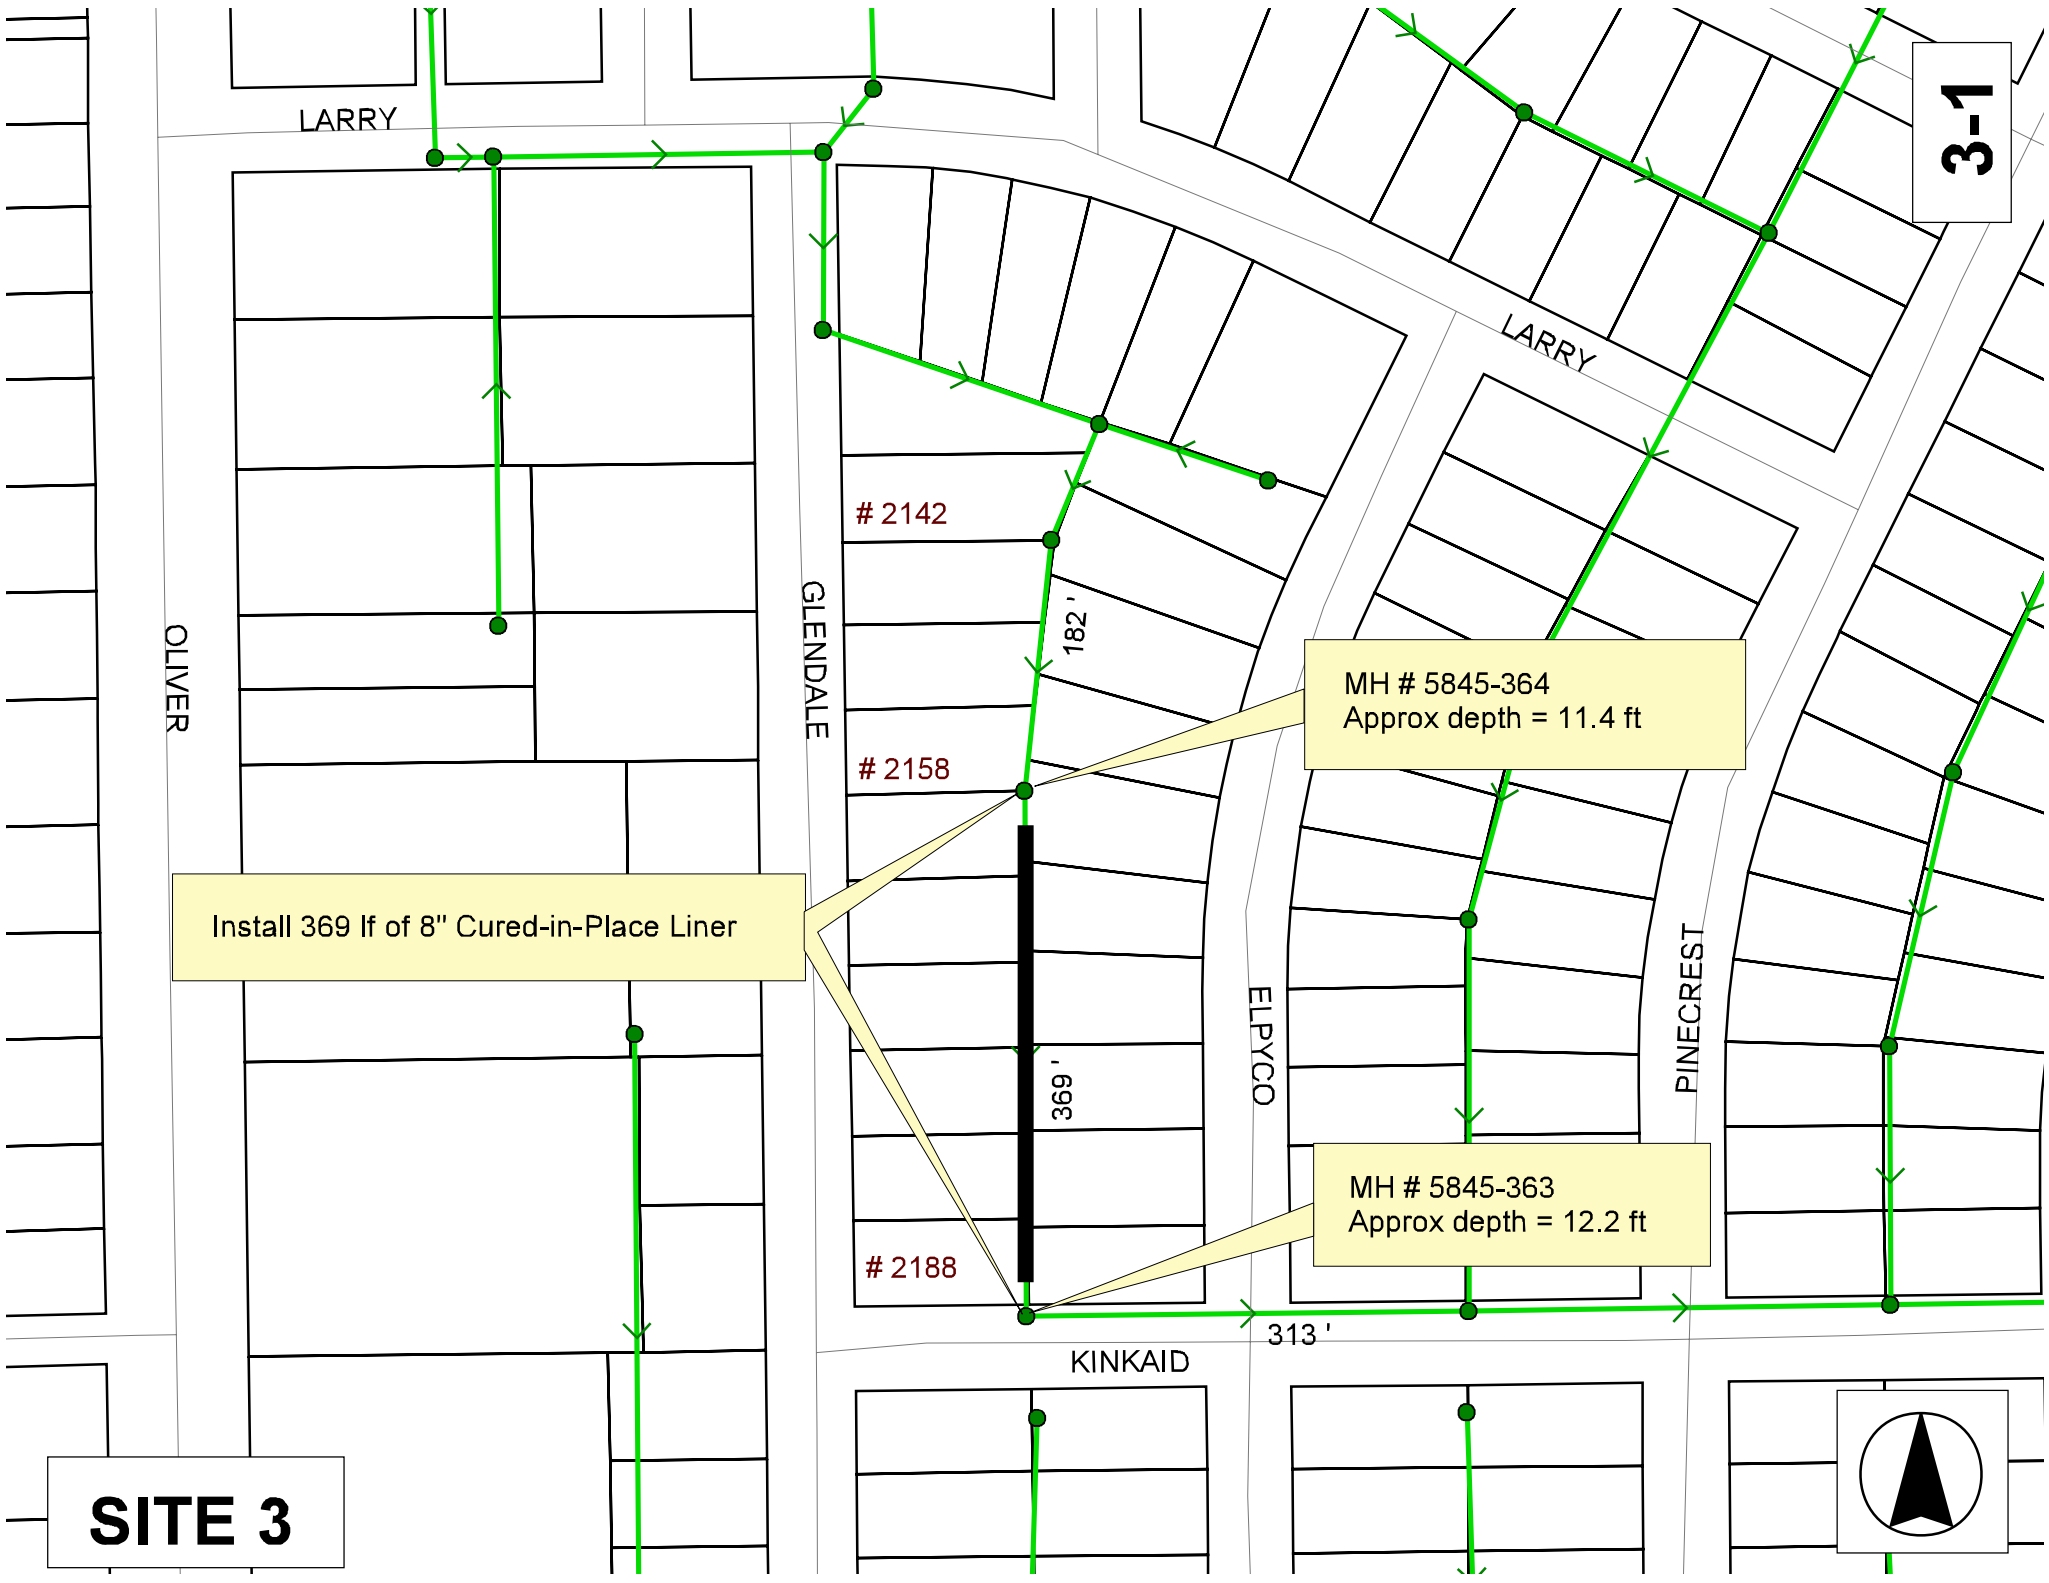
Aerial View

MH # 5845-364
Approx depth = 11.4 ft

MH # 5845-363
Approx depth = 12.2 ft

Lots of roots at the joints and small off-set joints not mentioned on the log. Line has maintenance problems.
