SITE 11

11-1

Television Inspection Master Report

US Manhole: 5348-043 1901 W 13TH ST Date Insp: 4/10/2007 Basin: C03E
DS Manhole: 5348-040 Dir Televised: Upstream To Downstream

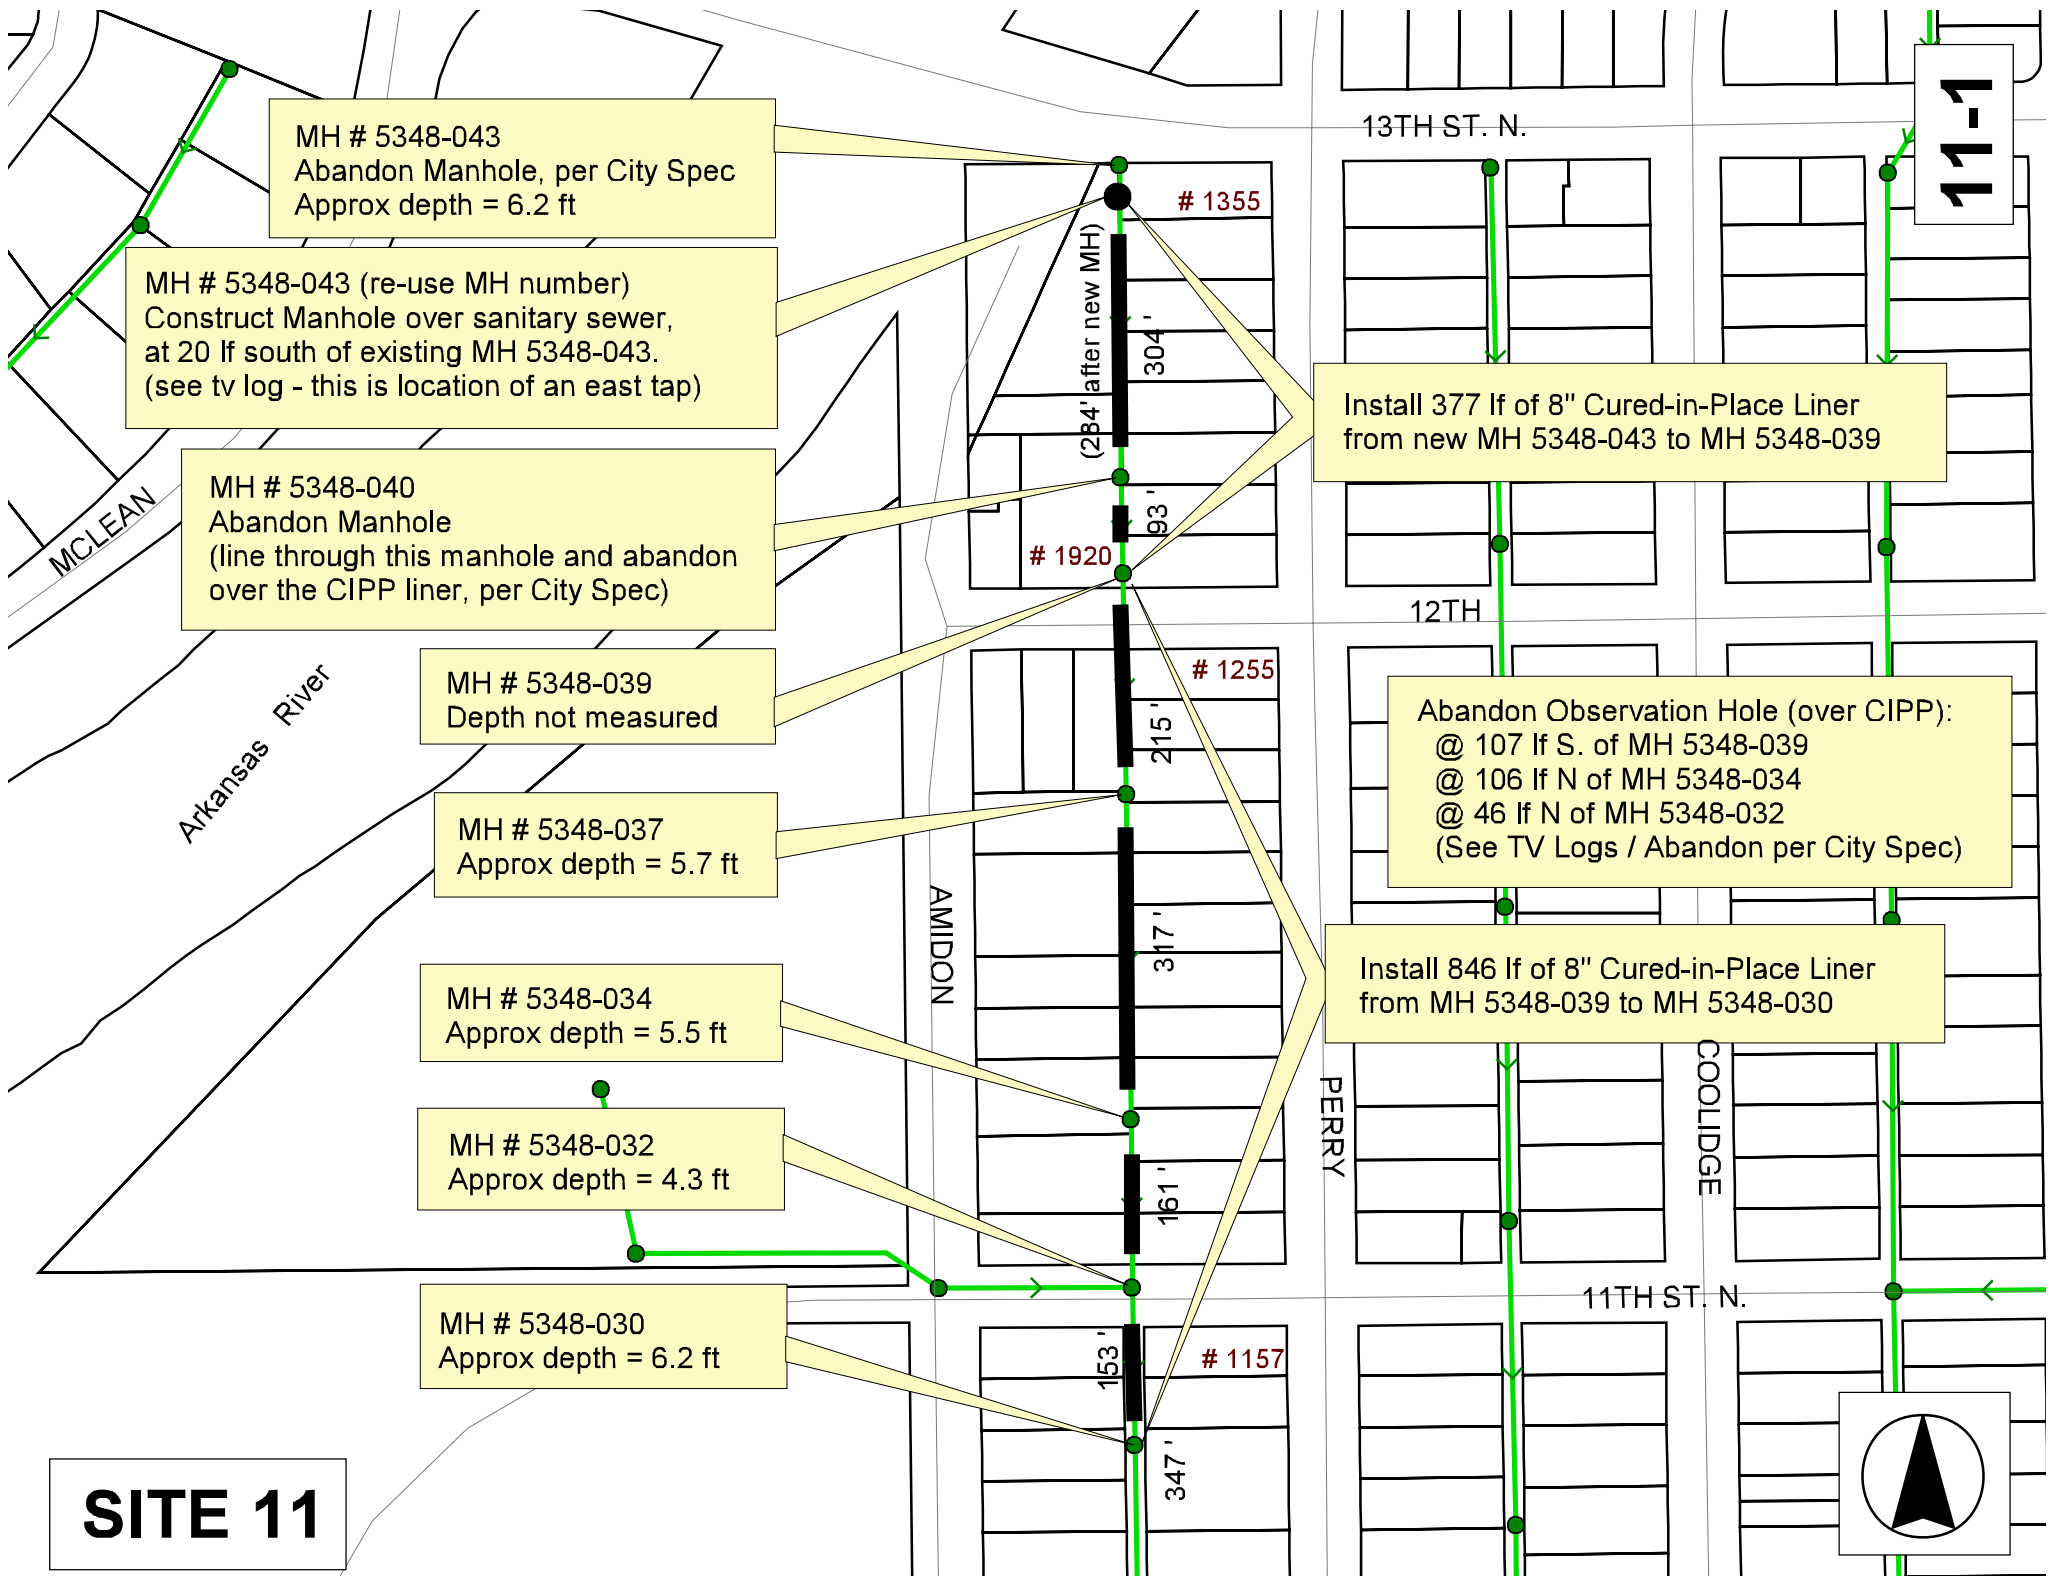
MH # 5348-043
 Abandon Manhole, per City Spec
 Approx depth = 6.2 ft

MH # 5348-040
 Abandon Manhole
 (line through this manhole and abandon
 over the CIPP liner, per City Spec)

MH # 5348-039
 Depth not measured

MH # 5348-037
 Approx depth = 5.7 ft

MH # 5348-034
 Approx depth = 5.5 ft

MH # 5348-032
 Approx depth = 4.3 ft

MH # 5348-030
 Approx depth = 6.2 ft

Abandon Observation Hole (over CIPP):
 @ 107 lf S. of MH 5348-039
 @ 106 lf N of MH 5348-034
 @ 46 lf N of MH 5348-032
 (See TV Logs / Abandon per City Spec)

MH # 5348-043 (re-use MH number)
 Construct Manhole over sanitary sewer,
 at 20 lf south of existing MH 5348-043.
 (see tv log - this is location of an east tap)

Install 377 lf of 8" Cured-in-Place Liner
 from new MH 5348-043 to MH 5348-039

Install 846 lf of 8" Cured-in-Place Liner
 from MH 5348-039 to MH 5348-030
