**2-1**

**SITE 2**

# Television Inspection Master Report

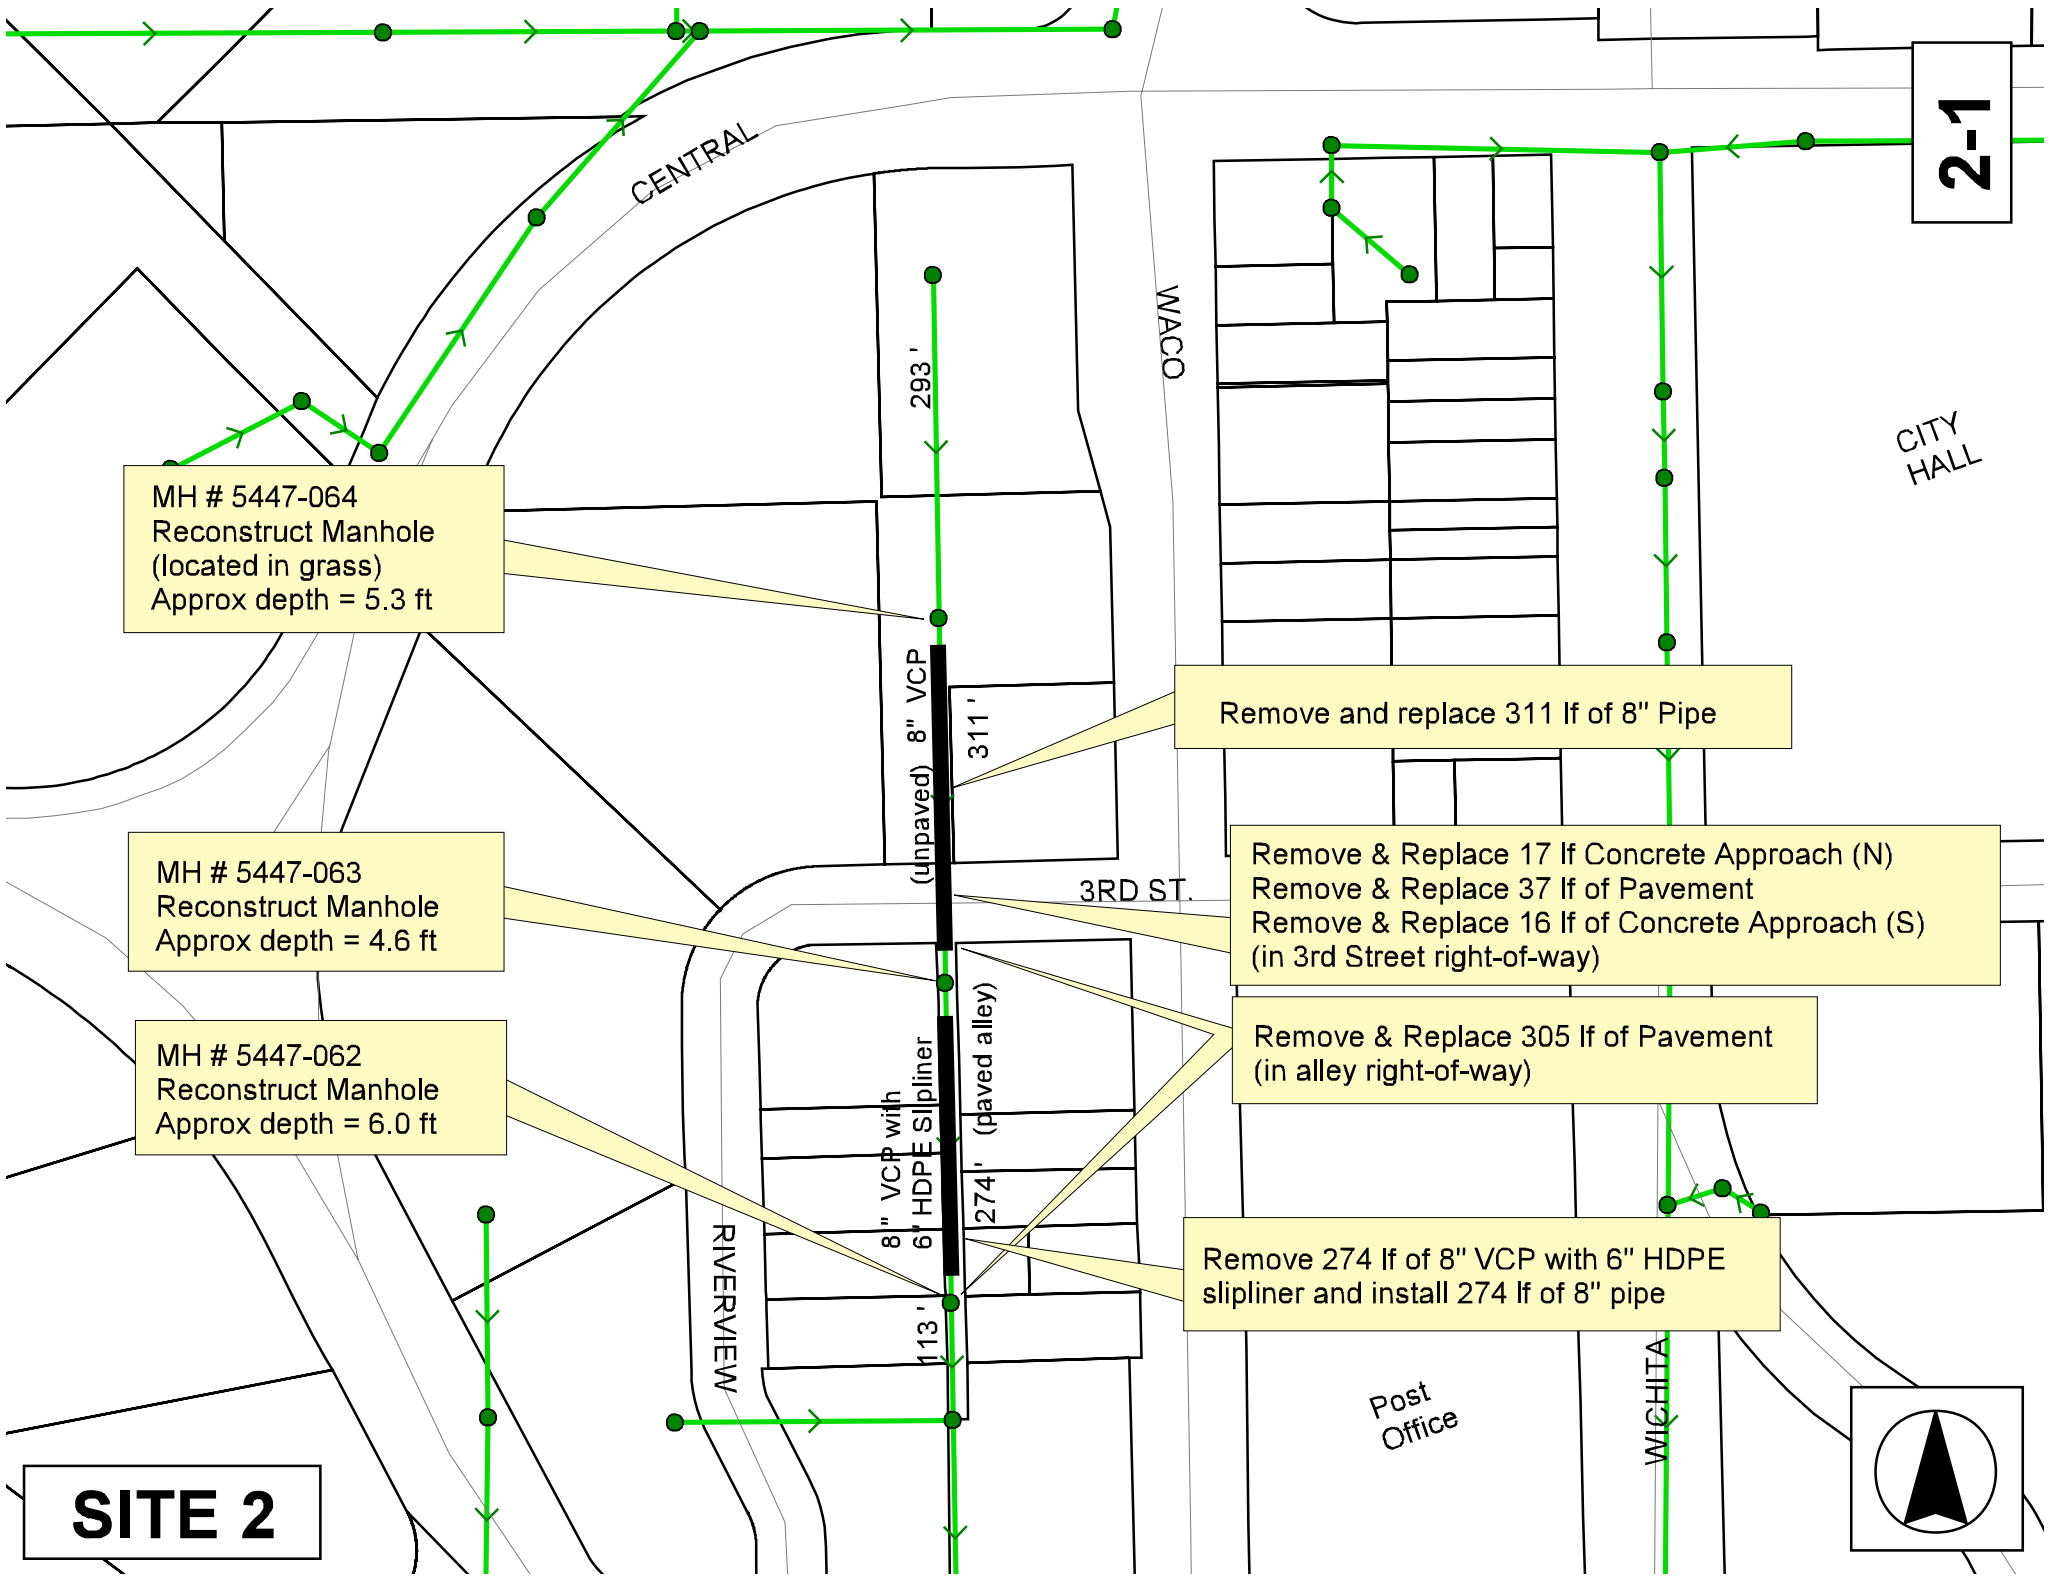
MH # 5447-064  
Reconstruct Manhole  
(located in grass)  
Approx depth = 5.3 ft

MH # 5447-063  
Reconstruct Manhole  
Approx depth = 4.6 ft

MH # 5447-062  
Reconstruct Manhole  
Approx depth = 6.0 ft

Remove and replace 311 lf of 8" Pipe

Remove 274 lf of 8" VCP with 6" HDPE  
slipliner and install 274 lf of 8" pipe
