SITE 6

Aerial View

Television Inspection Master Report

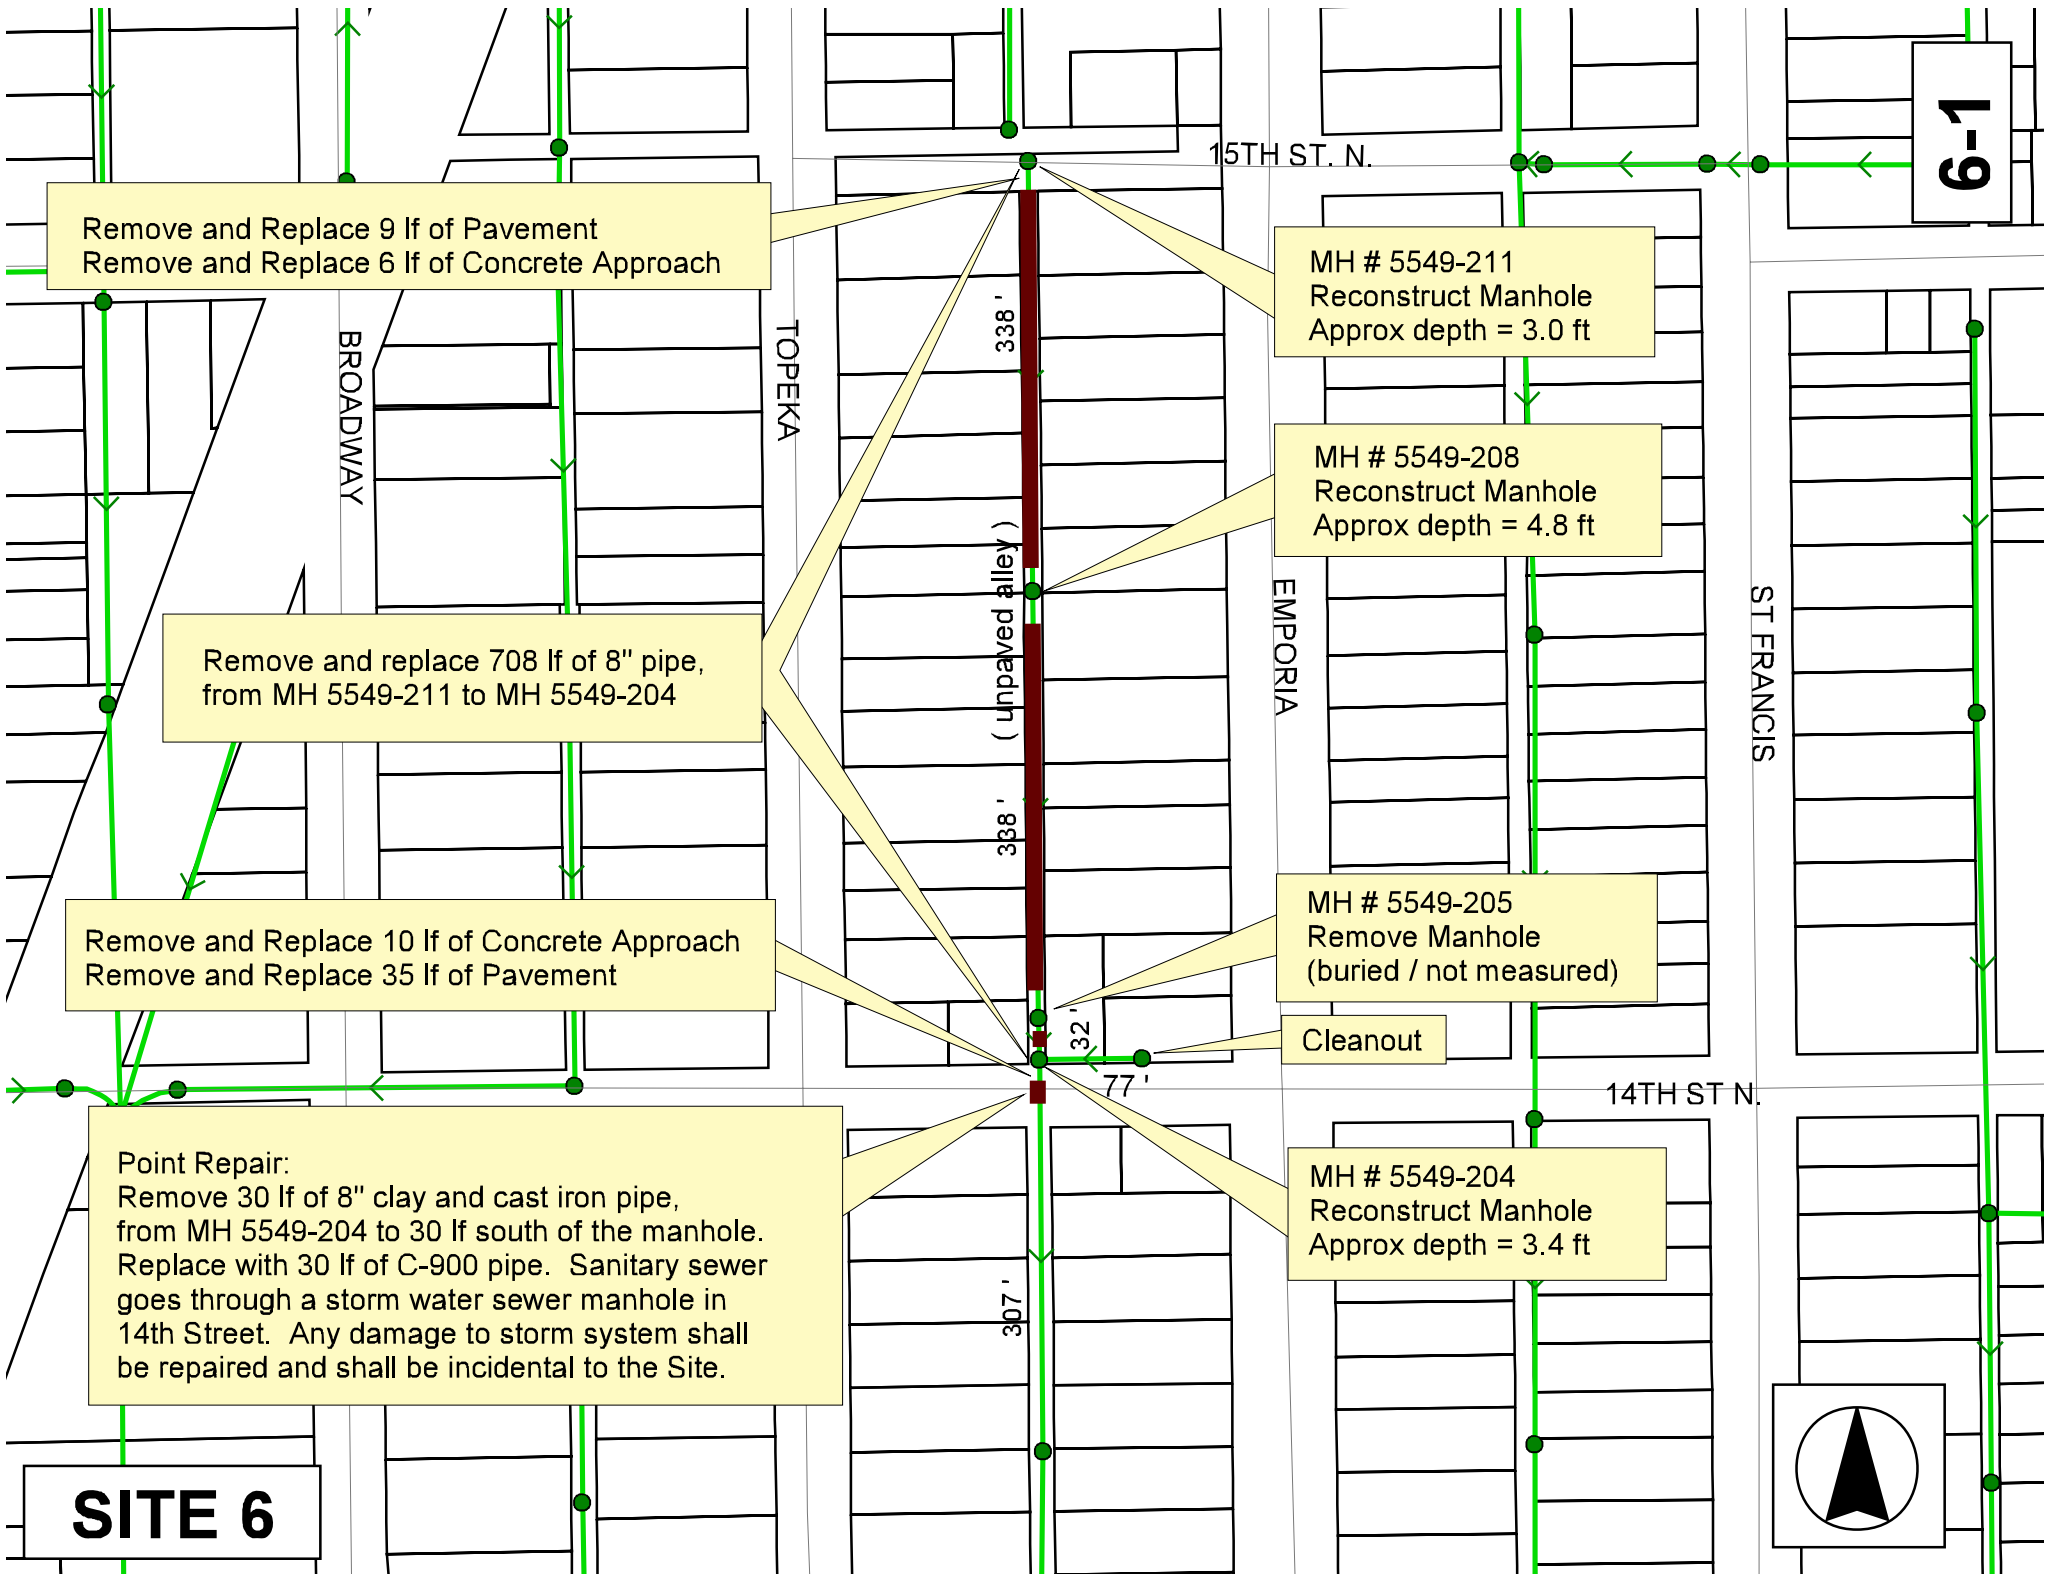
MH # 5549-211
Reconstruct Manhole
Approx depth = 3.0 ft

MH # 5549-208
Reconstruct Manhole
Approx depth = 4.8 ft

MH # 5549-205
Remove Manhole
(buried / not measured)

MH # 5549-204
Reconstruct Manhole
Approx depth = 3.4 ft

Remove and Replace 9 lf of Pavement
Remove and Replace 6 lf of Concrete Approach

Remove and replace 708 lf of 8" pipe,
from MH 5549-211 to MH 5549-204

Remove and Replace 10 lf of Concrete Approach
Remove and Replace 35 lf of Pavement

Point Repair:
Remove 30 lf of 8" clay and cast iron pipe,
from MH 5549-204 to 30 lf south of the manhole.
Replace with 30 lf of C-900 pipe. Sanitary sewer
goes through a storm water sewer manhole in
14th Street. Any damage to storm system shall
be repaired and shall be incidental to the Site.
