**SITE 1**

# Television Inspection Master Report

US Structure: 5750-302      2703 N TERRACE DR      Date Insp: 6/18/2010      Basin: EC02E  
 DS Structure: 5750-301      2731 N TERRACE DR      Dir Televised: Downstream To Upstream

US Structure: 5750-301      2731 N TERRACE DR      Date Insp: 6/18/2010      Basin: EC02E  
 DS Structure: 5750-300      4502 E GREENBRIAR ST      Dir Televised: Upstream To Downstream

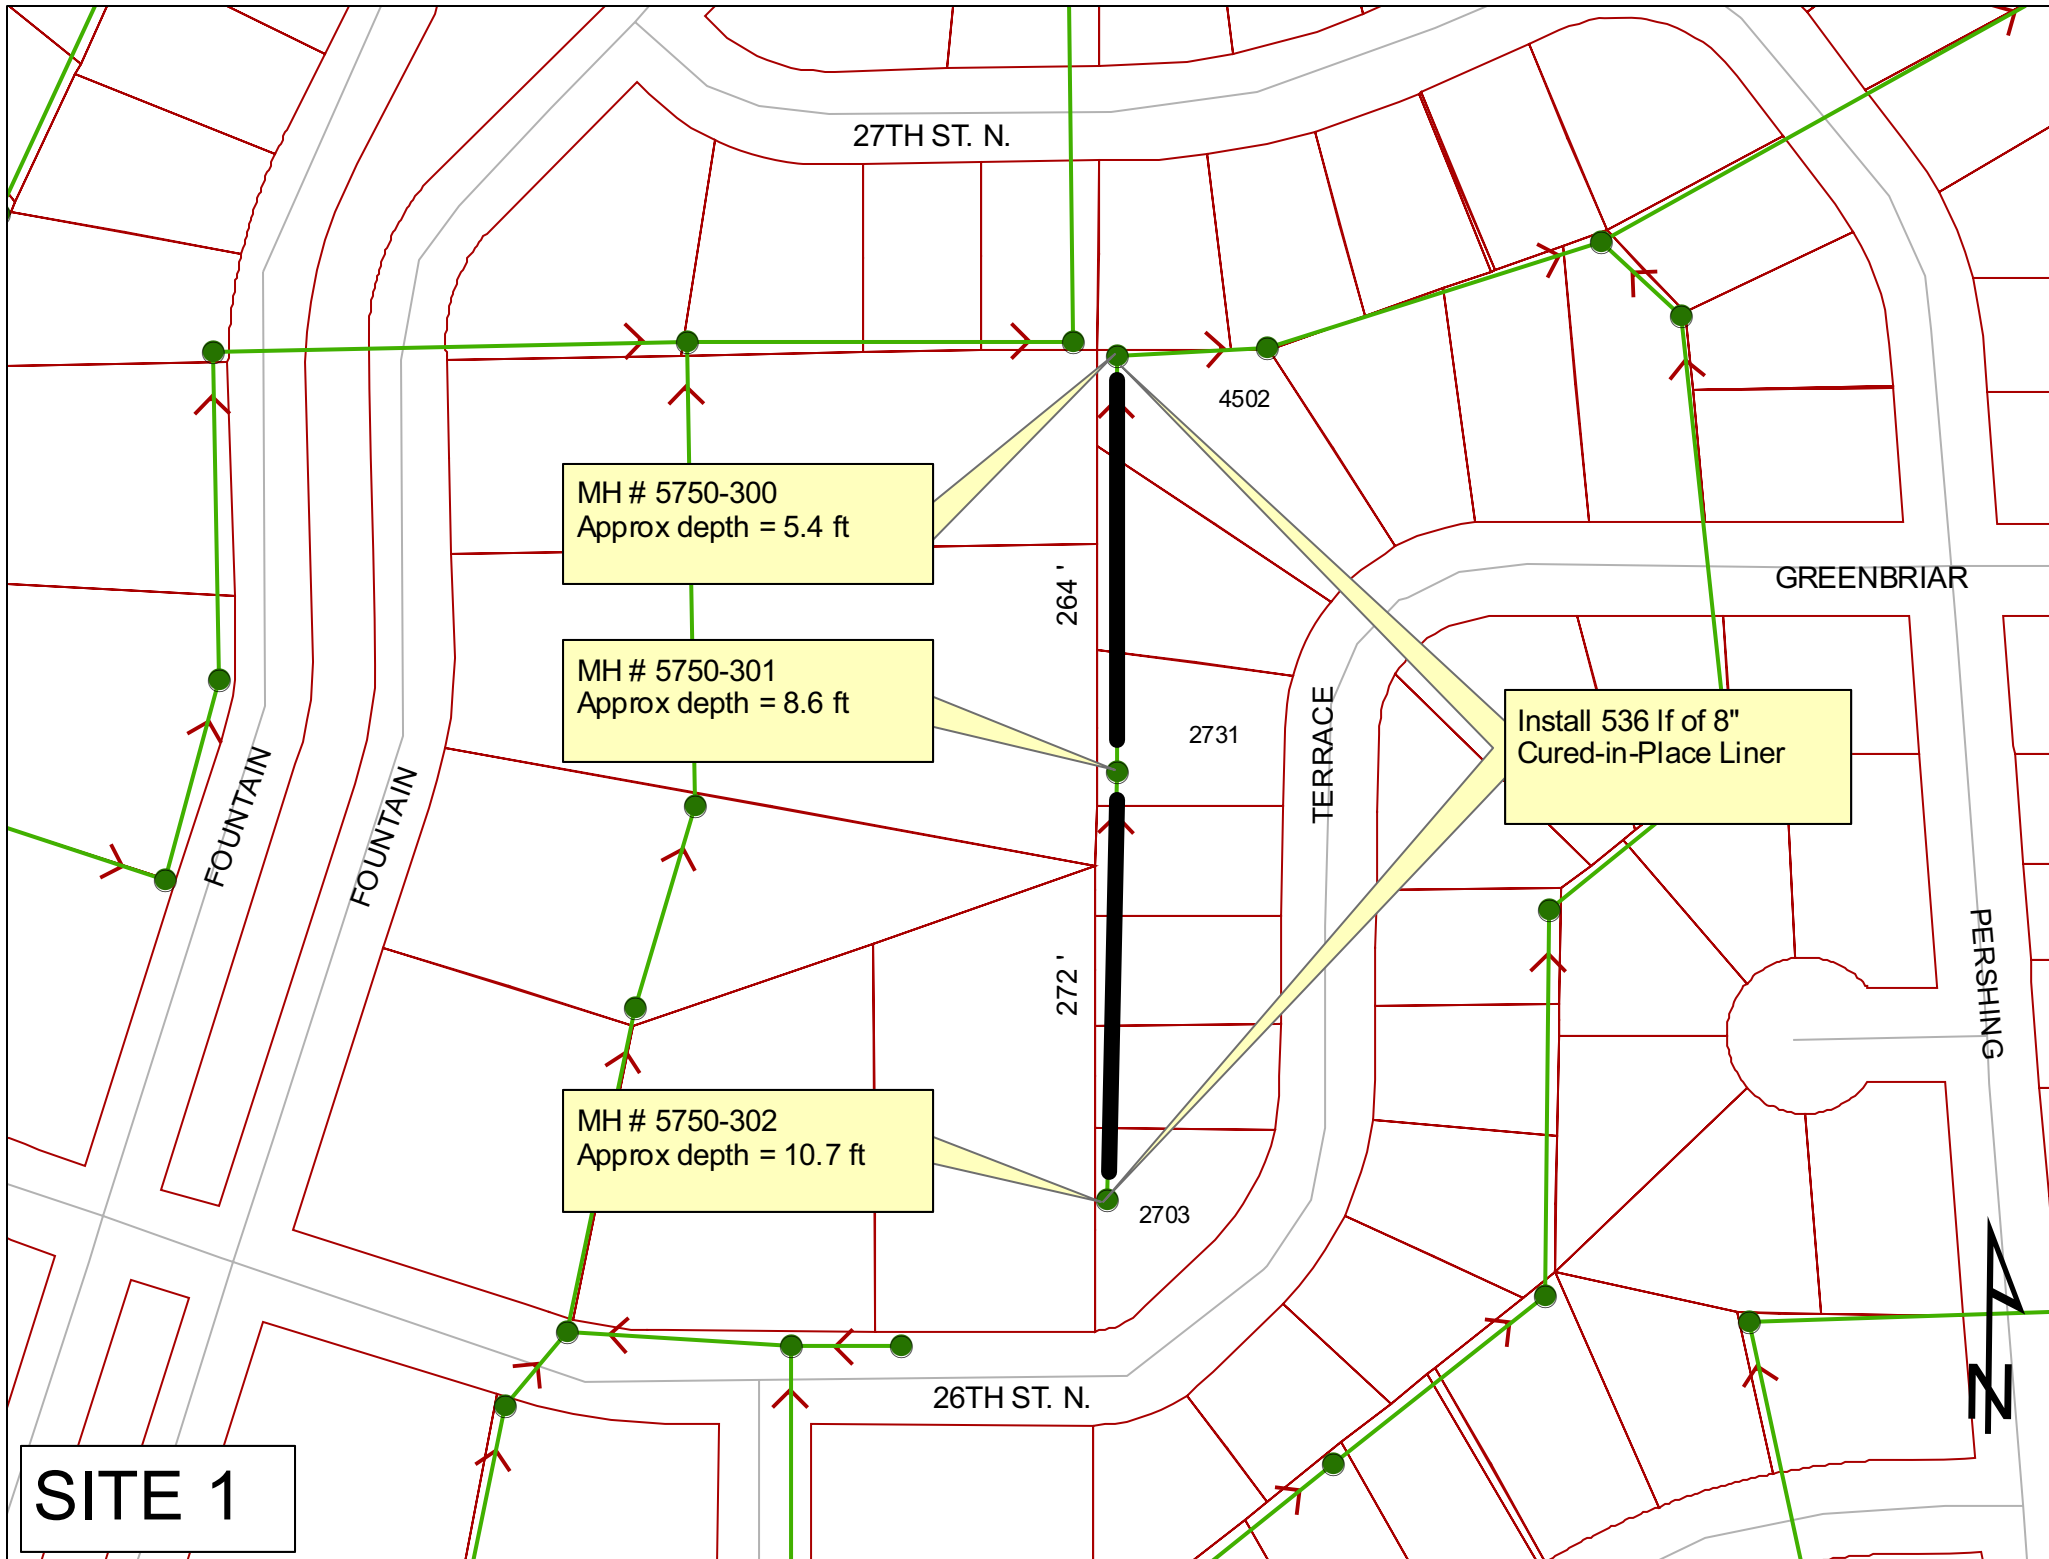
Obs. #	VTR Counter	Distance	Location	Description	Rating	Obsrvd (gpm)	Ratings			Remain (gpm)
							Est. (gpm)	Struct	Clean	
1		0.0		5750-301 / DS Manhole / 2731 NORTH TERRACE / tv against the flow						
2		15.3		Crack-Horizontal	4	0.008	10	0	0.008	
3		21.9		Roots	4	0.010	10	25	0.010	
4		24.1		Broken Pipe	3	0.010	60	0	0.010	
5		24.8		Roots	3	0.008	5	8	0.008	
6		38.0		Crack-Horizontal	3	0.004	5	0	0.004	
7		54.1	East	Wye Service	1	0.000	0	0	0.000	
2723 NORTH TERRACE										
8		62.3	Joint	Broken Pipe / Crown Shifting	5	0.060	100	0	0.060	
9		65.3		Broken Pipe / Crown Shifting	3	0.010	60	0	0.010	
10		69.2		Roots	3	0.008	5	8	0.008	
11		136.5	East	Wye Service / roots	4	0.000	60	0	0.000	
2715 NORTH TERRACE										
12		202.9	East	Wye Service	1	0.000	0	0	0.000	
2707 NORTH TERRACE										
13		262.7	East	Wye Service	1	0.000	0	0	0.000	
2703 NORTH TERRACE										
14		271.9		5750-302 / US Manhole / 2703 NORTH TERRACE This manhole raised by Sewer Maintenance August, 2010 Located southwest of the deck.

Lots of cracks and roots not listed on the tv log.

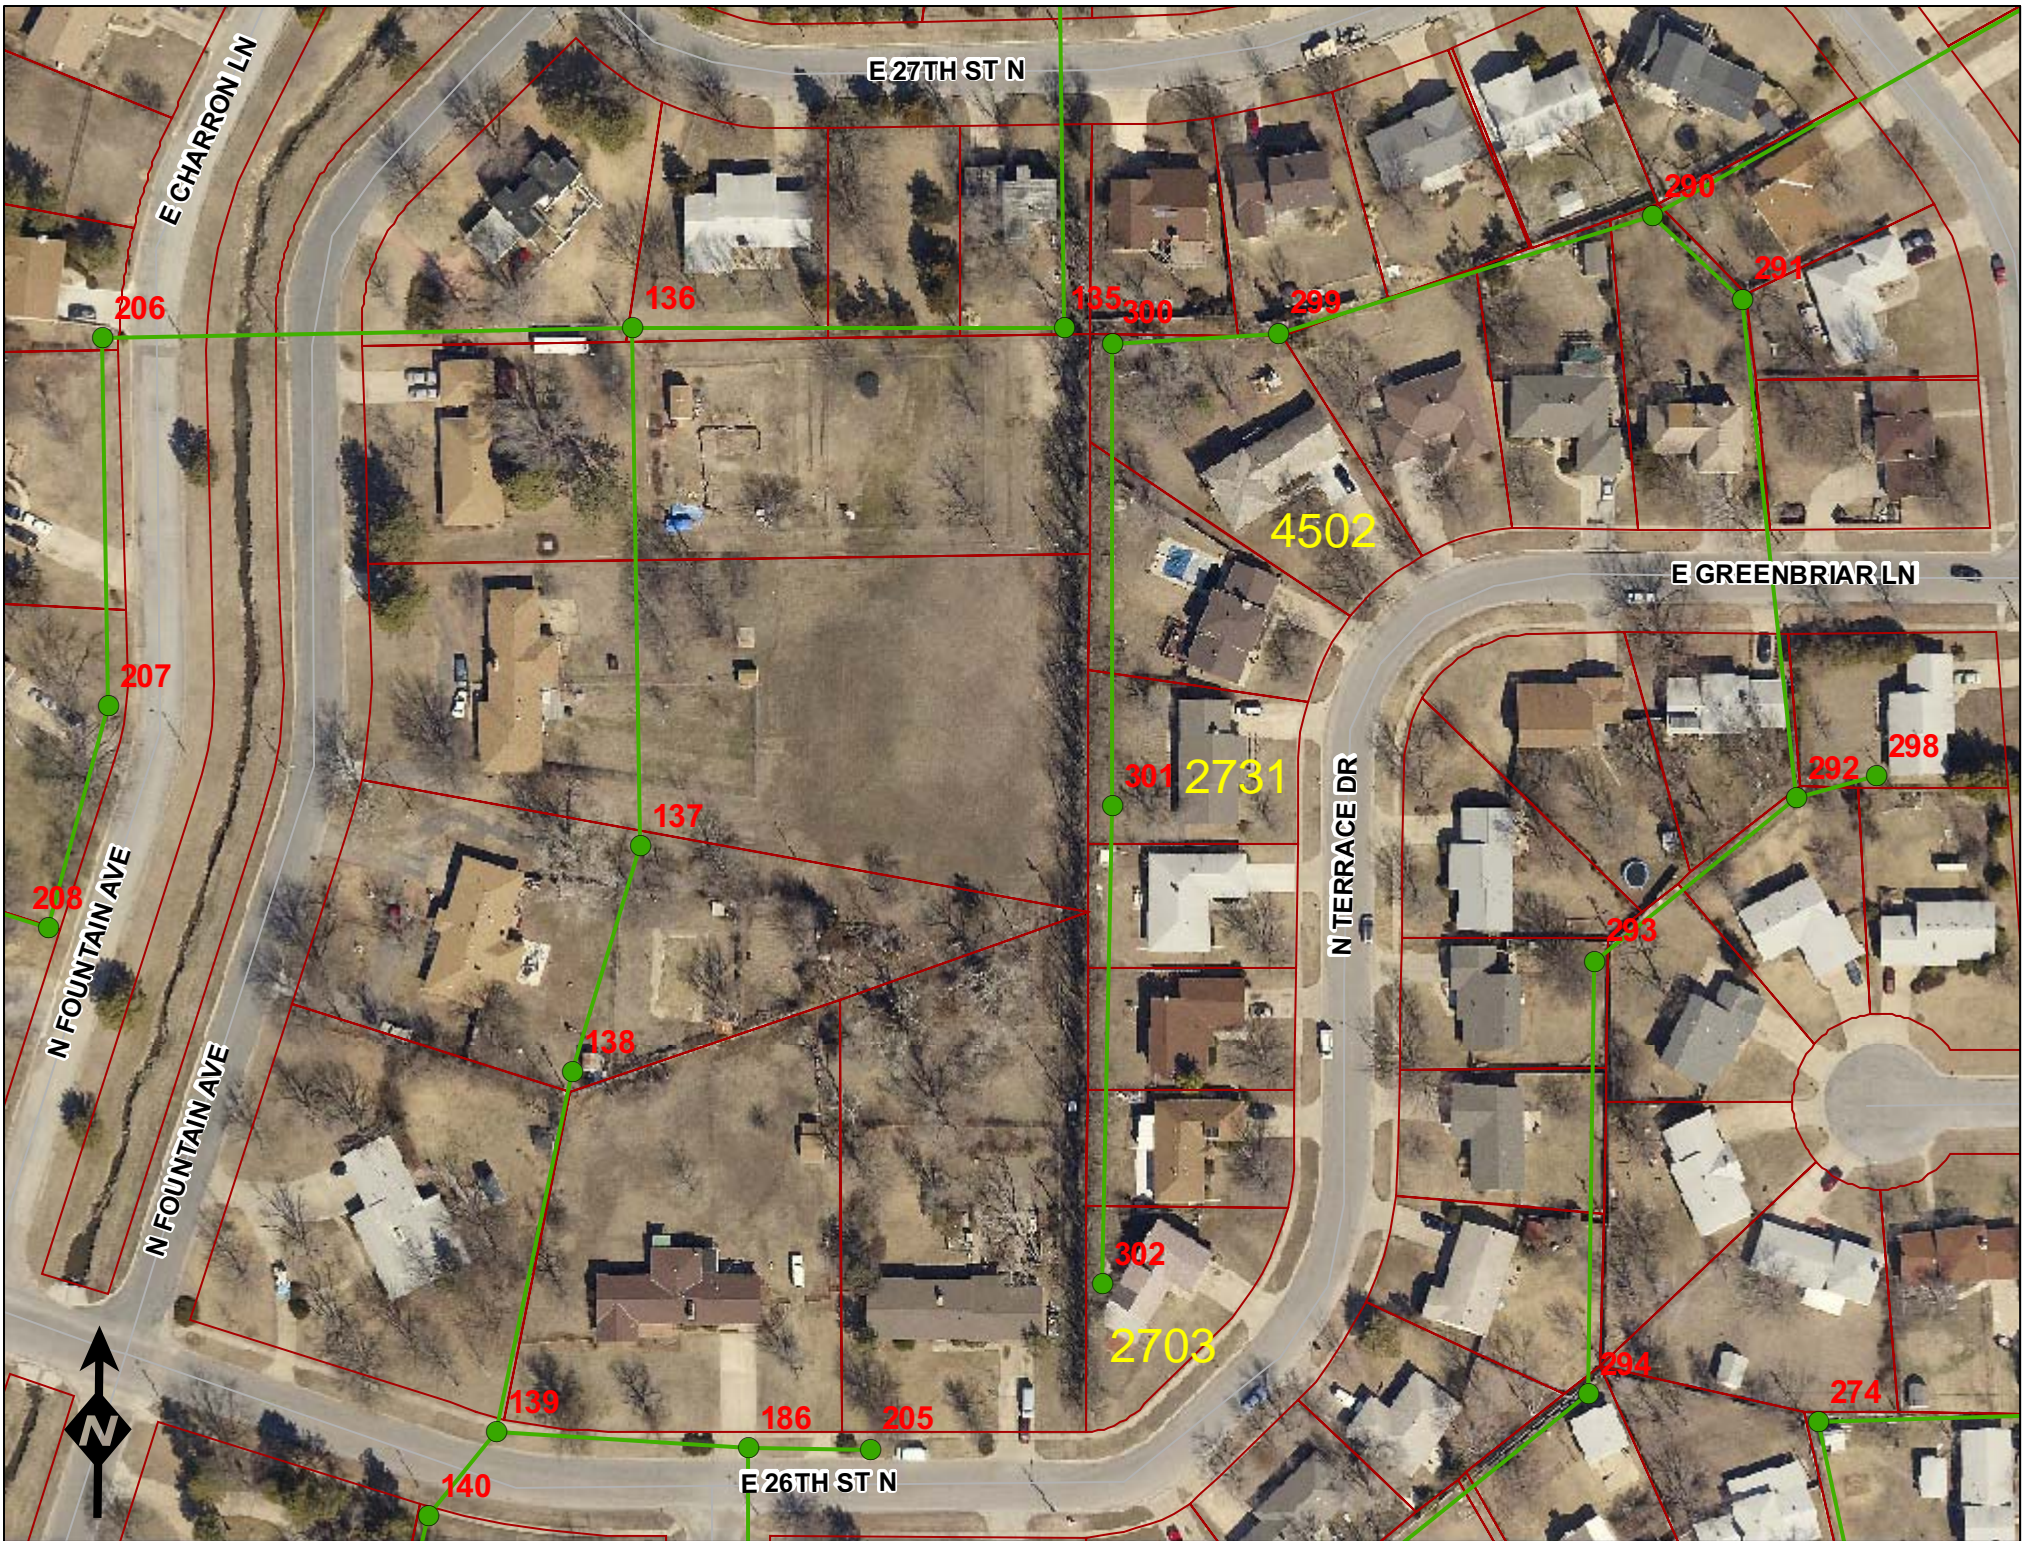
Obs. #	VTR Counter	Distance	Location	Description	Rating	Obsrvd (gpm)	Ratings			Remain (gpm)
							Est. (gpm)	Struct	Clean	
1		0.0		5750-301 / US Manhole	/	2731 NORTH TERRACE				
2		2.5		Crack-Horizontal	3		0.004	5	0	0.004
3		19.9	East	Break-In Conn	3		0.004	2	0	0.004
2731 NORTH TERRACE										
4		21.3		Crack-Horizontal	4		0.008	10	0	0.008
5		26.1		Crack-Horizontal	4		0.008	10	0	0.008
6		30.9		Broken Pipe	3		0.010	60	0	0.010
7		33.4		Broken Pipe	3		0.010	60	0	0.010
8		40.9		Broken Pipe	3		0.010	60	0	0.010
9		46.1		Broken Pipe	3		0.010	60	0	0.010
10		50.7		Broken Pipe	3		0.010	60	0	0.010
11		57.0		Roots (heavy roots)	4		0.010	10	25	0.010
12		60.2		Broken Pipe	4		0.030	78	0	0.030
13		70.6		Broken Pipe	4		0.030	78	0	0.030
14		126.6	East	Wye Service	1		0.000	0	0	0.000
2737 NORTH TERRACE										
15		172.4		Roots	3		0.008	5	8	0.008
16		258.8		Sag	3		0.000	5	0	0.000
17		262.4	Invert /	Broken Pipe / Shifted / camera cannot pass	4		0.030	78	0	0.030

Lots of cracks and roots not listed on the tv log.

<b>POINT REPAIR TO BE PERFORMED BY SEWER MAINTENANCE PRIOR TO LINER INSTALLATION</b>										
18		263.0		5750-300 / DS Manhole	1		0.000	0	0	0.000
4502 EAST GREENBRIAR
