Install 581 lf of 8" Cured-in-Place Liner

Television Inspection Master Report

US Structure: 5948-378
DS Structure: 5948-377

Project No. : J-051
Index:
Surface:

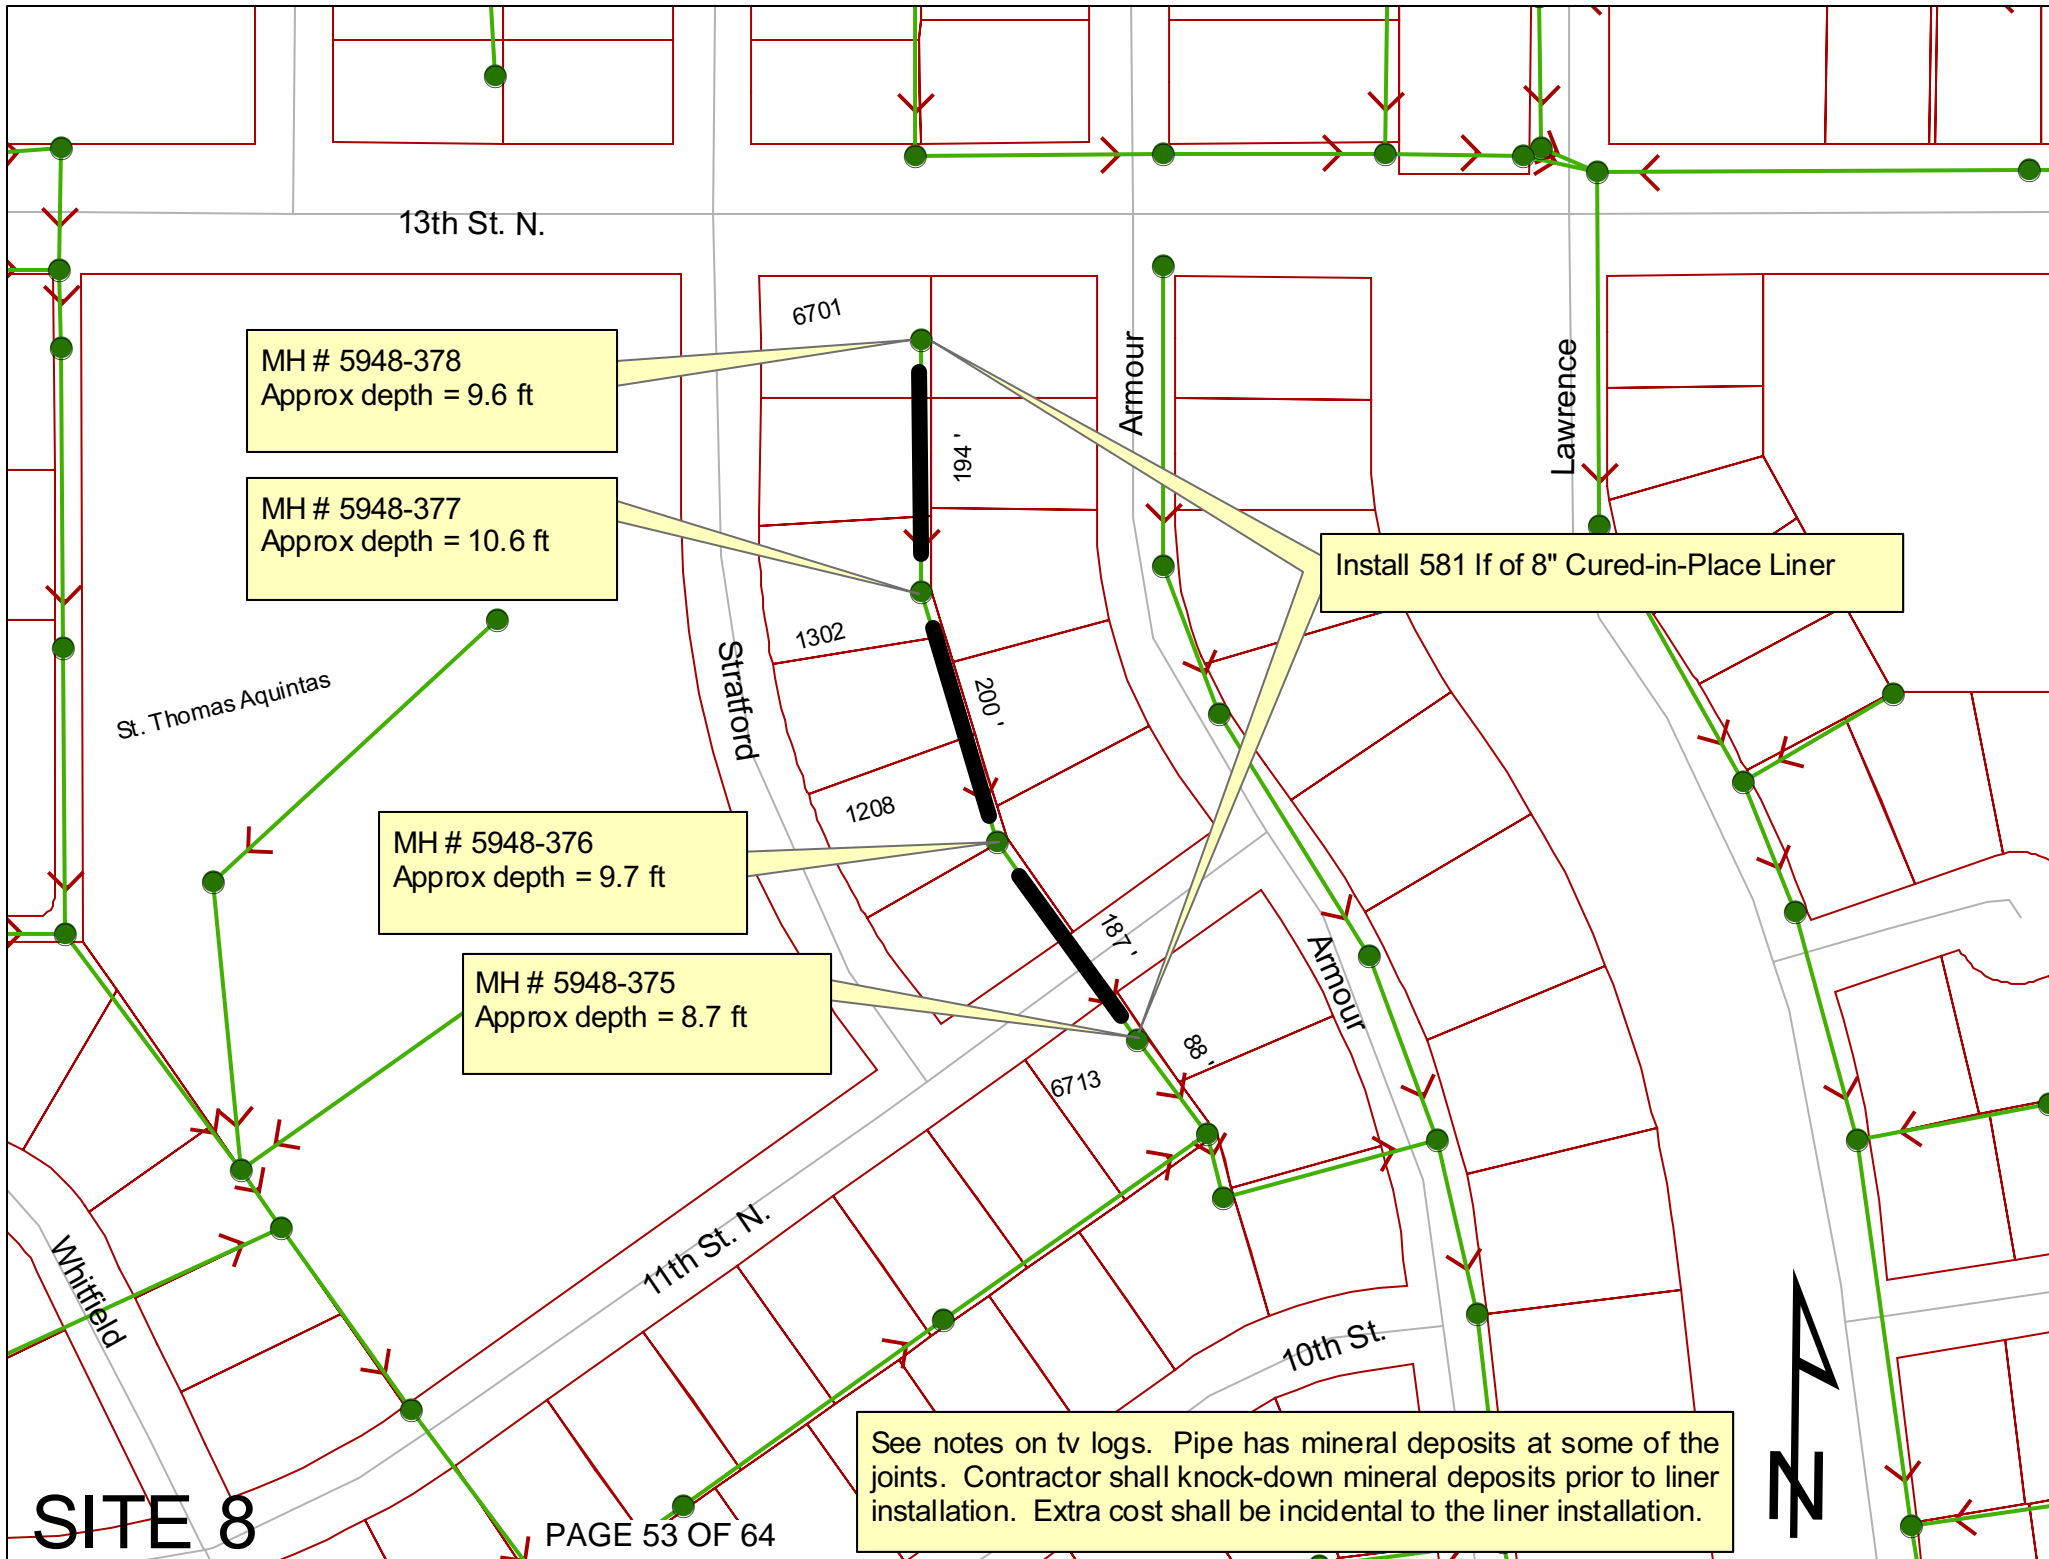
MH # 5948-378
Approx depth = 9.6 ft

MH # 5948-377
Approx depth = 10.6 ft

MH # 5948-376
Approx depth = 9.7 ft

MH # 5948-375
Approx depth = 8.7 ft

See notes on tv logs. Pipe has mineral deposits at some of the joints. Contractor shall knock-down mineral deposits prior to liner installation. Extra cost shall be incidental to the liner installation.

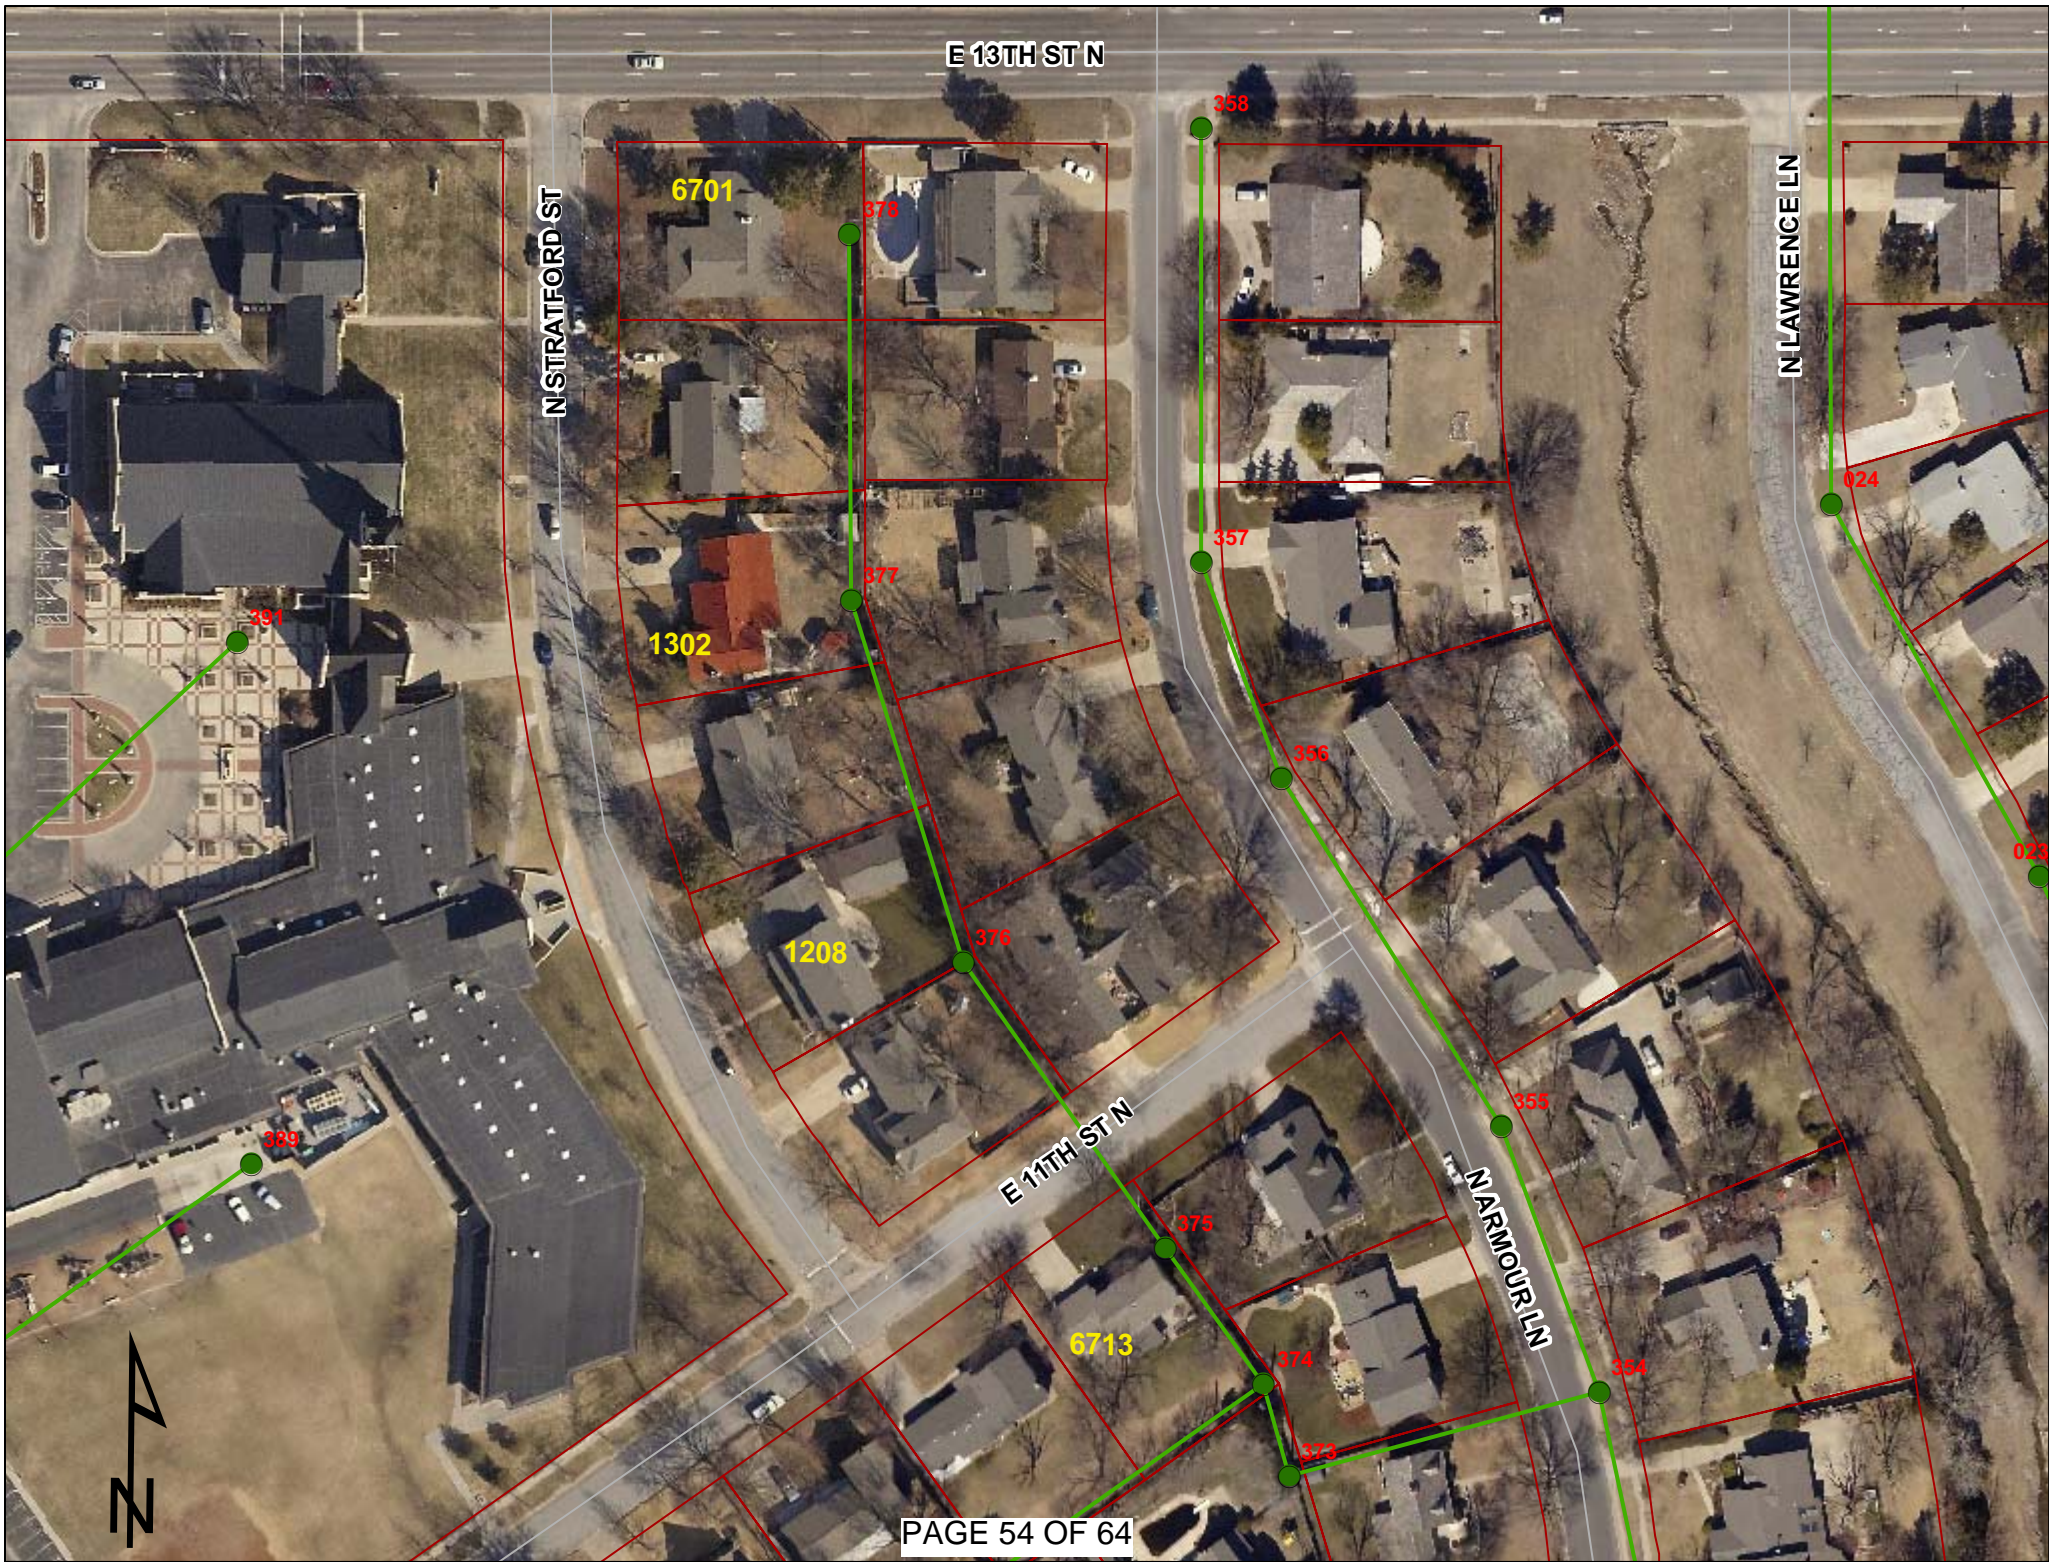
Obs. #	VTR Counter	Distance	Location	Description	Rating	Obsrvd (gpm)	Ratings			Remain (gpm)
							Est. (gpm)	Struct	Clean	
1		0.0	6701 EAST 13TH ST NORTH	5948-378 US Manhole	1	0.000	0	0	0.000	
2		20.5		Roots	3	0.008	5	8	0.008	
3		21.8	6701 EAST 13TH ST NORTH	W Wye Service	2	0.000	0	0	0.000	
4		31.9	1315 NORTH ARMOUJR	E Wye Service	1	0.000	0	0	0.000	
5		57.5		Roots	3	0.008	5	8	0.008	
6		115.4	1307 NORTH ARMOUR	E Wye Service	4	0.000	60	0	0.000	
7		145.8	1308 NORTH STRATFORD	W Wye Service	2	0.000	0	0	0.000	
8		192.0		Broken Pipe	3	0.010	60	0	0.010	
9		194.5	1302 NORTH STRATFORD	5948-377 DS Manhole	1	0.000	0	0	0.000

This segment is in good condition.
