SITE 1

Sheet 4 of 24

# Television Inspection Master Report

US Structure: 5845-087      1947 S ROANOKE ST      Date Insp: 5/12/2008      Basin: E01B2  
 DS Structure: 5845-086      1959 S ROANOKE DR      Dir Televised: Upstream To Downstream

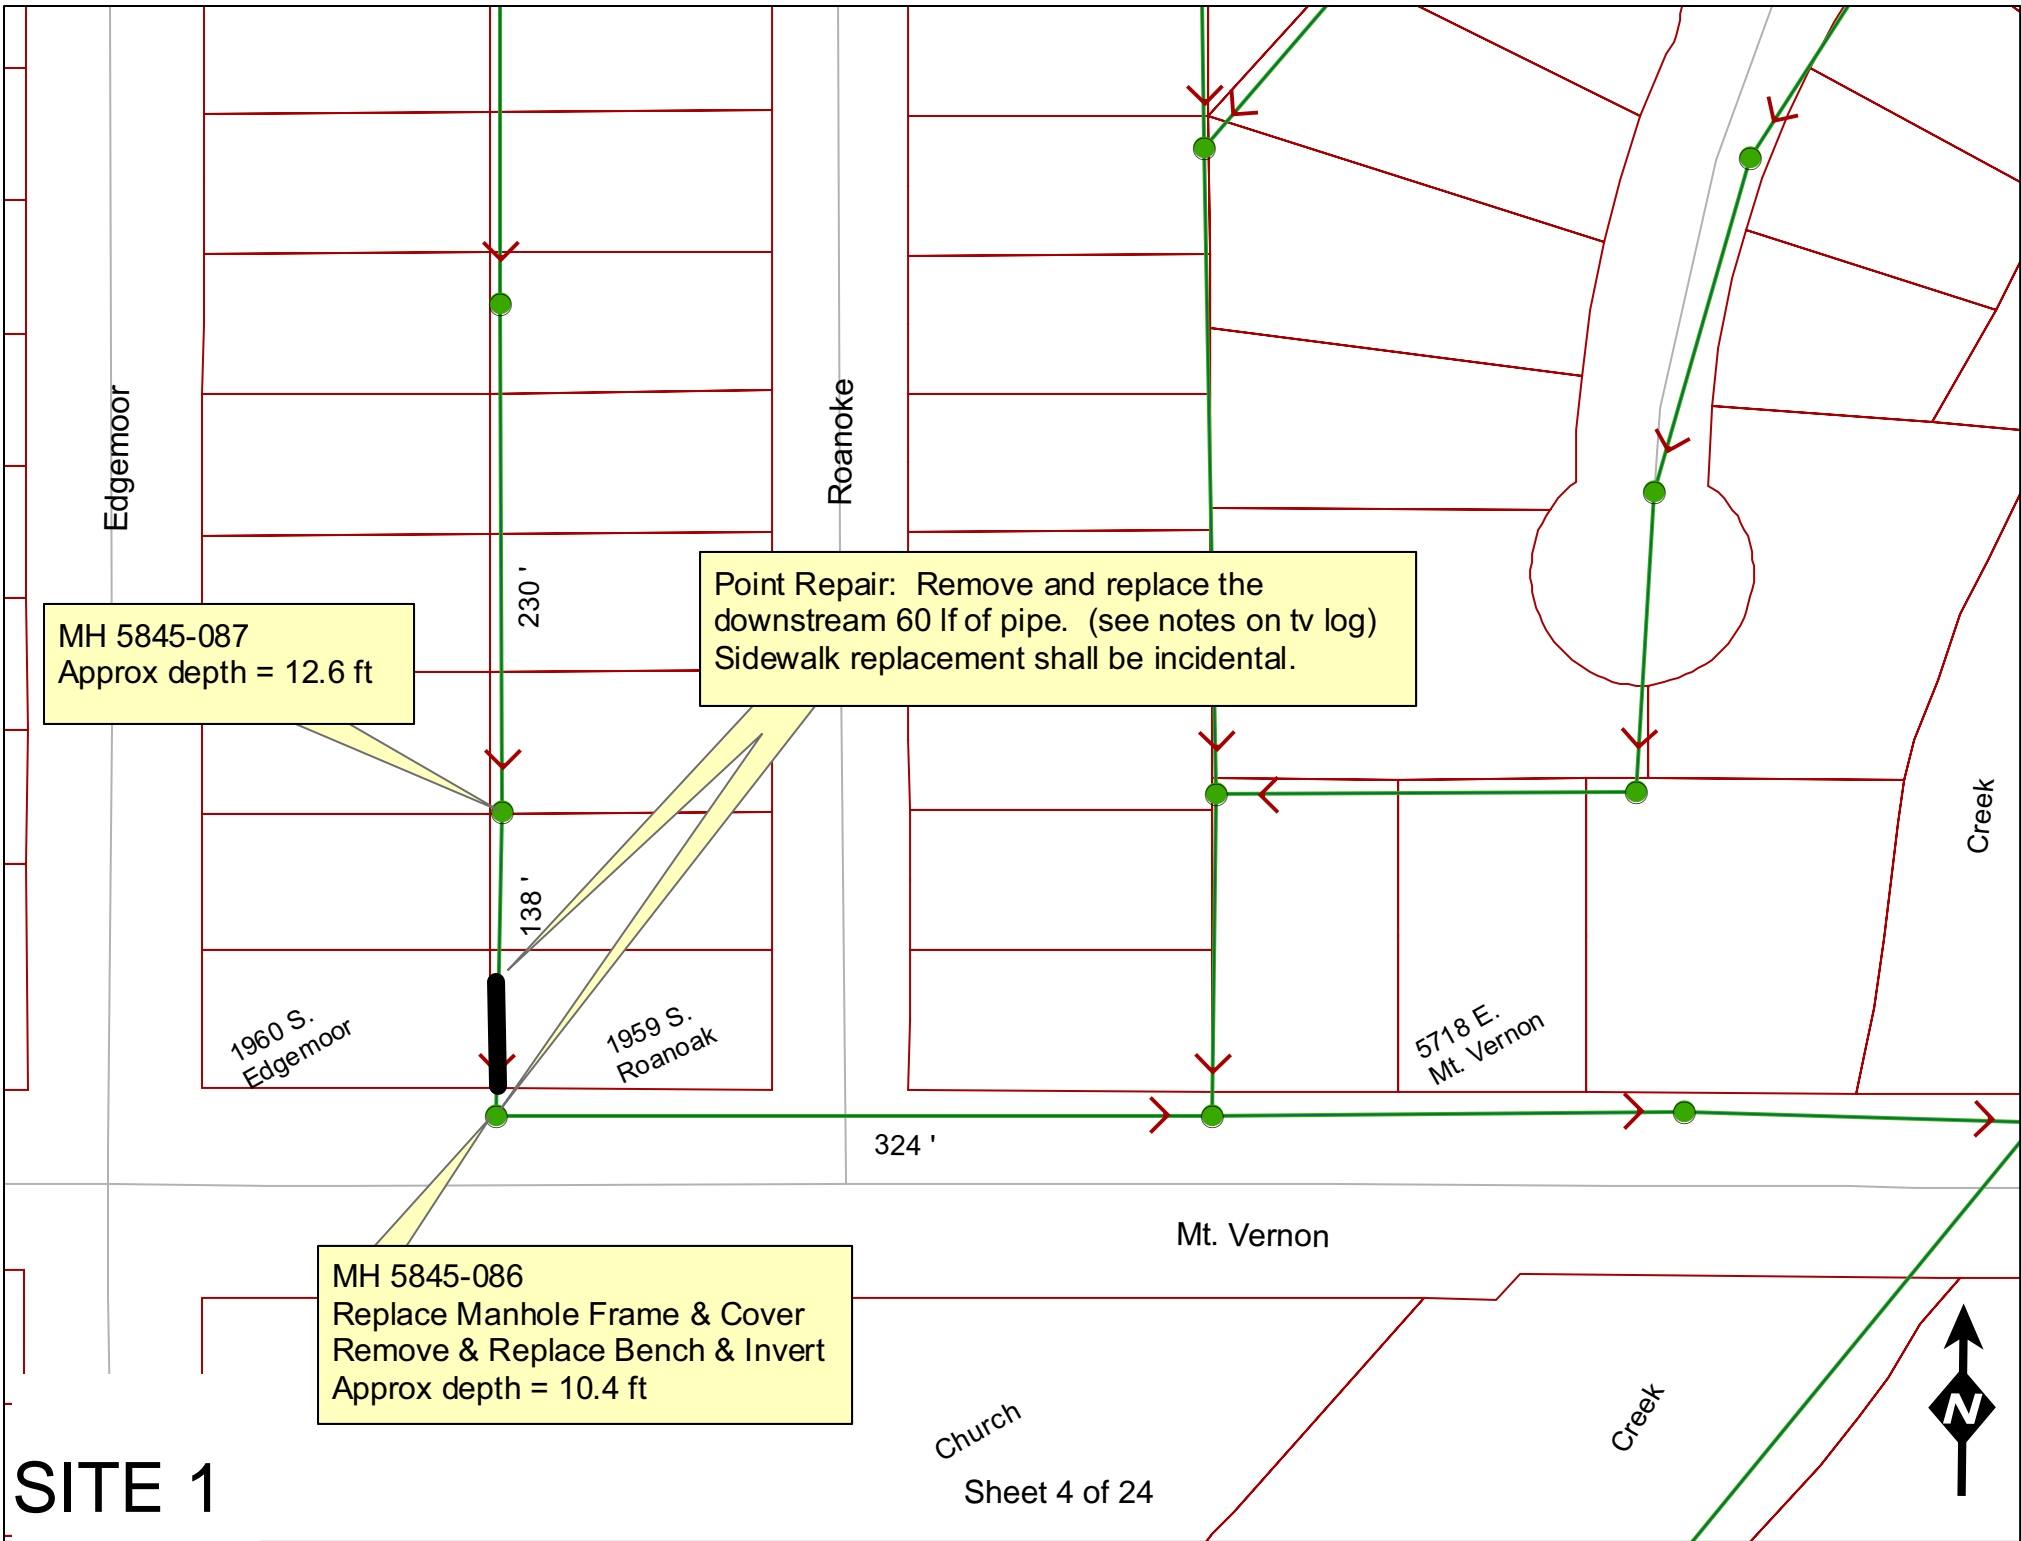
MH 5845-087  
Approx depth = 12.6 ft

MH 5845-086  
Replace Manhole Frame & Cover  
Remove & Replace Bench & Invert  
Approx depth = 10.4 ft

Point Repair: Remove and replace the downstream 60 lf of pipe. (see notes on tv log)  
Sidewalk replacement shall be incidental.

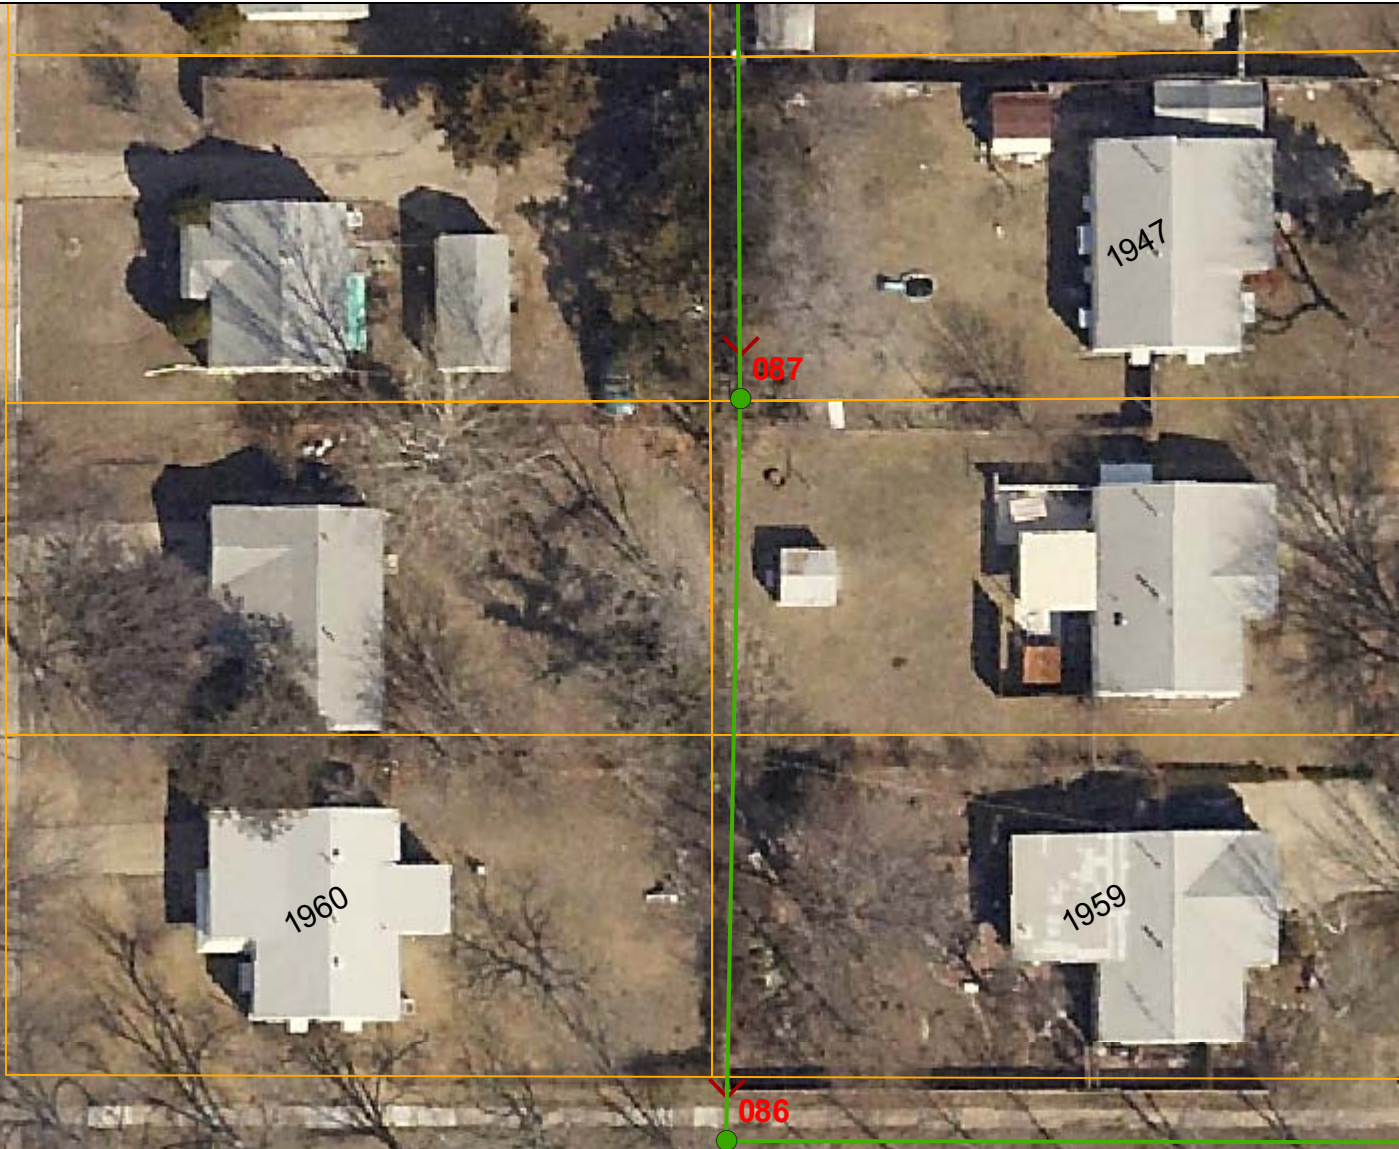
18		81.2	Joint / Offset / <u>pipe dips downward</u>	/	Roots & Grease					
27		82.0			Begin Sag	3	0.000	5	0	0.000
19		87.3	Joint / Roots		Offset	2	0.000	0	0	0.000
20		93.1	Lower Left		Grease	2	0.000	0	0	0.000
21		95.2	Upper Left		Grease	2	0.000	0	0	0.000
28		96.6	Camera Lens Emerged		Sag	2	0.000	2	0	0.000
22		103.4	Upper Left		Grease	2	0.000	0	0	0.000
29		105.8	Camera Lens Submerged		Sag	4	0.000	10	0	0.000
23		106.7	West		Wye Service	2	0.000	0	0	0.000
			1960 S EDGEMOOR / roots	4" Clay Wye Connection / located in a sag

24	109.6	East	Break-In Conn	2	0.002	0	0	0.002
1959 S ROANOKE			4" Break In Connection / located in a sag					
30	133.8	Camera Lens Emerged	Sag	1	0.000	1	0	0.000
26	134.2	Lower Right	Crack-Horizontal	1	0.001	1	0	0.001
31	134.2	Offset Joint / roots	End Sag	1	0.000	1	0	0.000
32	138.0	DS Manhole 5845-086		3				(small inside drop)

The ground elevation in the back yards is mounded up and higher than the elevation of the downstream manhole lid.  
 (pipe is deeper than the 10.4 feet shown as the downstream manhole depth)

Replace the downstream 60 lf of pipe. (from the wall of manhole 5845-086, past the point of the severe offset shown at 81.2 ft)

Sidewalk replacement shall be incidental to the pipe replacement.

Includes replacement of two service connections
