McCormick-Armstrong
1501 E. Douglas

SITE 3

Television Inspection Master Report

US Structure: 5547-415 1501 E DOUGLAS AVE Date Insp: 7/8/2010 Basin: C03A
 DS Structure: 5547-414 1501 E DOUGLAS AVE Dir Televised: Upstream To Downstream

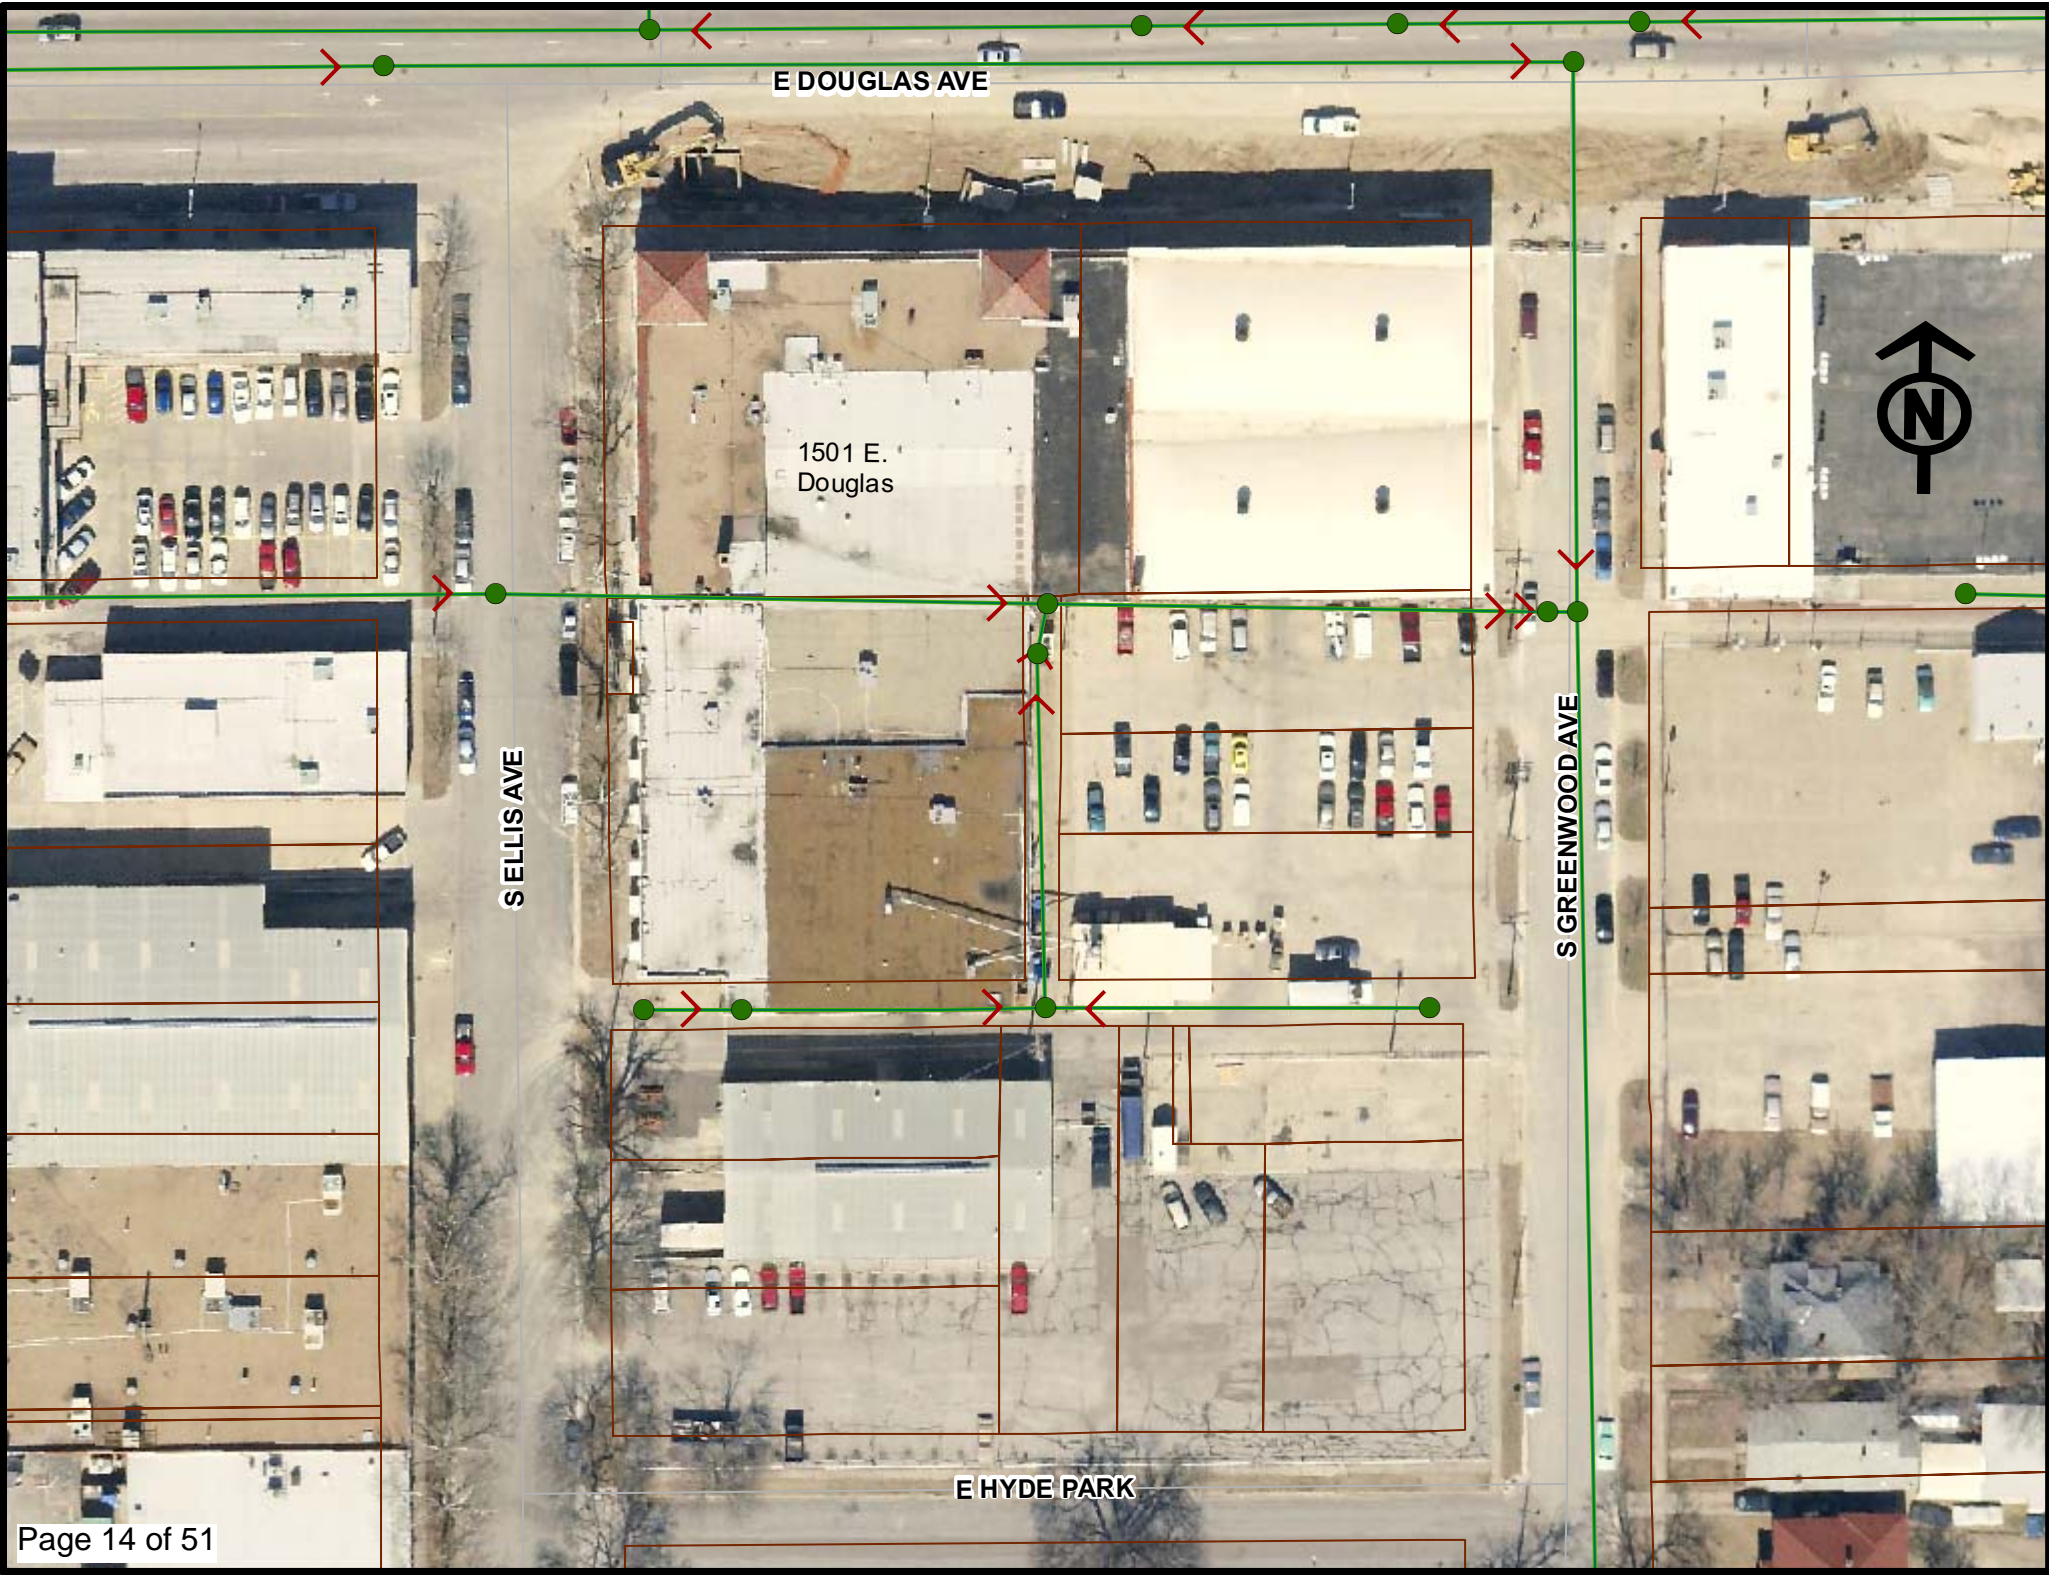
MH # 5547-415
Approx depth = 10.3 ft

MH # 5547-414
Approx MH depth = 11.6 ft
(inside drop from south)

MH # 5547-413
Approx depth = 10.4 ft

MH # 5547-433
Approx depth = 8.6 ft

MH # 5547-435
Approx depth = 4.0 ft

Install 360 lf of 18" Cured-in-Place Liner
from MH 5547-415 to MH 5547-413

Install 149 lf of 8" Cured-in-Place Liner
from MH 5547-435 to MH 5547-414
