SITE 4

Television Inspection Master Report

Shape: Round Project No. : C-049 Tape ID: DVD #0441
Dia/Ht: 8 Material: VCP
Length: 105.5 Slope: 0.400 Crew: 692

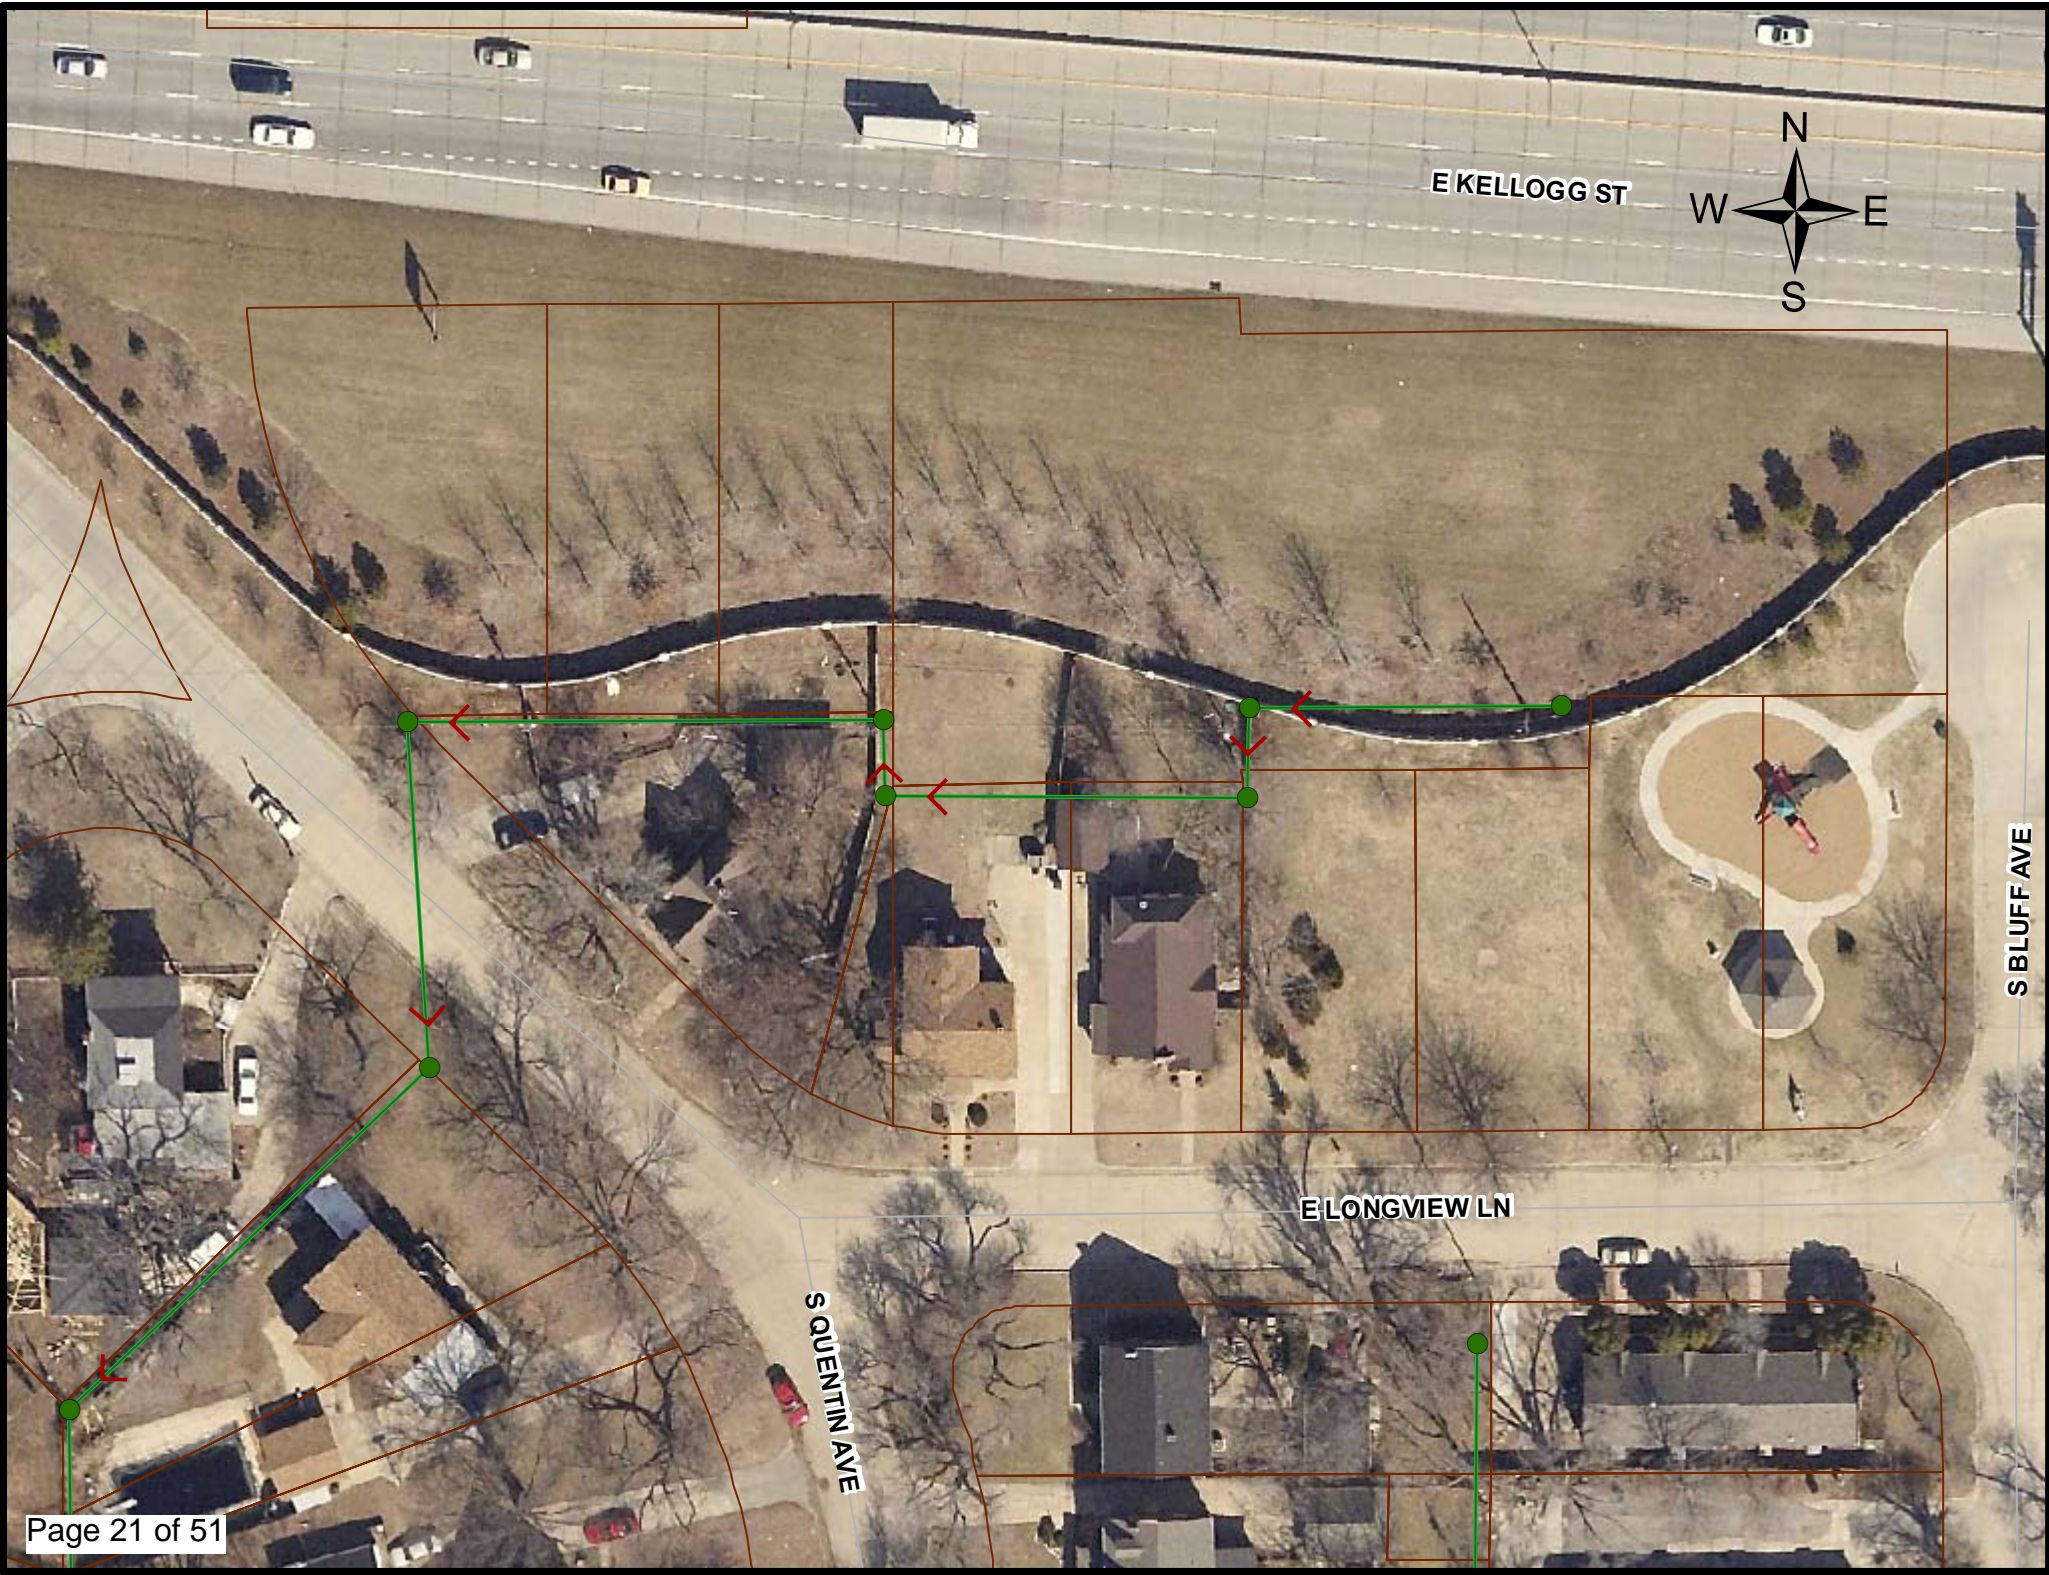
Obs. #	VTR Counter	Distance	Location	Description	Rating	Obsrvd (gpm)	Ratings			Remain (gpm)
							Est. (gpm)	Struct	Clean	
1		0.0	US Manhole	5746-396						
3906 E LONGVIEW / There should be nothing tapped upstream of MH 5746-396										
2		10.7		Sealed Off Wye North	1	0.000	0	0	0.000	
3		11.6	Joint	Roots	1	0.002	1	1	0.002	
4		12.6	South	Break-In Conn	3	0.004	2	0	0.004	
3906 E LONGVIEW 4" Predco Saddle / roots around perimeter of tap										
5		14.7	Upper Left	Crack-Horizontal	2	0.002	2	0	0.002	
6		17.5	North	Possibly Sealed Off Break-In Conn	(sealoff is not visible)					
7		36.0		Sealed Off Wye North	1	0.000	0	0	0.000	
8		39.3		Sealed Off Wye South	1	0.000	0	0	0.000	
9		64.1		Sealed Off Wye North	1	0.000	0	0	0.000	
10		66.9		Sealed Off Wye South	1	0.000	0	0	0.000	
11		81.3		Mat. Chngs to PVC	1	0.000	0	0	0.000	
12		82.2	South	Break-In Conn	1	0.001	0	0	0.001	
3904 E LONGVIEW 4" Predco Saddle

13		83.9	Crown	Mat. Chngs to VCP	1	0.000	0	0	0.000	
14		85.4	North	Sealed Off Break-In Conn	1	0.001	0	0	0.001	
15		87.0	Start	Sag	1	0.000	1	0	0.000	
16		88.6	Camera Lens Emerged	Sag	4	0.000	10	0	0.000	
17		90.5	Camera Lens Submerged	Sag	1	0.000	1	0	0.000	
18		94.1	End	Sag	1	0.000	1	0	0.000	
(sag not too bad / camera pulls back and you can see clear across the pipe / too deep to dig up here for small sag)										
19		105.6	DS Manhole	5746-395	1	0.000	0	0	0.000

Obs. #	VTR Counter	Distance	Location	Description	Rating	Obsrvd (gpm)	Ratings		Remain (gpm)
							Est. (gpm)	Struct Clean	
1		0.0	DS Manhole	5746-393 / tv against the flow	3902 E LONGVIEW				
2		14.5		Sealed Off Wye North	5	0.005	0	0	0.005
3		17.7		Sealed Off Wye South	1	0.000	0	0	0.000
4		51.9	Upper Right	Crack-Horizontal	2	0.002	2	0	0.002
5		55.0	Upper Right	Crack-Horizontal	2	0.002	2	0	0.002
6		61.2		Sealed Off Wye North	5	0.005	0	0	0.005
7		64.6		Sealed Off Wye South	1	0.000	0	0	0.000
8		72.4	Joint	Roots	1	0.002	1	1	0.002
9		77.7	Joint	Roots	1	0.002	1	1	0.002
10		80.2	Offset Joint	Roots	1	0.002	1	1	0.002
11		82.9	Offset Joint	Roots	1	0.002	1	1	0.002
12		85.4	Joint	Roots	1	0.002	1	1	0.002
13		93.3	Upper Right	Mat. Chngs to PVC	1	0.000	0	0	0.000
14		94.5	South	Break-In Conn	1	0.001	0	0	0.001
				4" PVC Saddle "T" Conn					
15		96.2	Crown	Mat. Chngs to VCP	1	0.000	0	0	0.000
16		103.7		Sealed Off Wye South	1	0.000	0	0	0.000

17		116.8	Upper Right	Mat. Chngs to PVC	1	0.000	0	0	0.000
18		118.5		Sealed Off Wye North	1	0.000	0	0	0.000
19		119.5	Crown	Mat. Chngs to VCP	1	0.000	0	0	0.000
20		137.6	US Manhole	5746-393

No TV Inspection has been made to date. This line is being included in this project because the block south of MH 5746-392 has already been lined with CIPP. There should be no taps on this segment.

Install 105 lf of 8" Cured-in-Place Liner

Install 138 lf of 8" Cured-in-Place Liner

Install 88 lf of 8" Cured-in-Place Liner
