SITE 5A

Television Inspection Master Report

US Structure: 5744-933
DS Structure: 5744-882

Project No. : J-137 Dia: 12 Material: VCP Length: 708.0 Slope: 0.220 Tape ID: DVD #0573

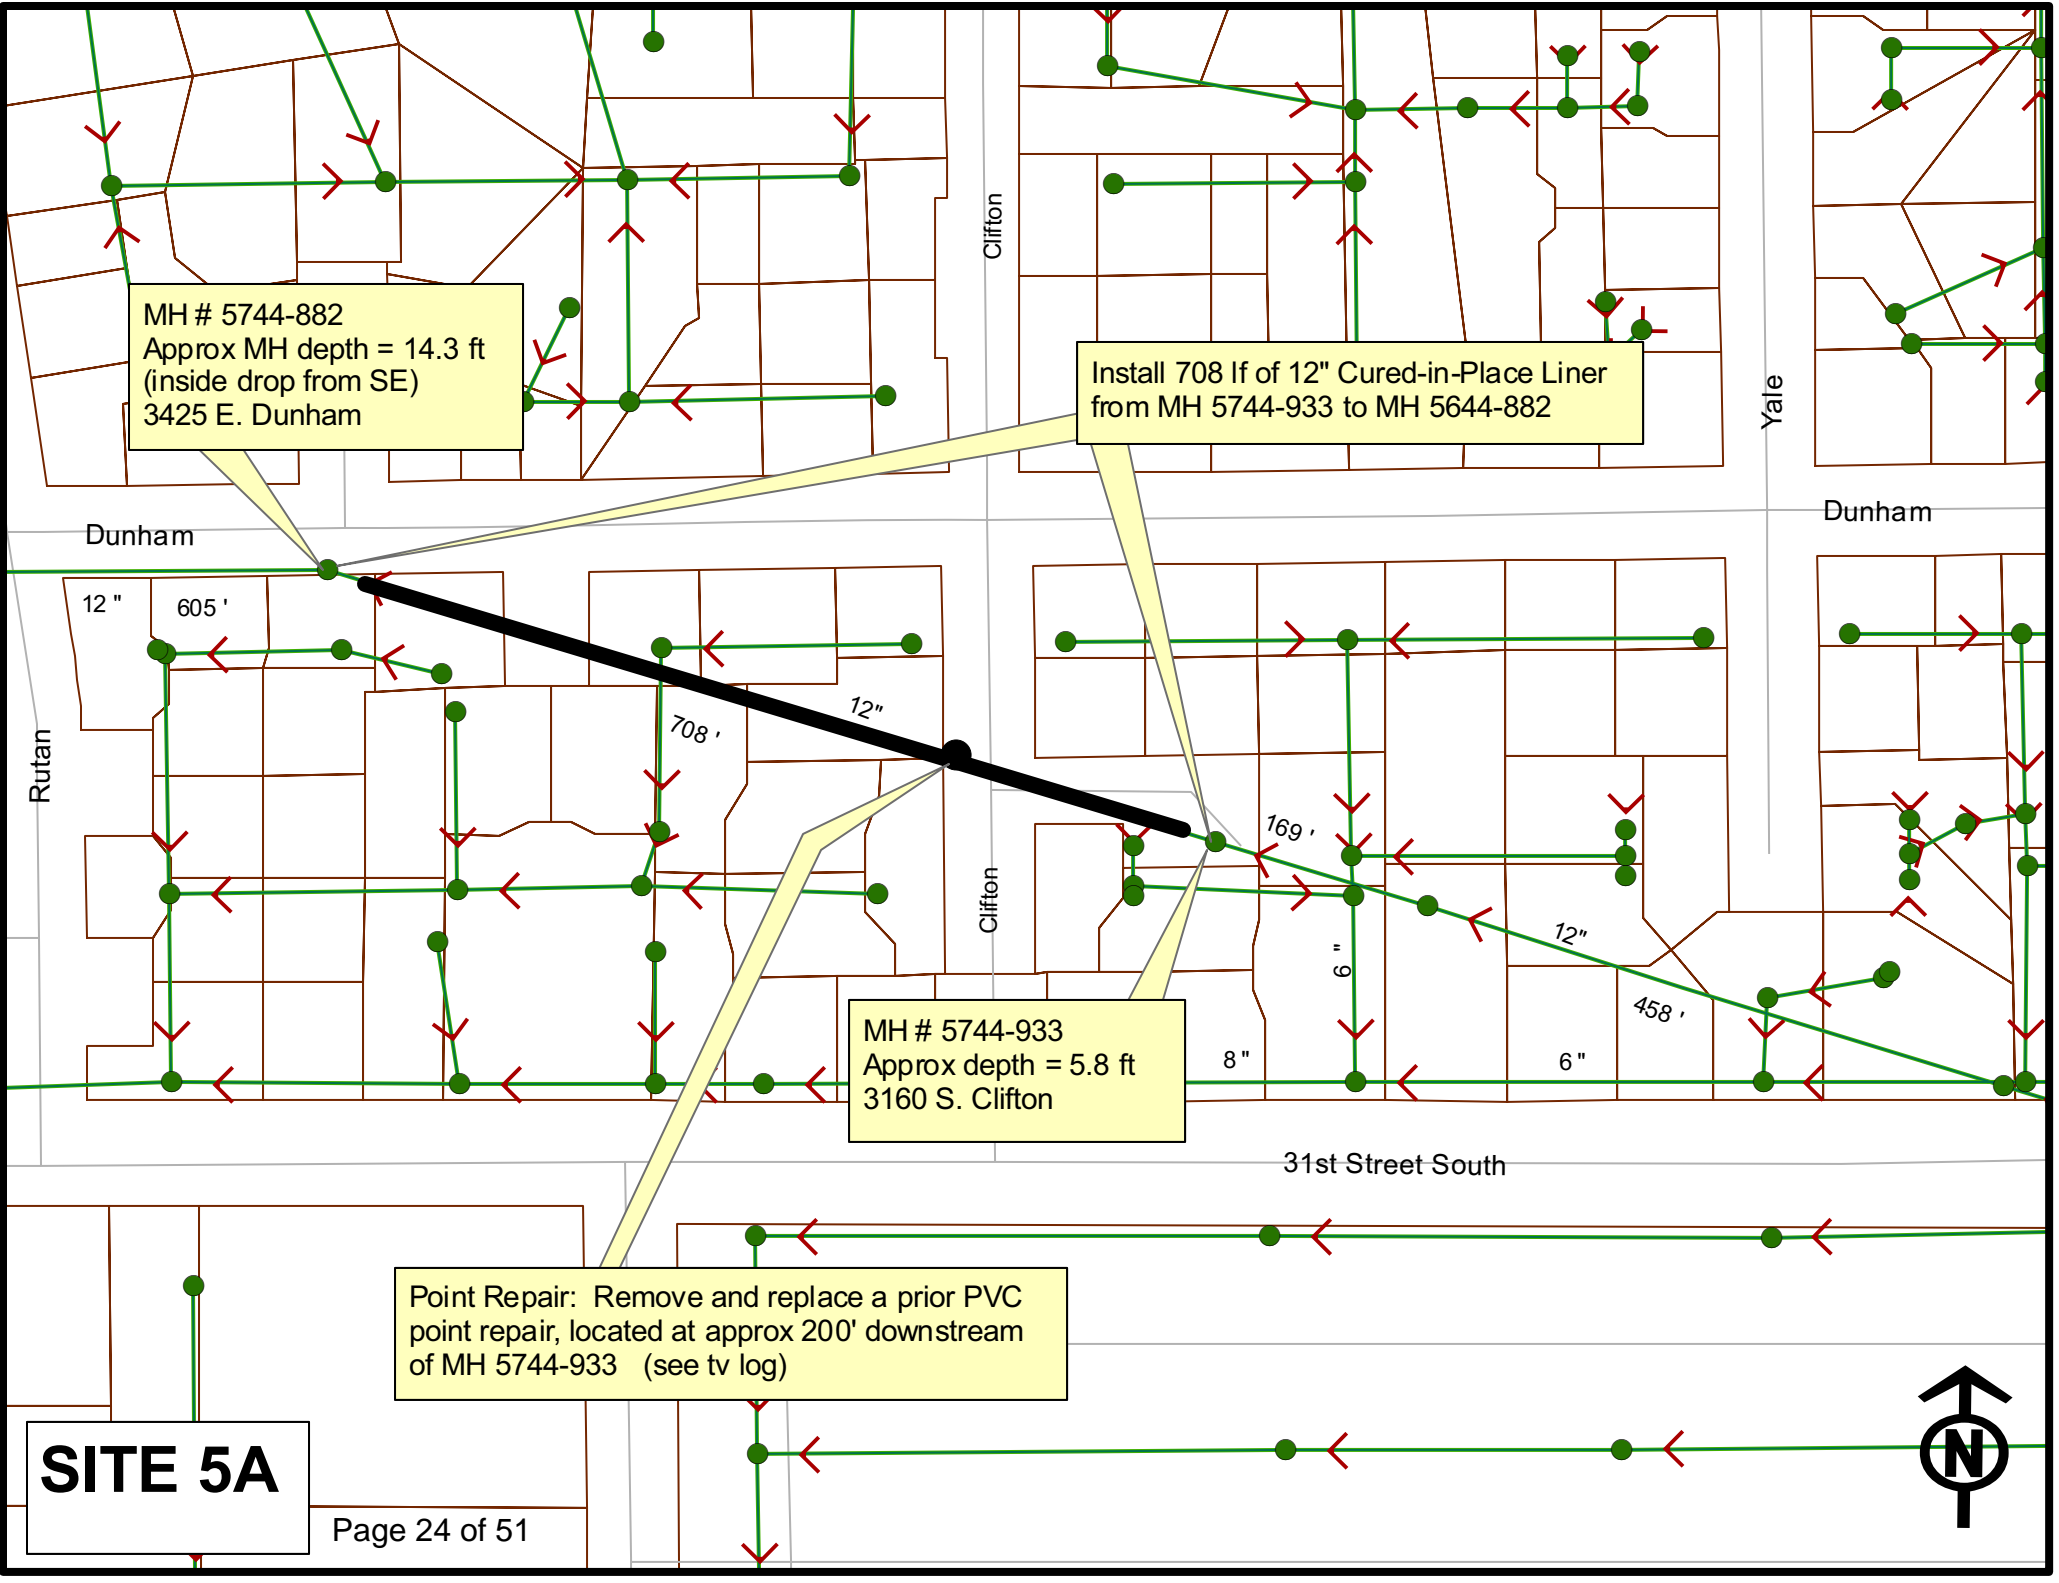
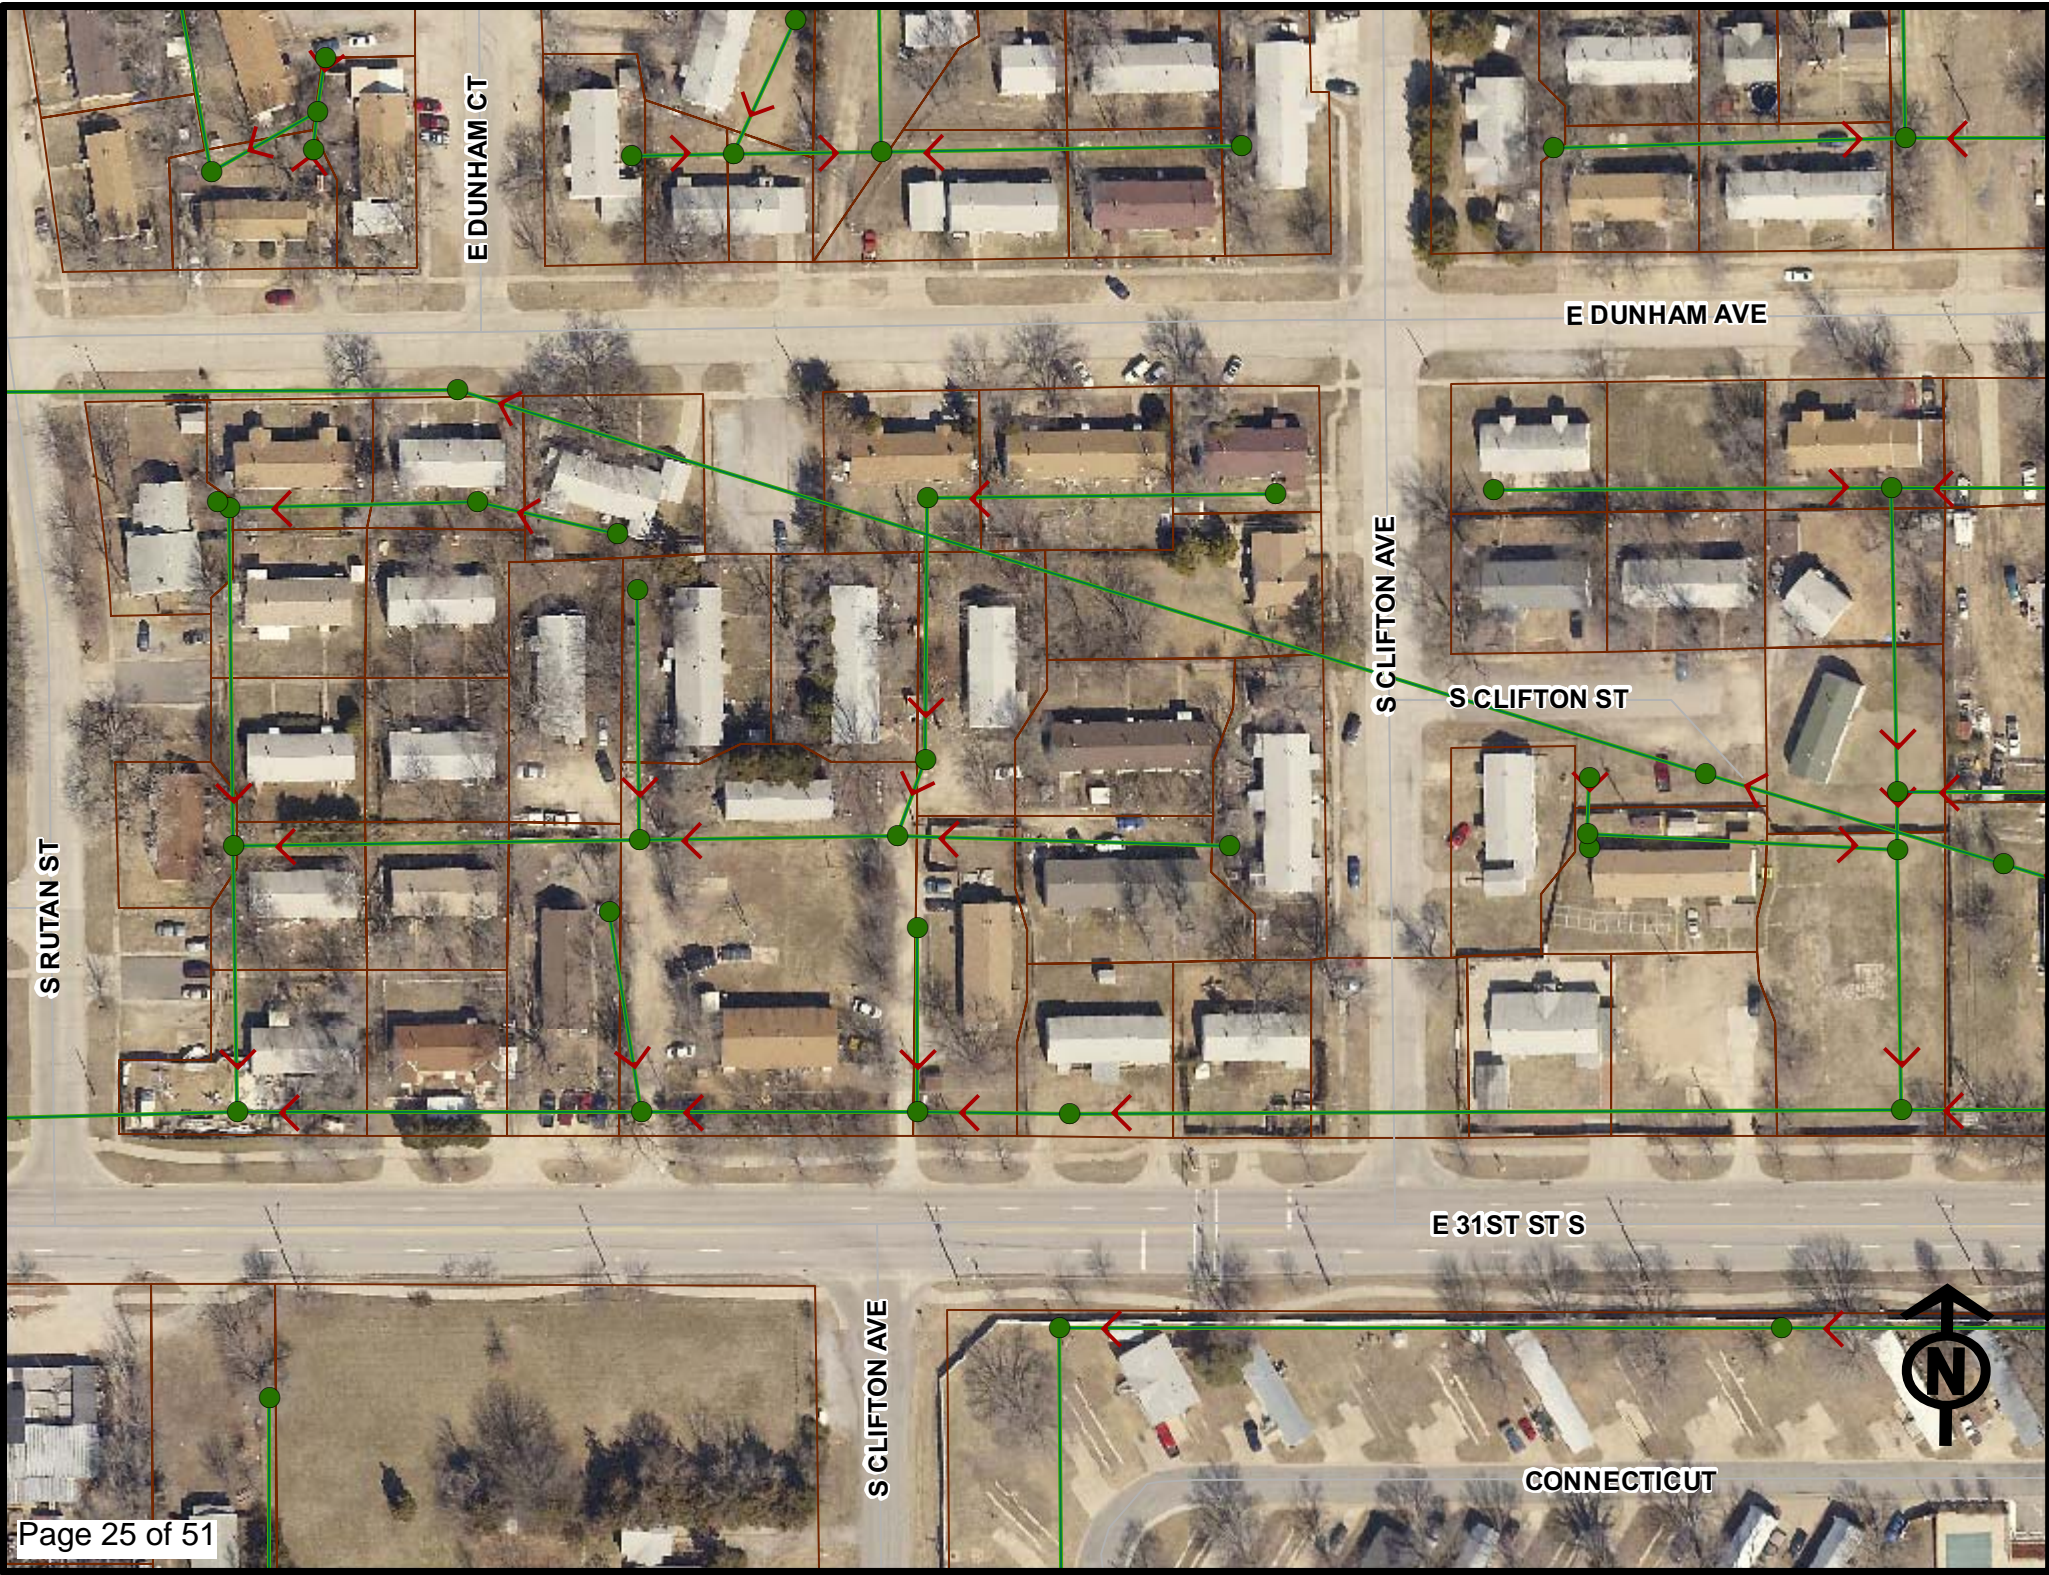
MH # 5744-882
Approx MH depth = 14.3 ft
(inside drop from SE)
3425 E. Dunham

MH # 5744-933
Approx depth = 5.8 ft
3160 S. Clifton

Install 708 lf of 12" Cured-in-Place Liner
from MH 5744-933 to MH 5644-882

Point Repair: Remove and replace a prior PVC
point repair, located at approx 200' downstream
of MH 5744-933 (see tv log)
