SITE 5C

Television Inspection Master Report

US Structure: 5644-023 3141 S HILLSIDE ST Date Insp: 3/18/2010 Basin: C01A
 DS Structure: 5644-024 2813 E DUNHAM ST Dir Televised:Upstream To Downstream

Project No. : J-136 Dia: 12 Material: VCP Length: 1100.0 Slope: 0.220 Tape ID: DVD #0564

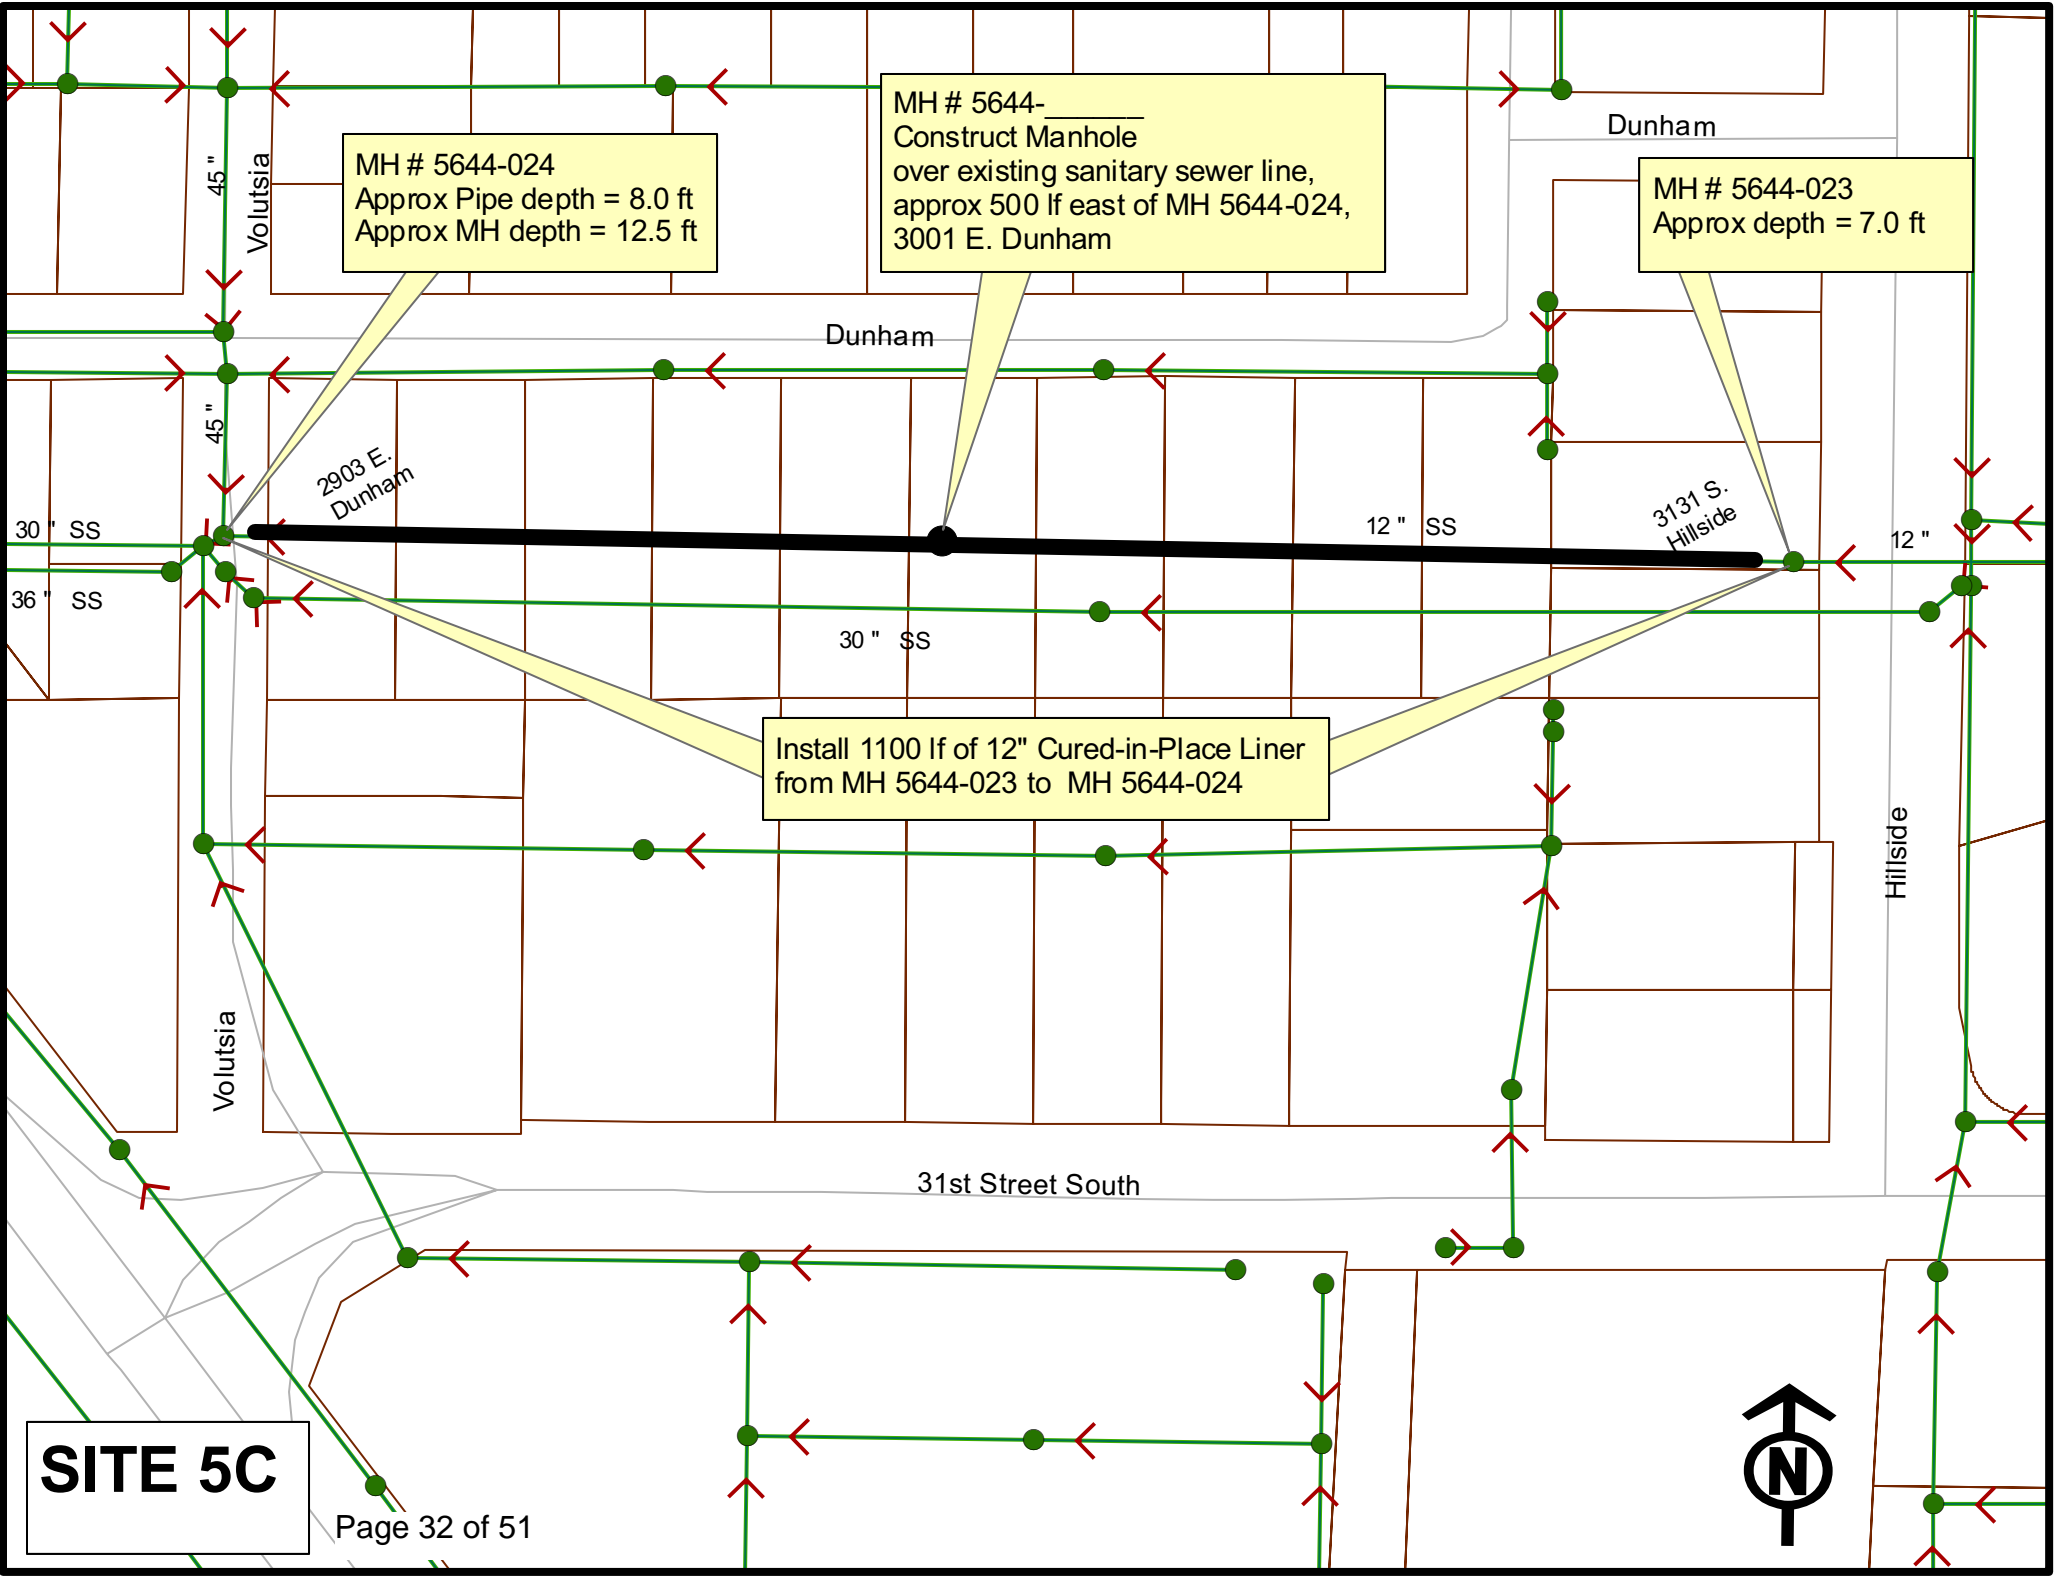
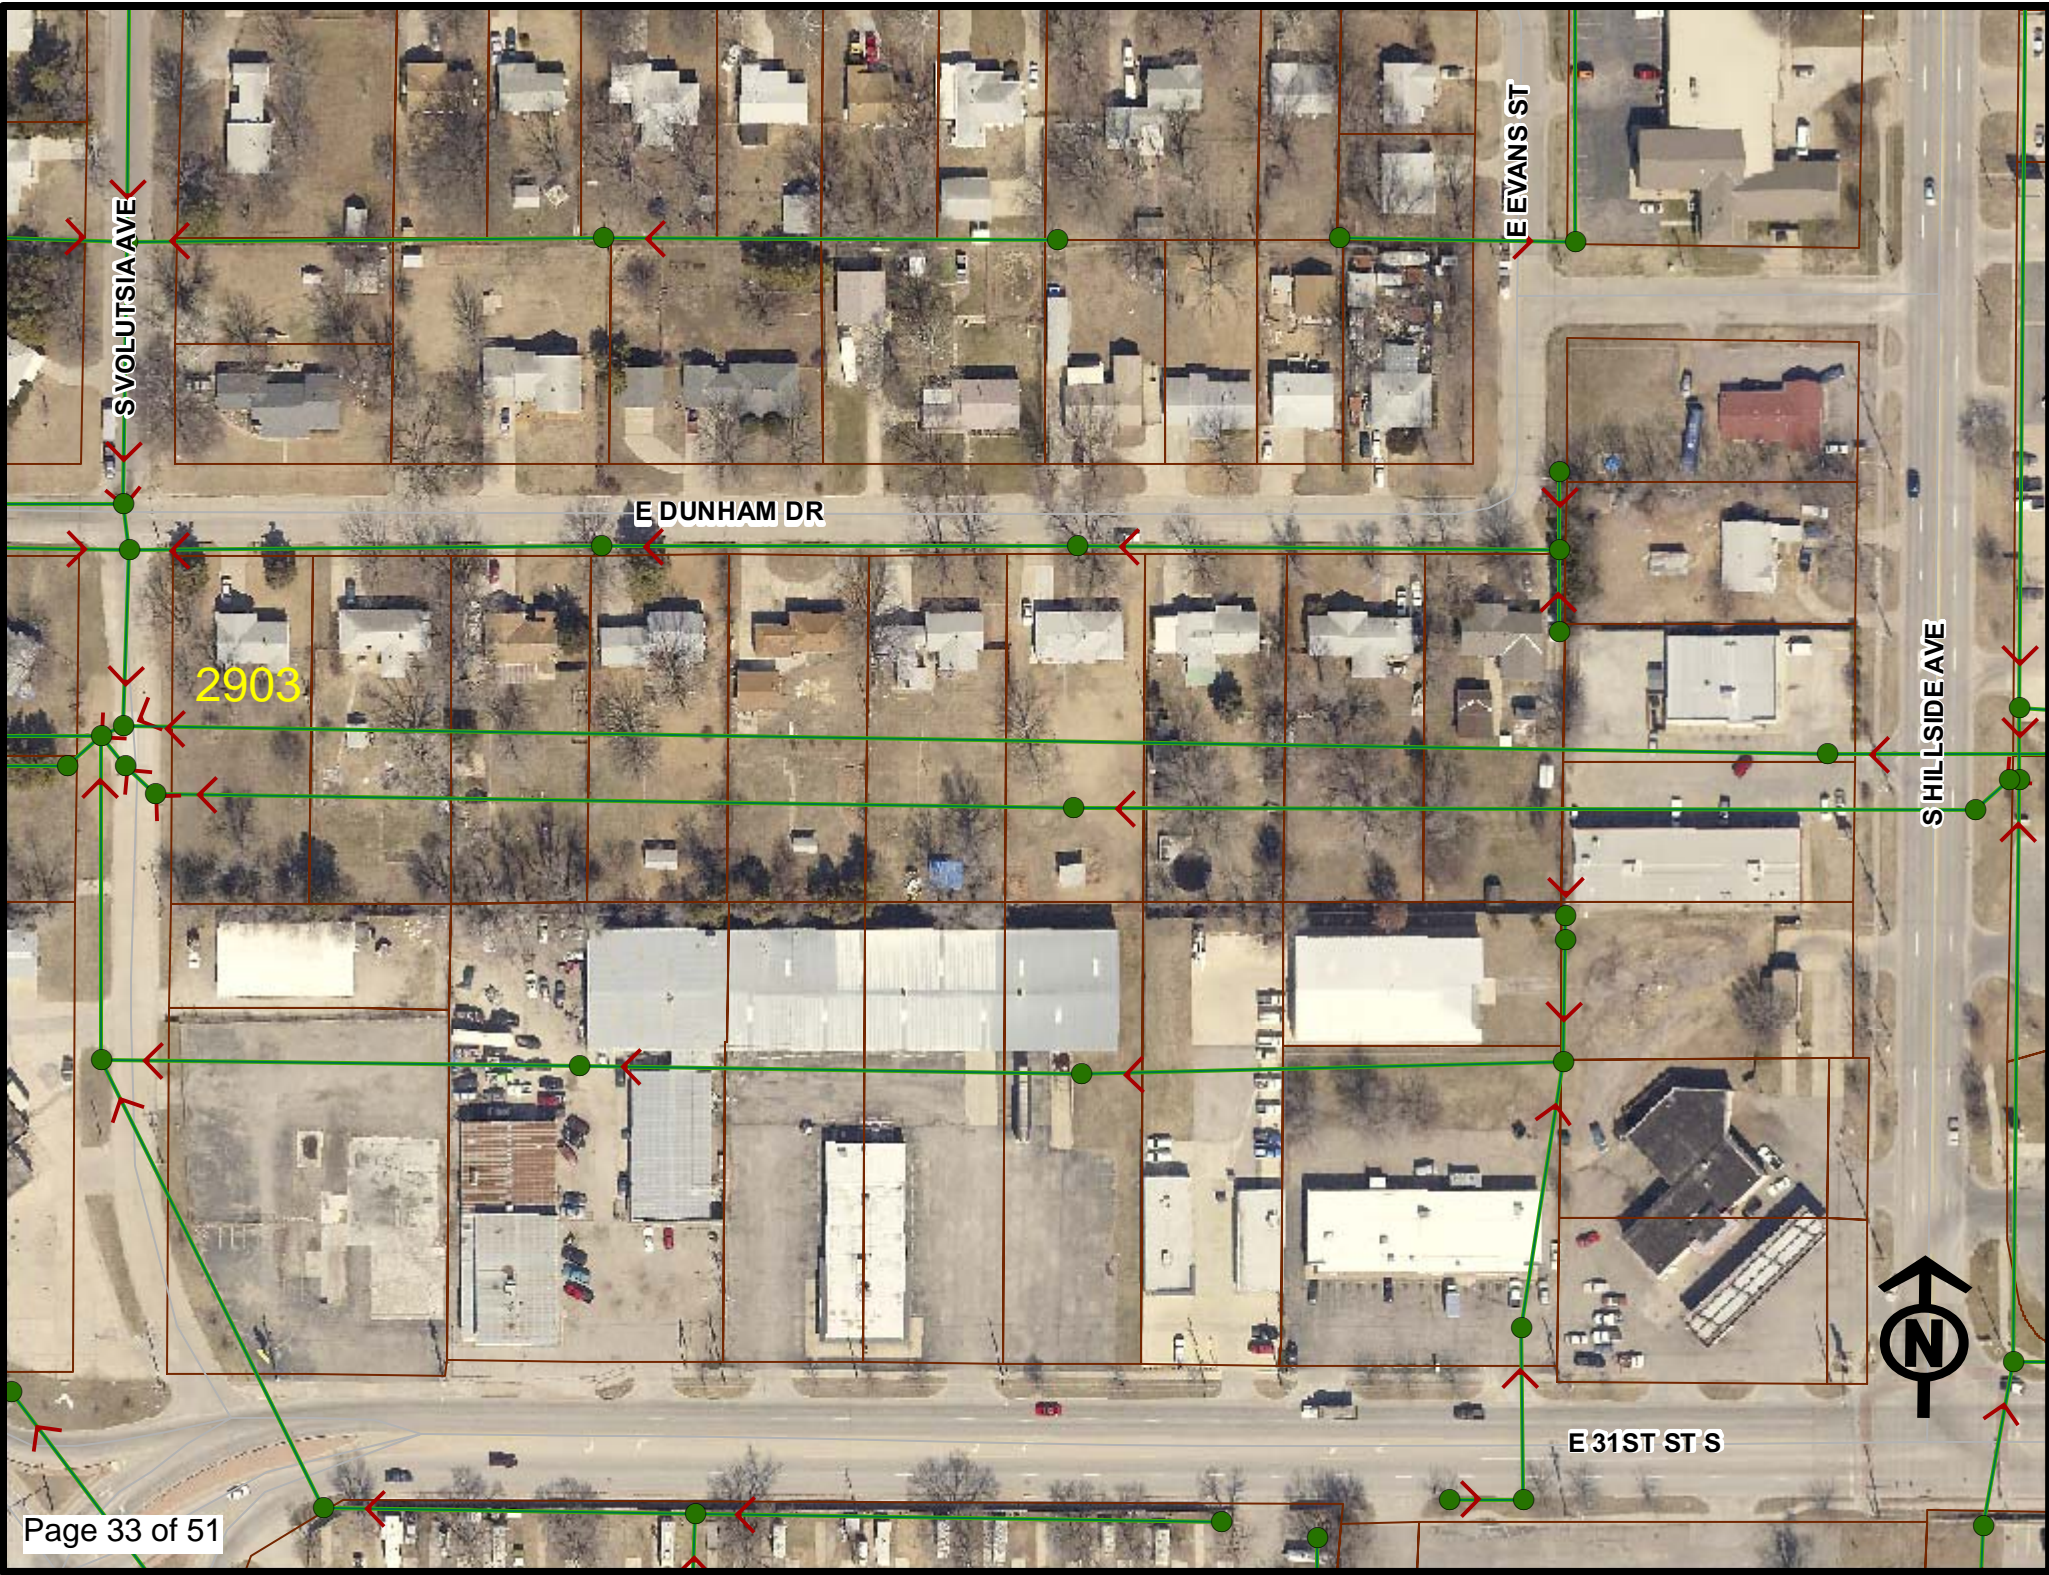
MH # 5644-024
Approx Pipe depth = 8.0 ft
Approx MH depth = 12.5 ft

MH # 5644-
Construct Manhole
over existing sanitary sewer line,
approx 500 lf east of MH 5644-024,
3001 E. Dunham

MH # 5644-023
Approx depth = 7.0 ft

Install 1100 lf of 12" Cured-in-Place Liner
from MH 5644-023 to MH 5644-024
