SITE 1

Sheet 4 of 23

Video Inspection Master Report

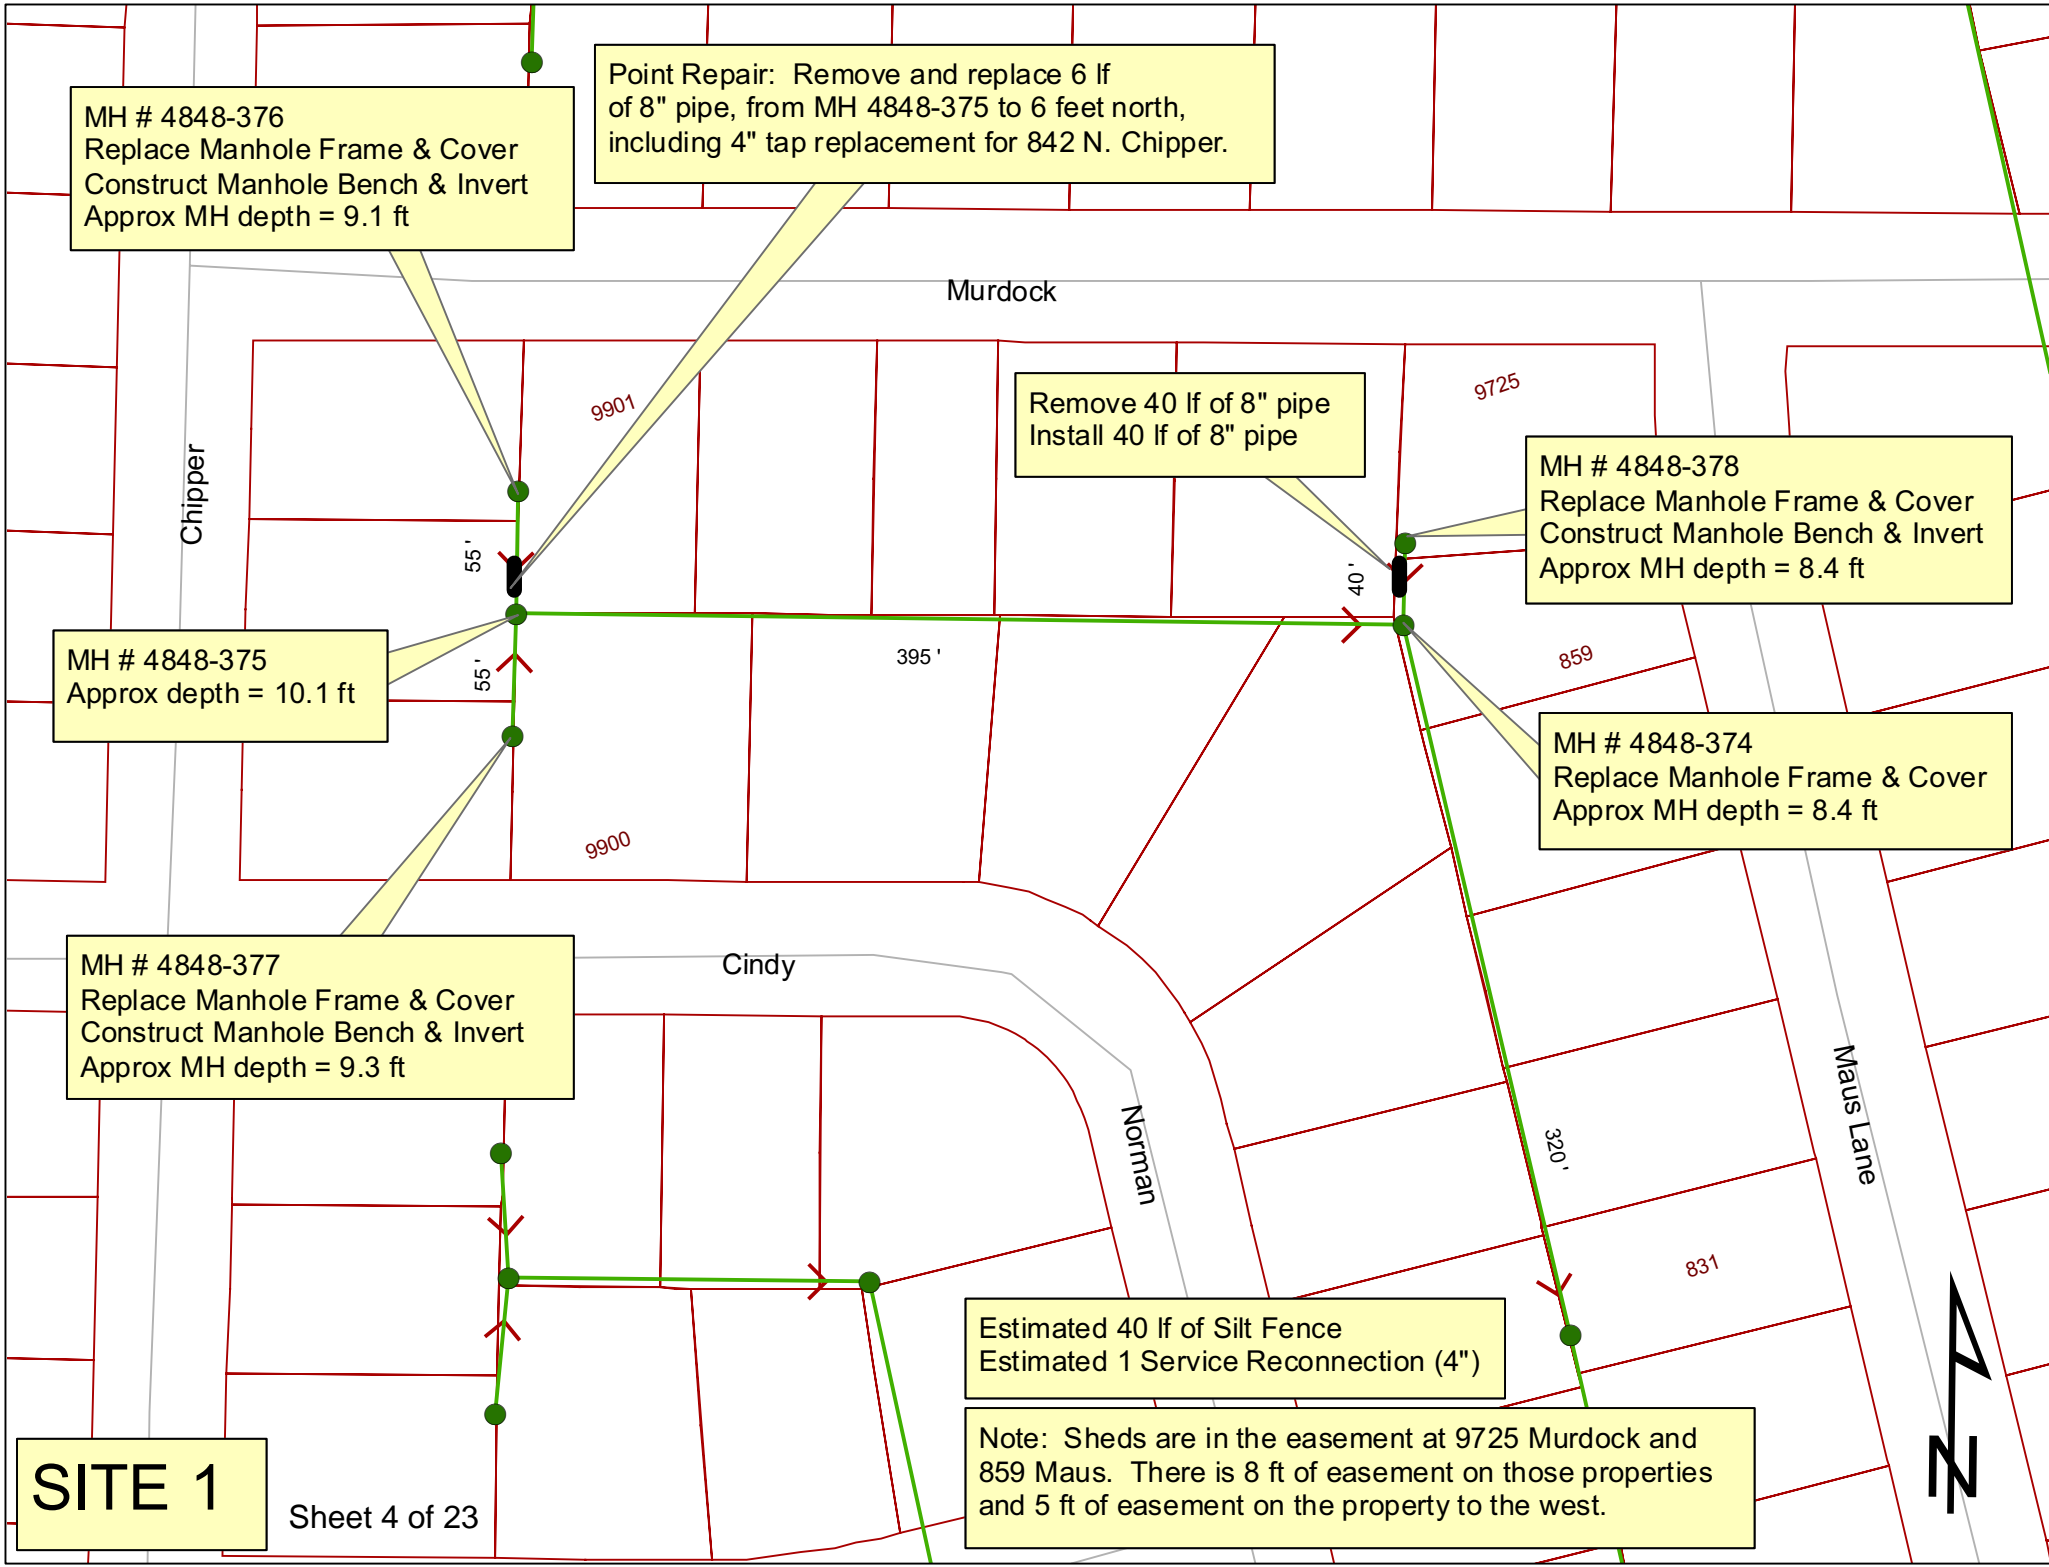
Note: Sheds are in the easement at 9725 Murdock and 859 Maus. There is 8 ft of easement on those properties and 5 ft of easement on the property to the west.

MH # 4848-376
Replace Manhole Frame & Cover
Construct Manhole Bench & Invert
Approx MH depth = 9.1 ft

Point Repair: Remove and replace 6 lf of 8" pipe, from MH 4848-375 to 6 feet north, including 4" tap replacement for 842 N. Chipper.

Remove 40 lf of 8" pipe
Install 40 lf of 8" pipe

MH # 4848-378
Replace Manhole Frame & Cover
Construct Manhole Bench & Invert
Approx MH depth = 8.4 ft

MH # 4848-374
Replace Manhole Frame & Cover
Approx MH depth = 8.4 ft

MH # 4848-377
Replace Manhole Frame & Cover
Construct Manhole Bench & Invert
Approx MH depth = 9.3 ft

Estimated 40 lf of Silt Fence
Estimated 1 Service Reconnection (4")

The owners of 9725 Murdock and 859 Maus have not been contacted about moving their sheds. The contractor shall notify and work with the homeowners to move the sheds as necessary.

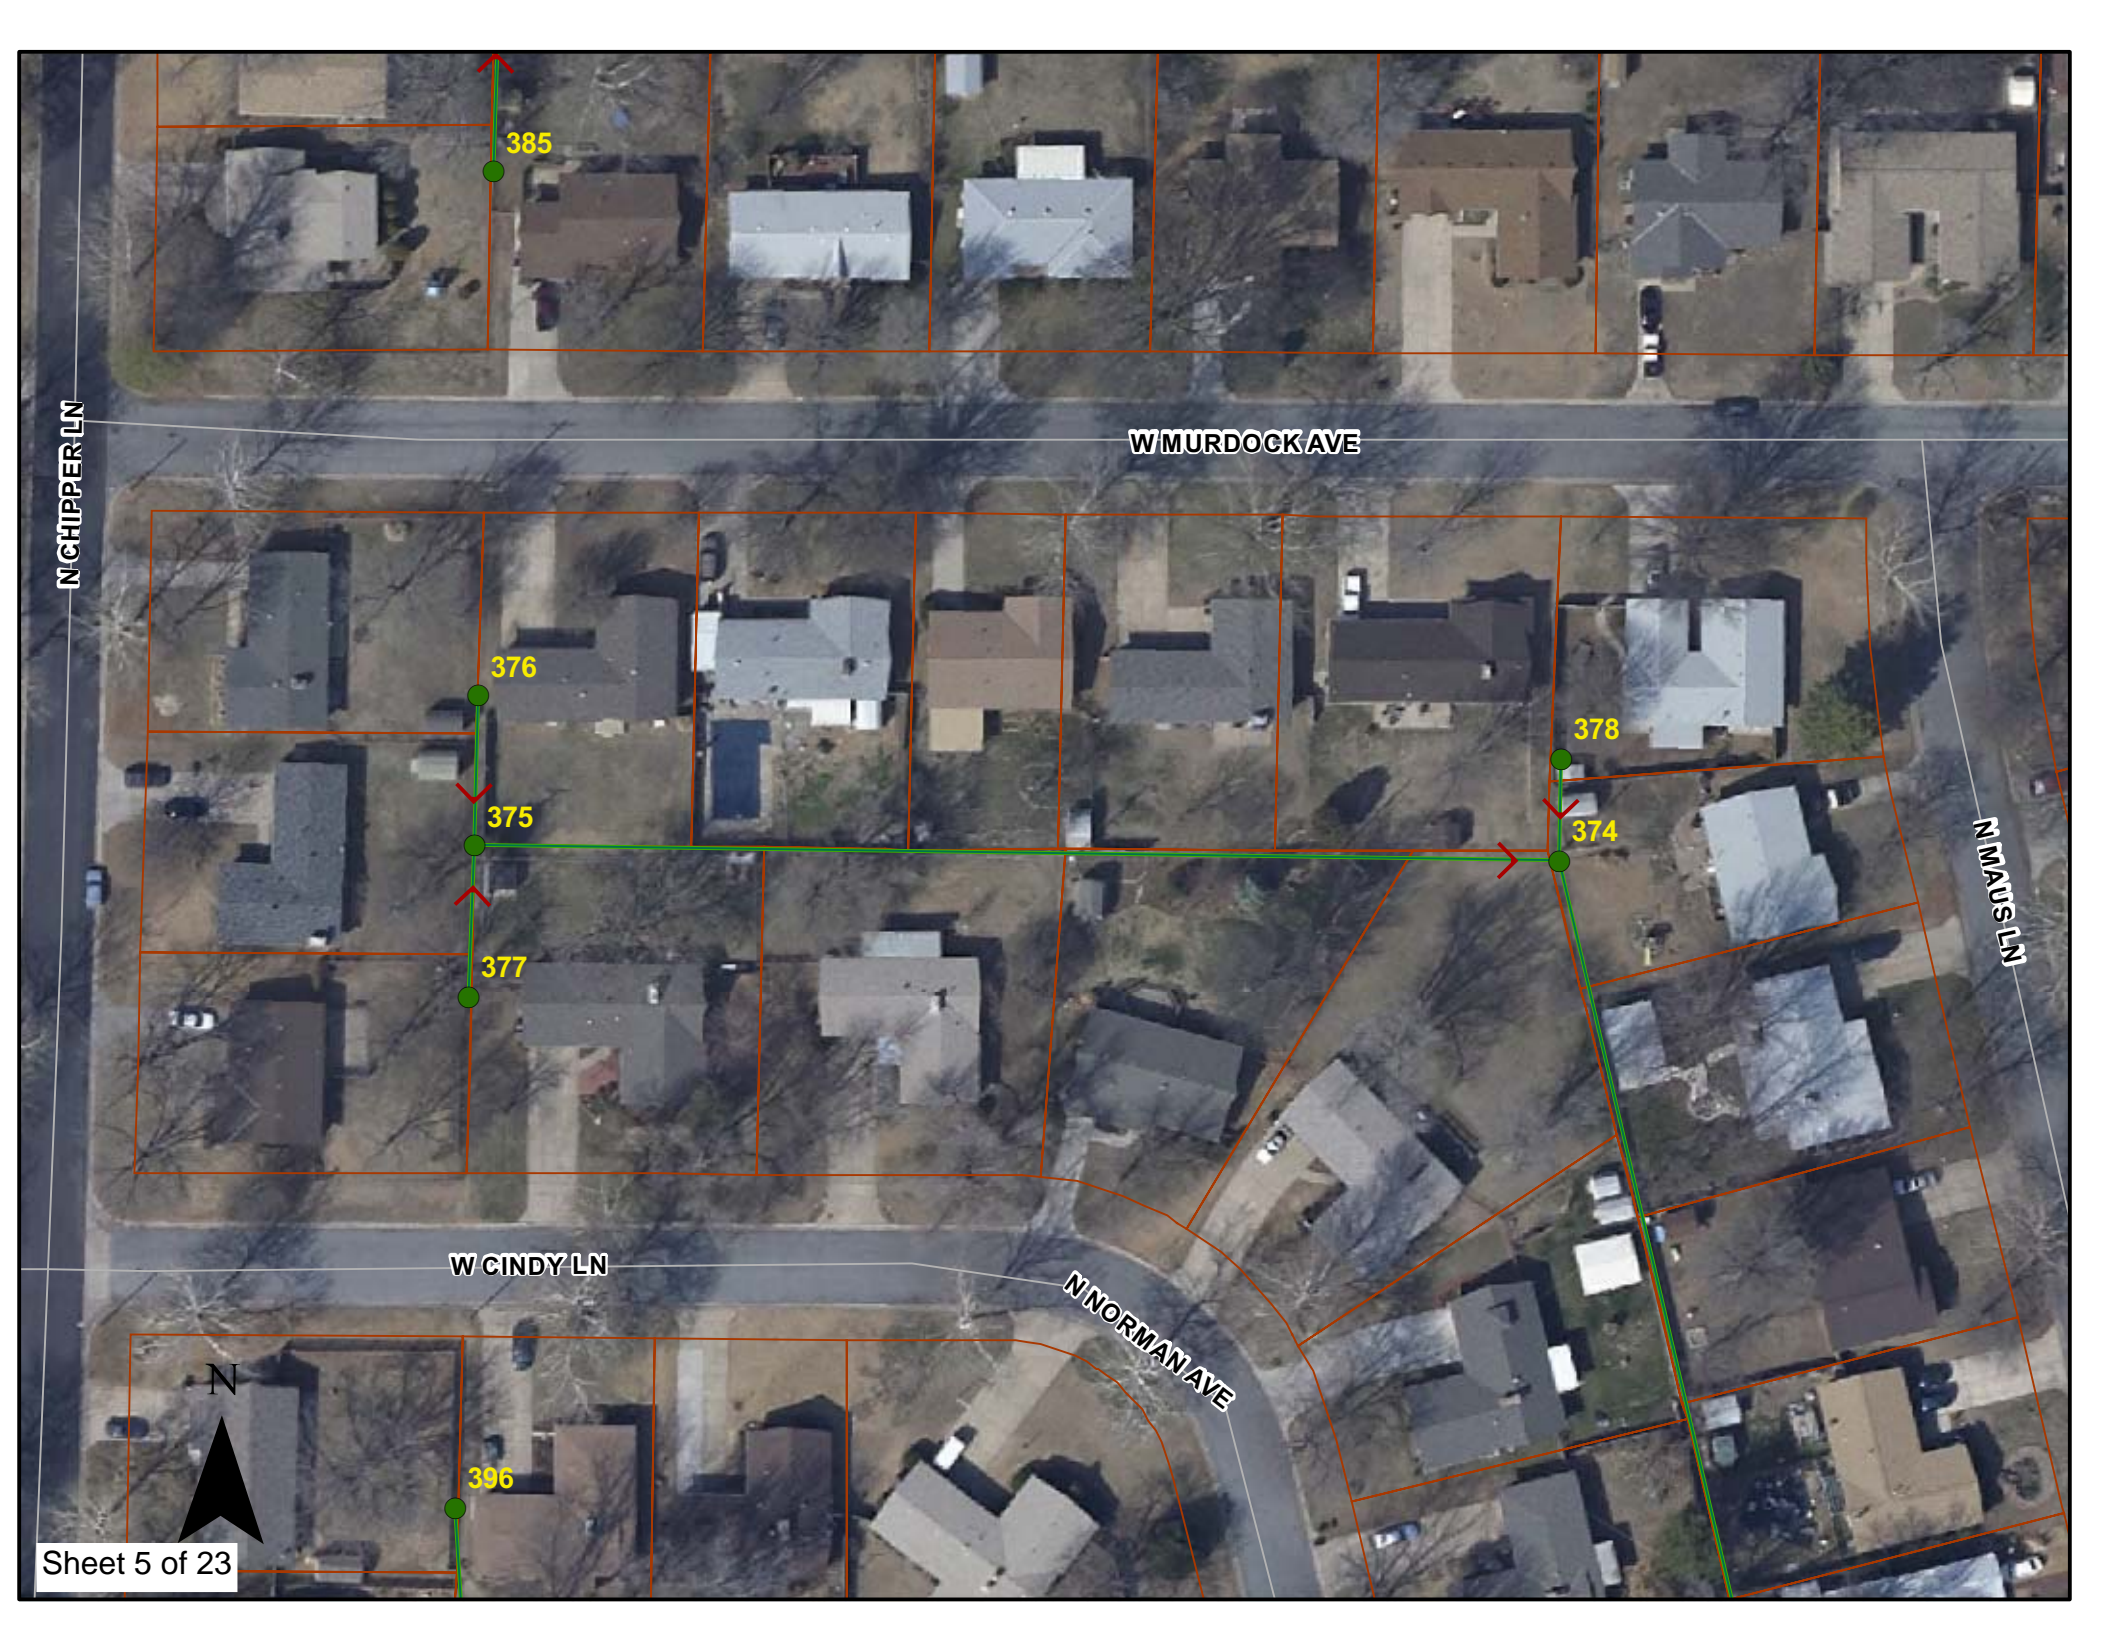
Obs. #	VTR	Counter	Distance	Location	Description	Rating	Obsrvd (gpm)	Ratings			Remain (gpm)	
								Est. (gpm)	Struct	Clean		
1			0.0		4848-375 DS Manhole	3						
2			3.0	842 S CHIPPER LANE	Break-In Conn	4		0.008	60	0	0.008	
Tap is protruding slightly and pipe is cracked all around the tap. Roots intruding from the cracks. Tap may be broken down.												
<u>REPLACE 6 LF OF PIPE TO FIX TAP AND BROKEN PIPE</u>												
3			9.0		Wye Service Sealed off	1		0.000	0	0	0.000	
4			9.0		Roots	2		0.004	2	4	0.004	
5			12.5		Roots	3		0.008	5	8	0.008	
6			18.3		Roots	2		0.004	2	4	0.004	
7			22.2		Roots	2		0.004	2	4	0.004	
8			22.2	Joint	Offset	2		0.000	0	0	0.000	
9			27.8		Roots	2		0.004	2	4	0.004	
10			36.9	Joint	Offset	3		0.010	20	0	0.010	
11			42.8		Roots	2		0.004	2	4	0.004	
12			45.8	850 S CHIPPER LANE	W Wye Service	1		0.000	0	0	0.000	
13			45.8	Joint	Offset	3		0.010	20	0	0.010	
14			49.7	Joint	Offset	3		0.010	20	0	0.010

15			54.5		4848-376 US Manhole	3		0.000	0	0	0.000	
Pipe is higher than floor of the manhole. Manhole needs a bench & invert. Camera does not pan around to look at the manhole.

Roots at joints

Comments: LINE HAS LOTS OF SILT AND SAND, CAMERA WON'T PASS. LINE NEEDS TO BE CLEANED AND THEN TELEVISED.

Obs. #	VTR Counter	Distance	Ratings		Rating	Obsrvd (gpm)	Est. (gpm)	Struct	Clean	Remain (gpm)
			Location	Description						
1		0.0		4848-378 US Manhole MH needs a bench & invert	3		0.000	0	0	0.000
2		7.0	9725 W MURDOCK AVE	Break-In Conn Tap is rough & jagged with roots	3		0.004	2	0	0.004
3		11.2		Wye Service Sealed	1		0.000	0	0	0.000
4		24.7	Joint	Offset	3		0.010	20	0	0.010
5		24.7	Invert	Crack-Radial	3		0.004	5	0	0.004
6		26.7	Heavy Sand & Silt (2")	Debris	5		0.000	0	75	0.000

INCOMPLETE TELEVISIONING
