SITE 4

Sheet 15 of 23

Video Inspection Master Report

US Structure: **4848-181** 8924 W 10TH ST Date Insp: 7/15/2009 Basin: W06A
 DS Structure: **4848-180** 9028 W 10TH ST N Dir Televised: Downstream To Upstream

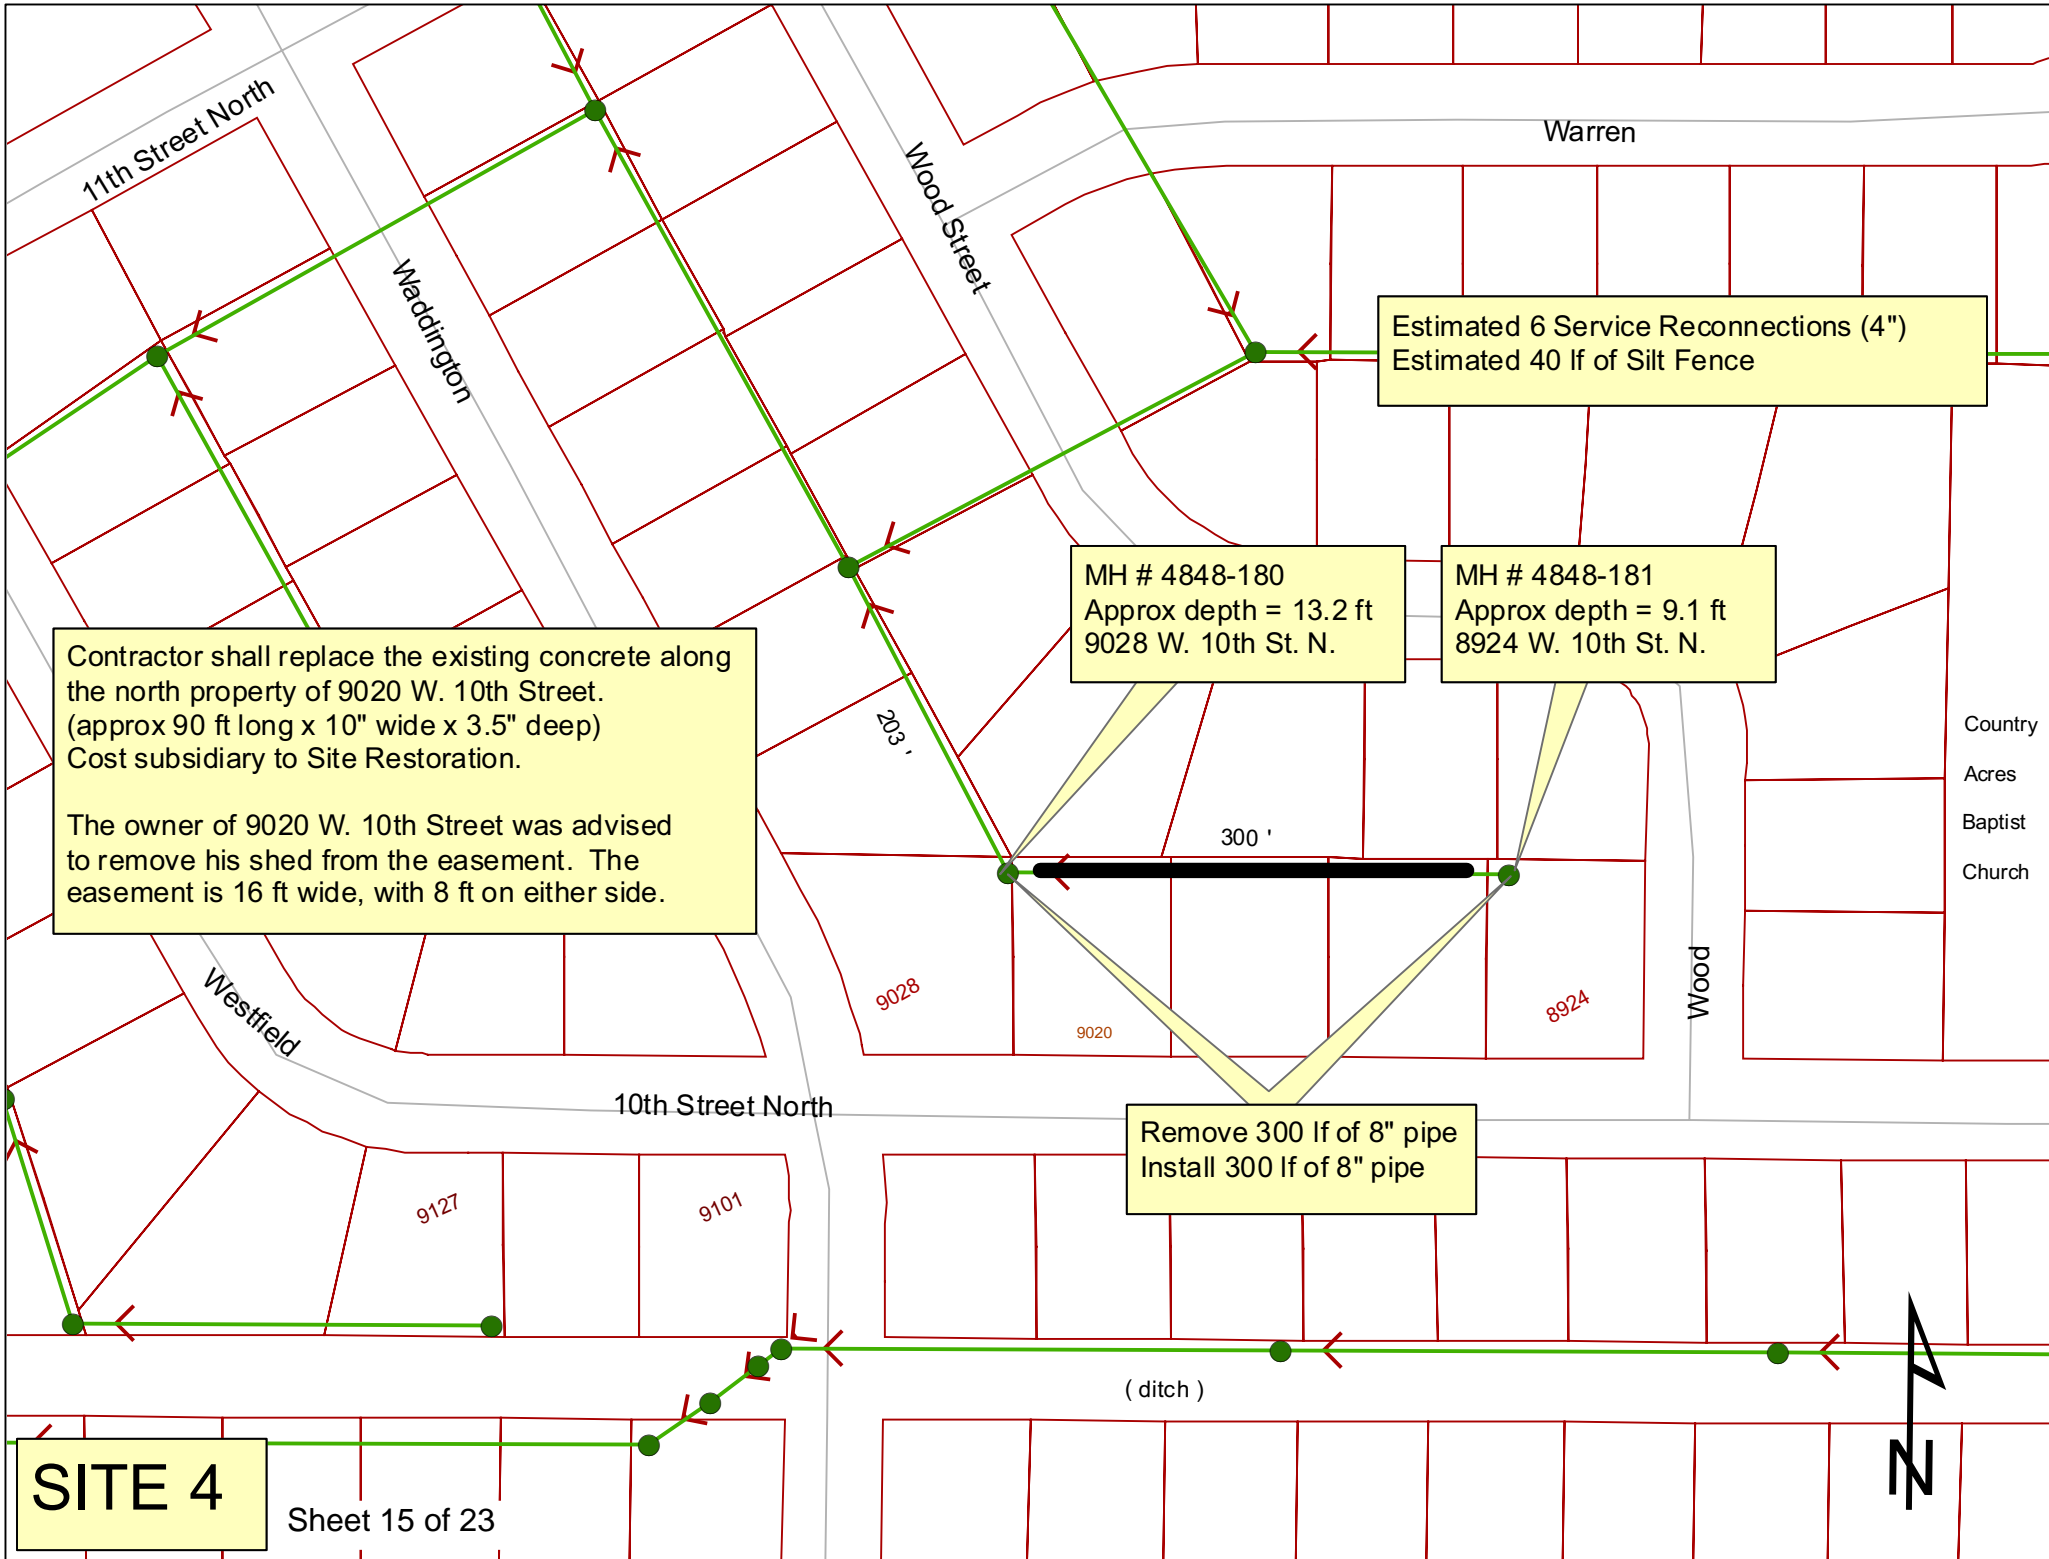
The owner of 9020 W. 10th Street was advised to remove his shed from the easement. The easement is 16 ft wide, with 8 ft on either side.

MH # 4848-180
 Approx depth = 13.2 ft
 9028 W. 10th St. N.

MH # 4848-181
 Approx depth = 9.1 ft
 8924 W. 10th St. N.

Contractor shall replace the existing concrete along the north property of 9020 W. 10th Street. (approx 90 ft long x 10" wide x 3.5" deep) Cost subsidiary to Site Restoration.

Estimated 6 Service Reconnections (4")
 Estimated 40 lf of Silt Fence

Remove 300 lf of 8" pipe
 Install 300 lf of 8" pipe
