Install 658 lf of 8" Cured-in-Place Liner

Video Inspection Master Report

US Structure: 4848-374 859 N MAUS LN Date Insp: 5/8/2009 Basin: W06A
 DS Structure: 4848-373 831 N MAUS LN Dir Televised: Downstream To Upstream

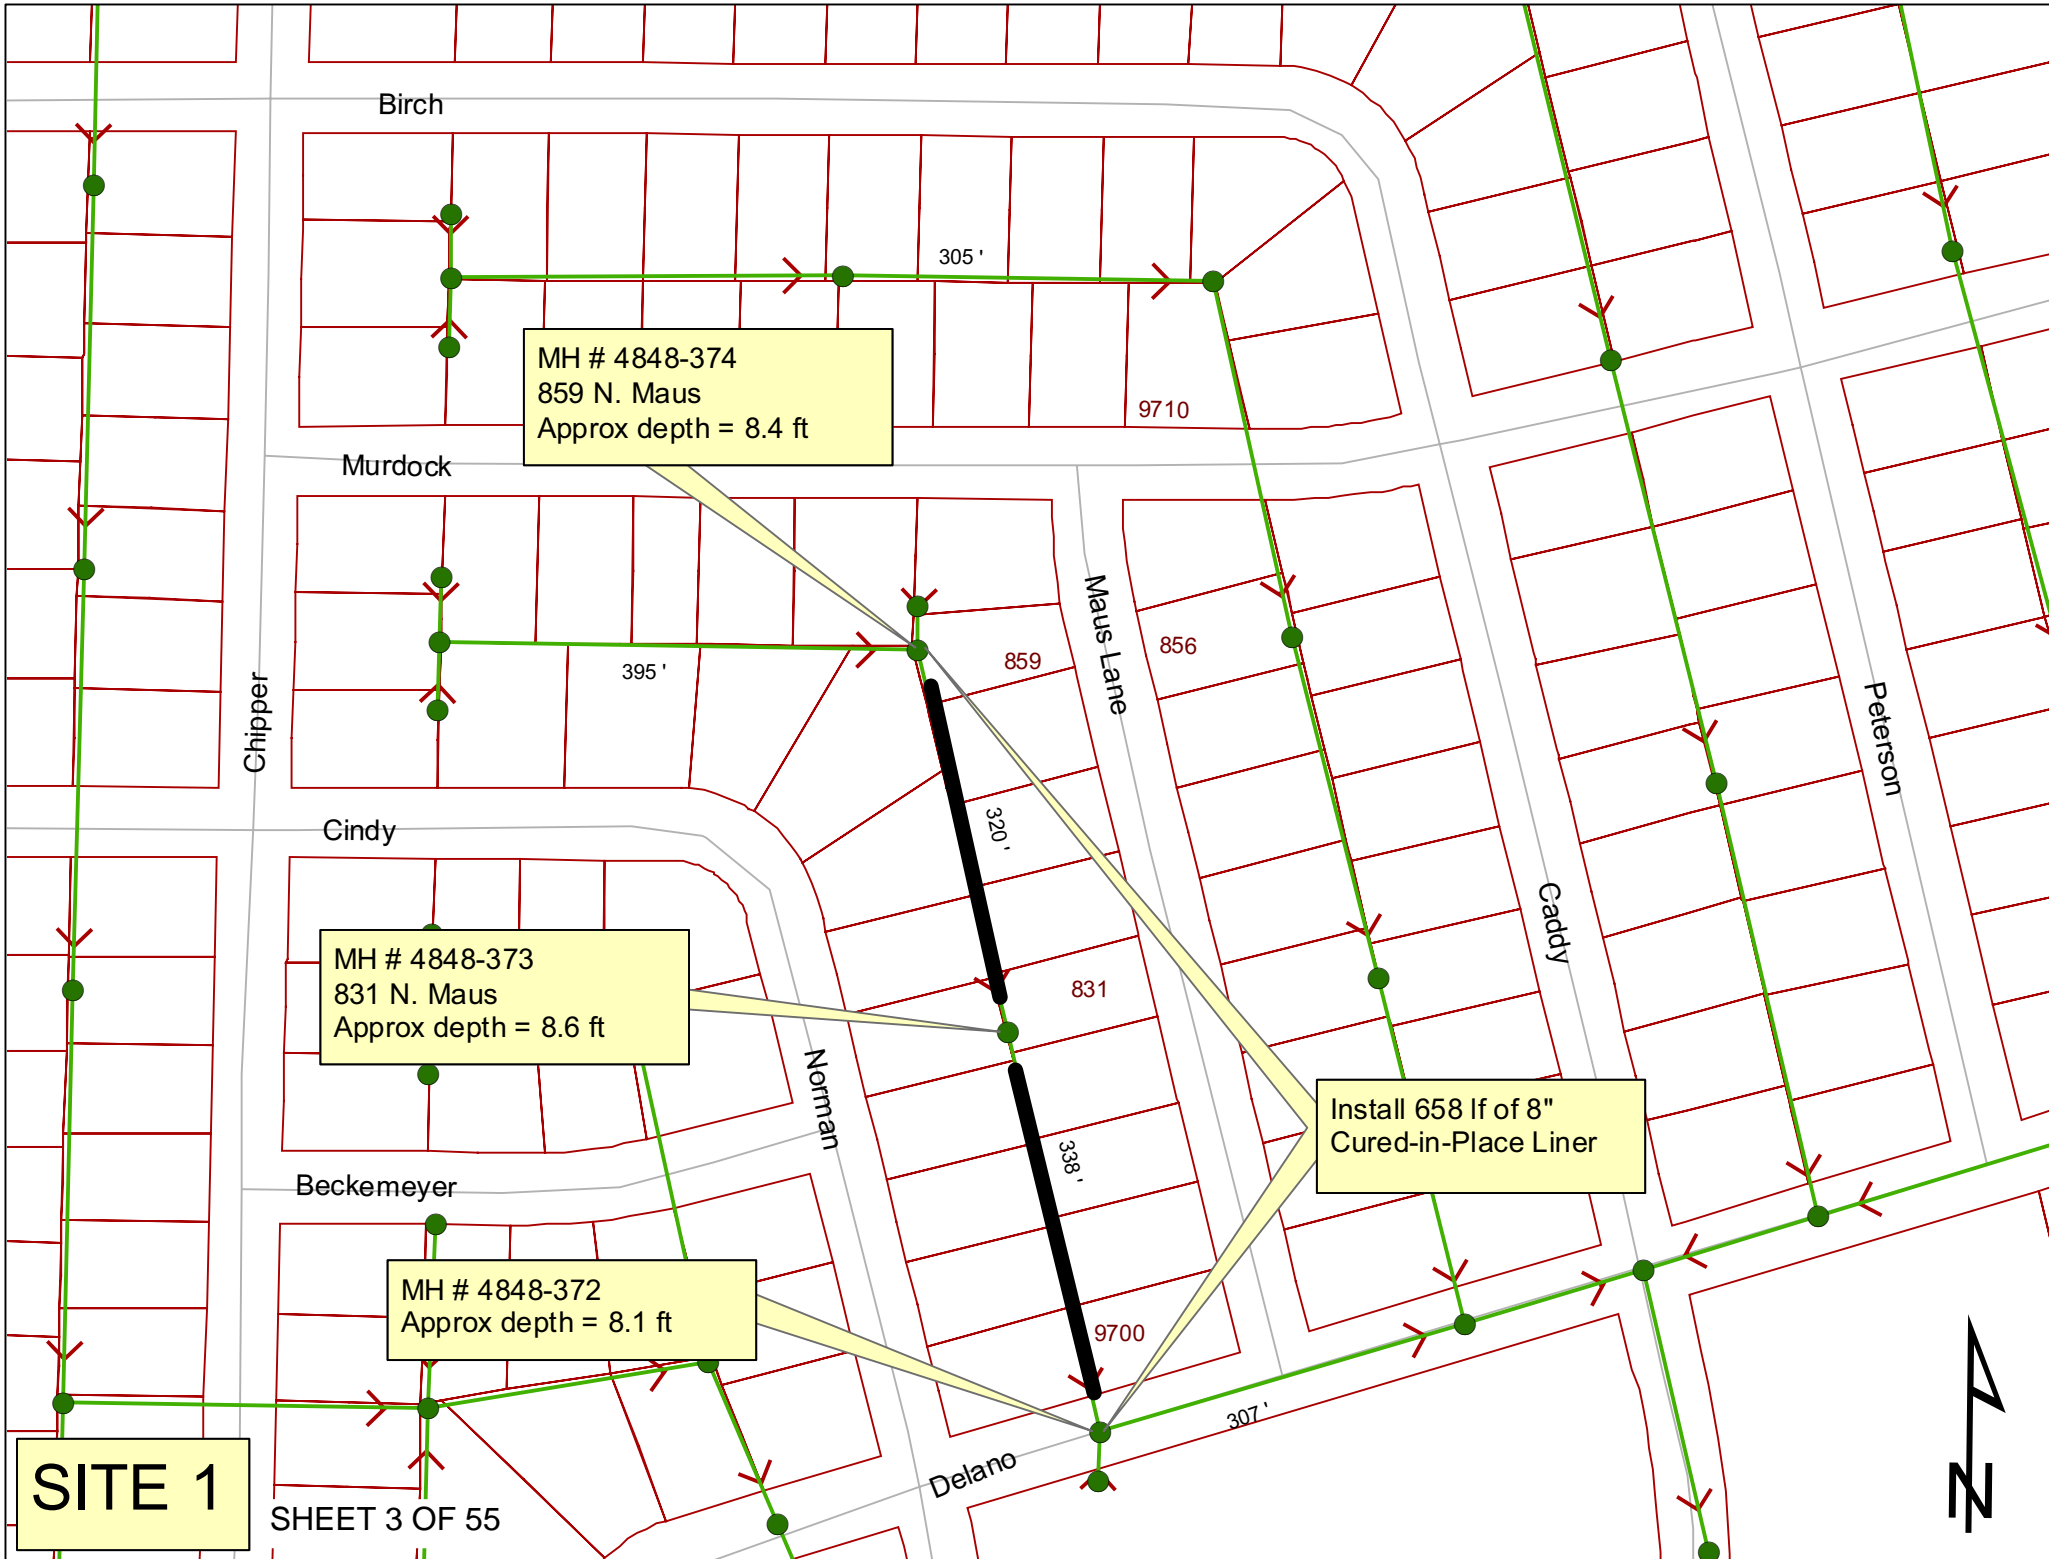
SITE 1

MH # 4848-374
859 N. Maus
Approx depth = 8.4 ft

MH # 4848-373
831 N. Maus
Approx depth = 8.6 ft

MH # 4848-372
Approx depth = 8.1 ft

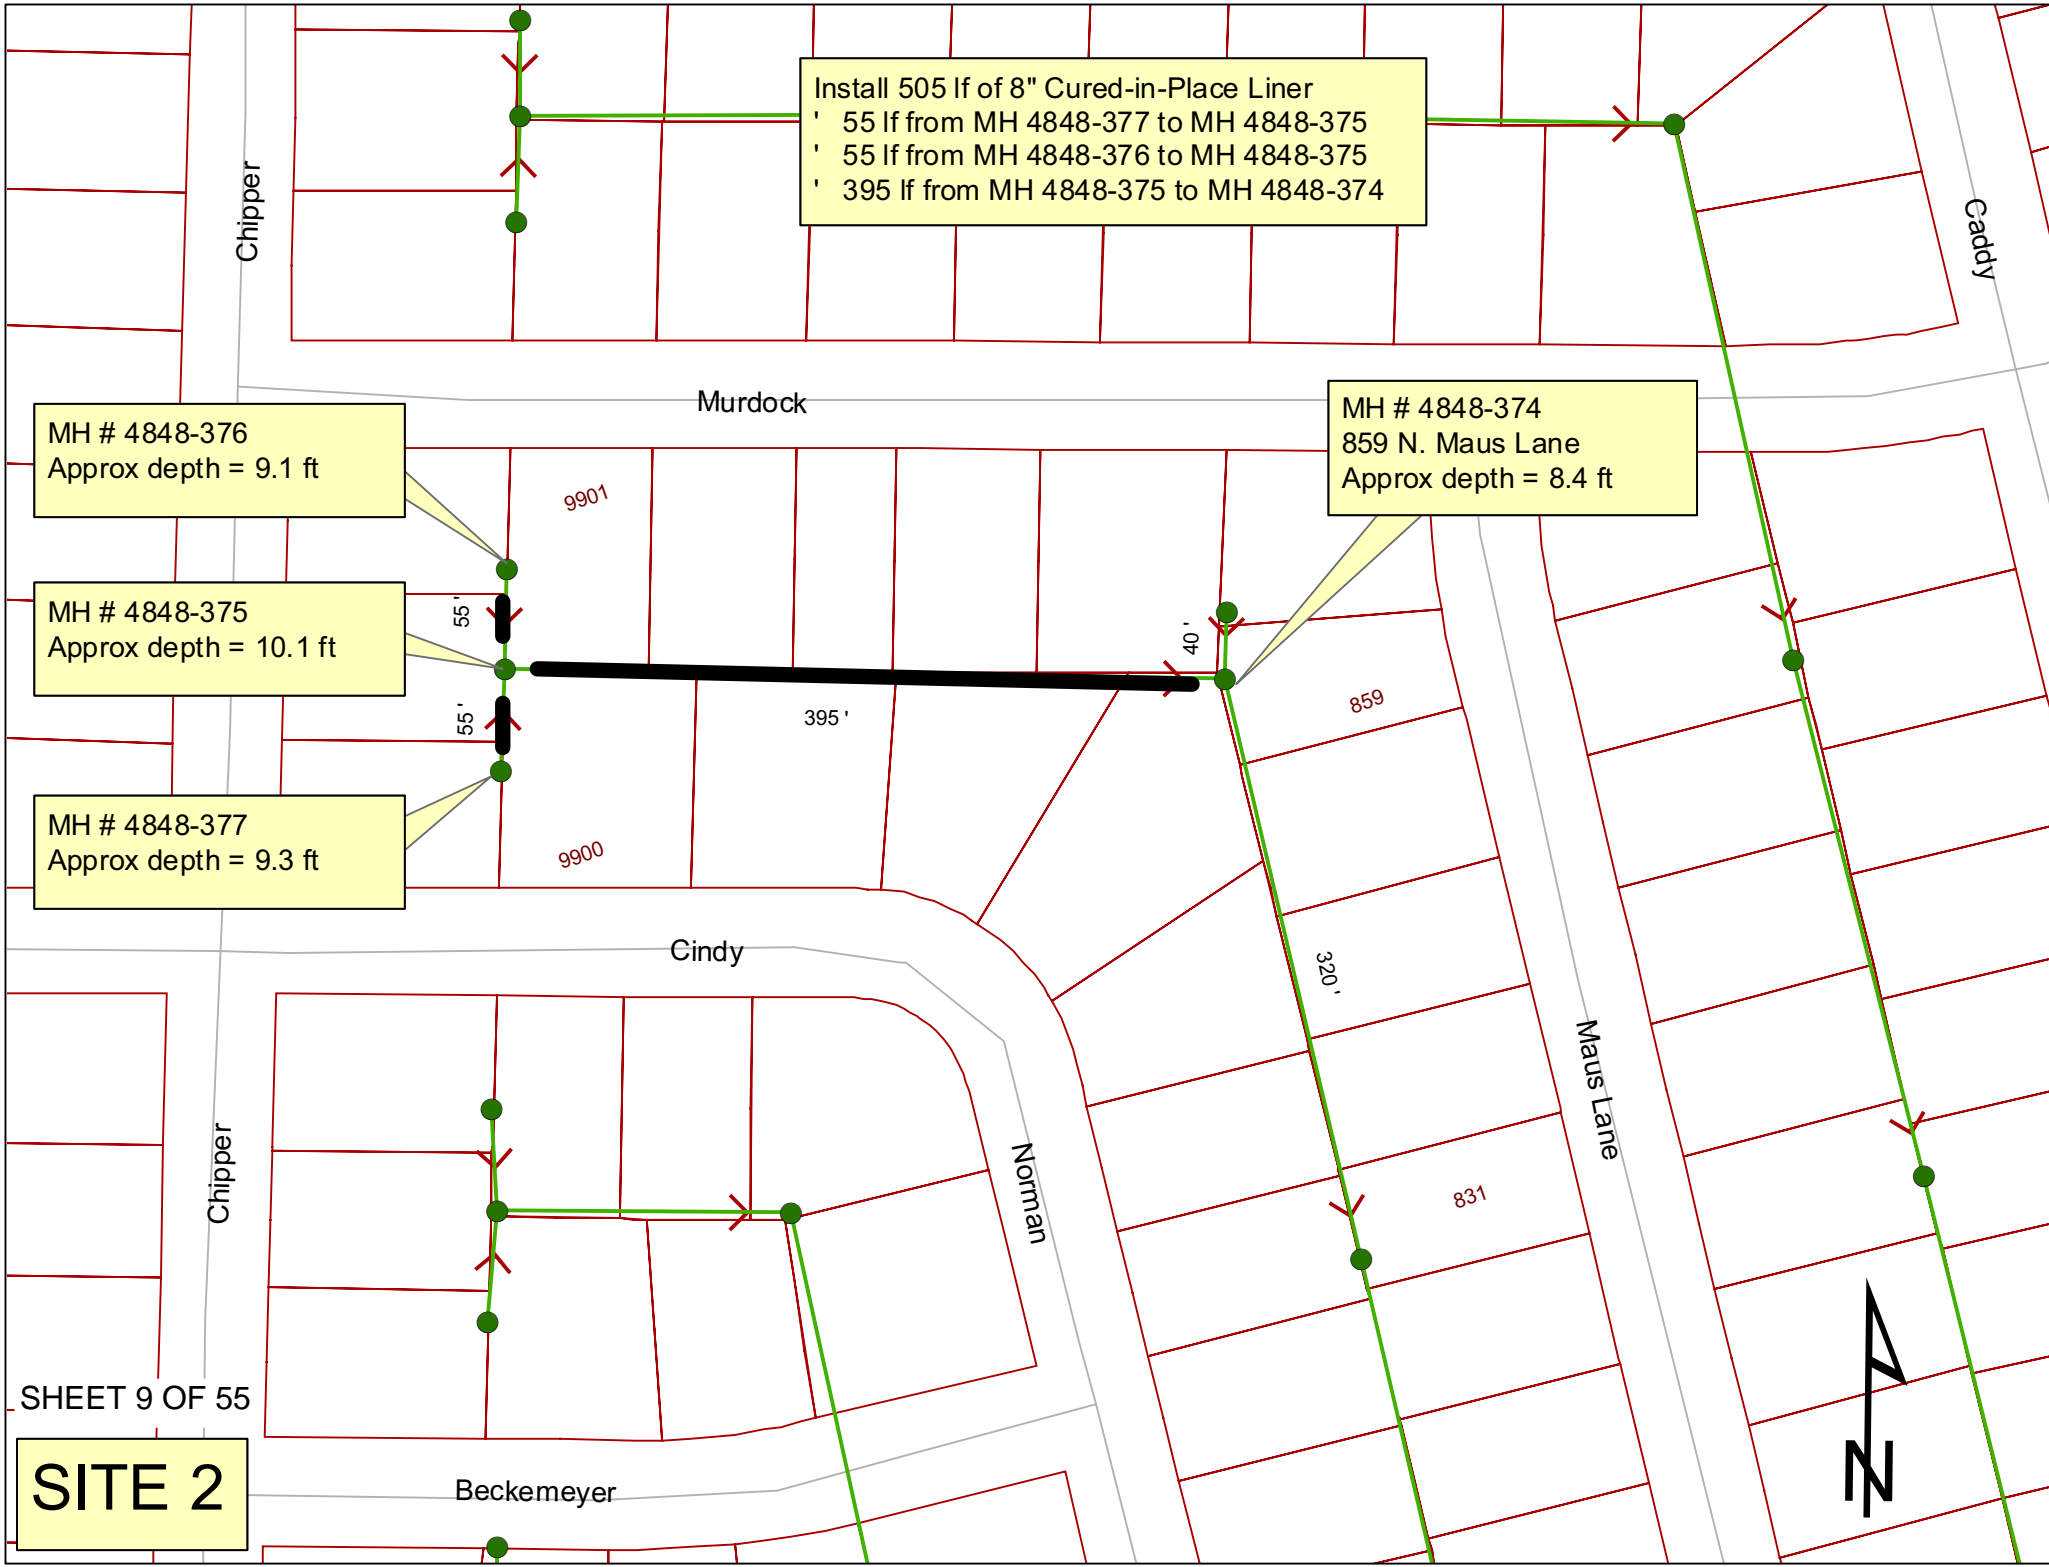
SITE 2

MH # 4848-374
859 N. Maus Lane
Approx depth = 8.4 ft

MH # 4848-376
Approx depth = 9.1 ft

MH # 4848-375
Approx depth = 10.1 ft

MH # 4848-377
Approx depth = 9.3 ft

Install 505 lf of 8" Cured-in-Place Liner

- ' 55 lf from MH 4848-377 to MH 4848-375
- ' 55 lf from MH 4848-376 to MH 4848-375
- ' 395 lf from MH 4848-375 to MH 4848-374

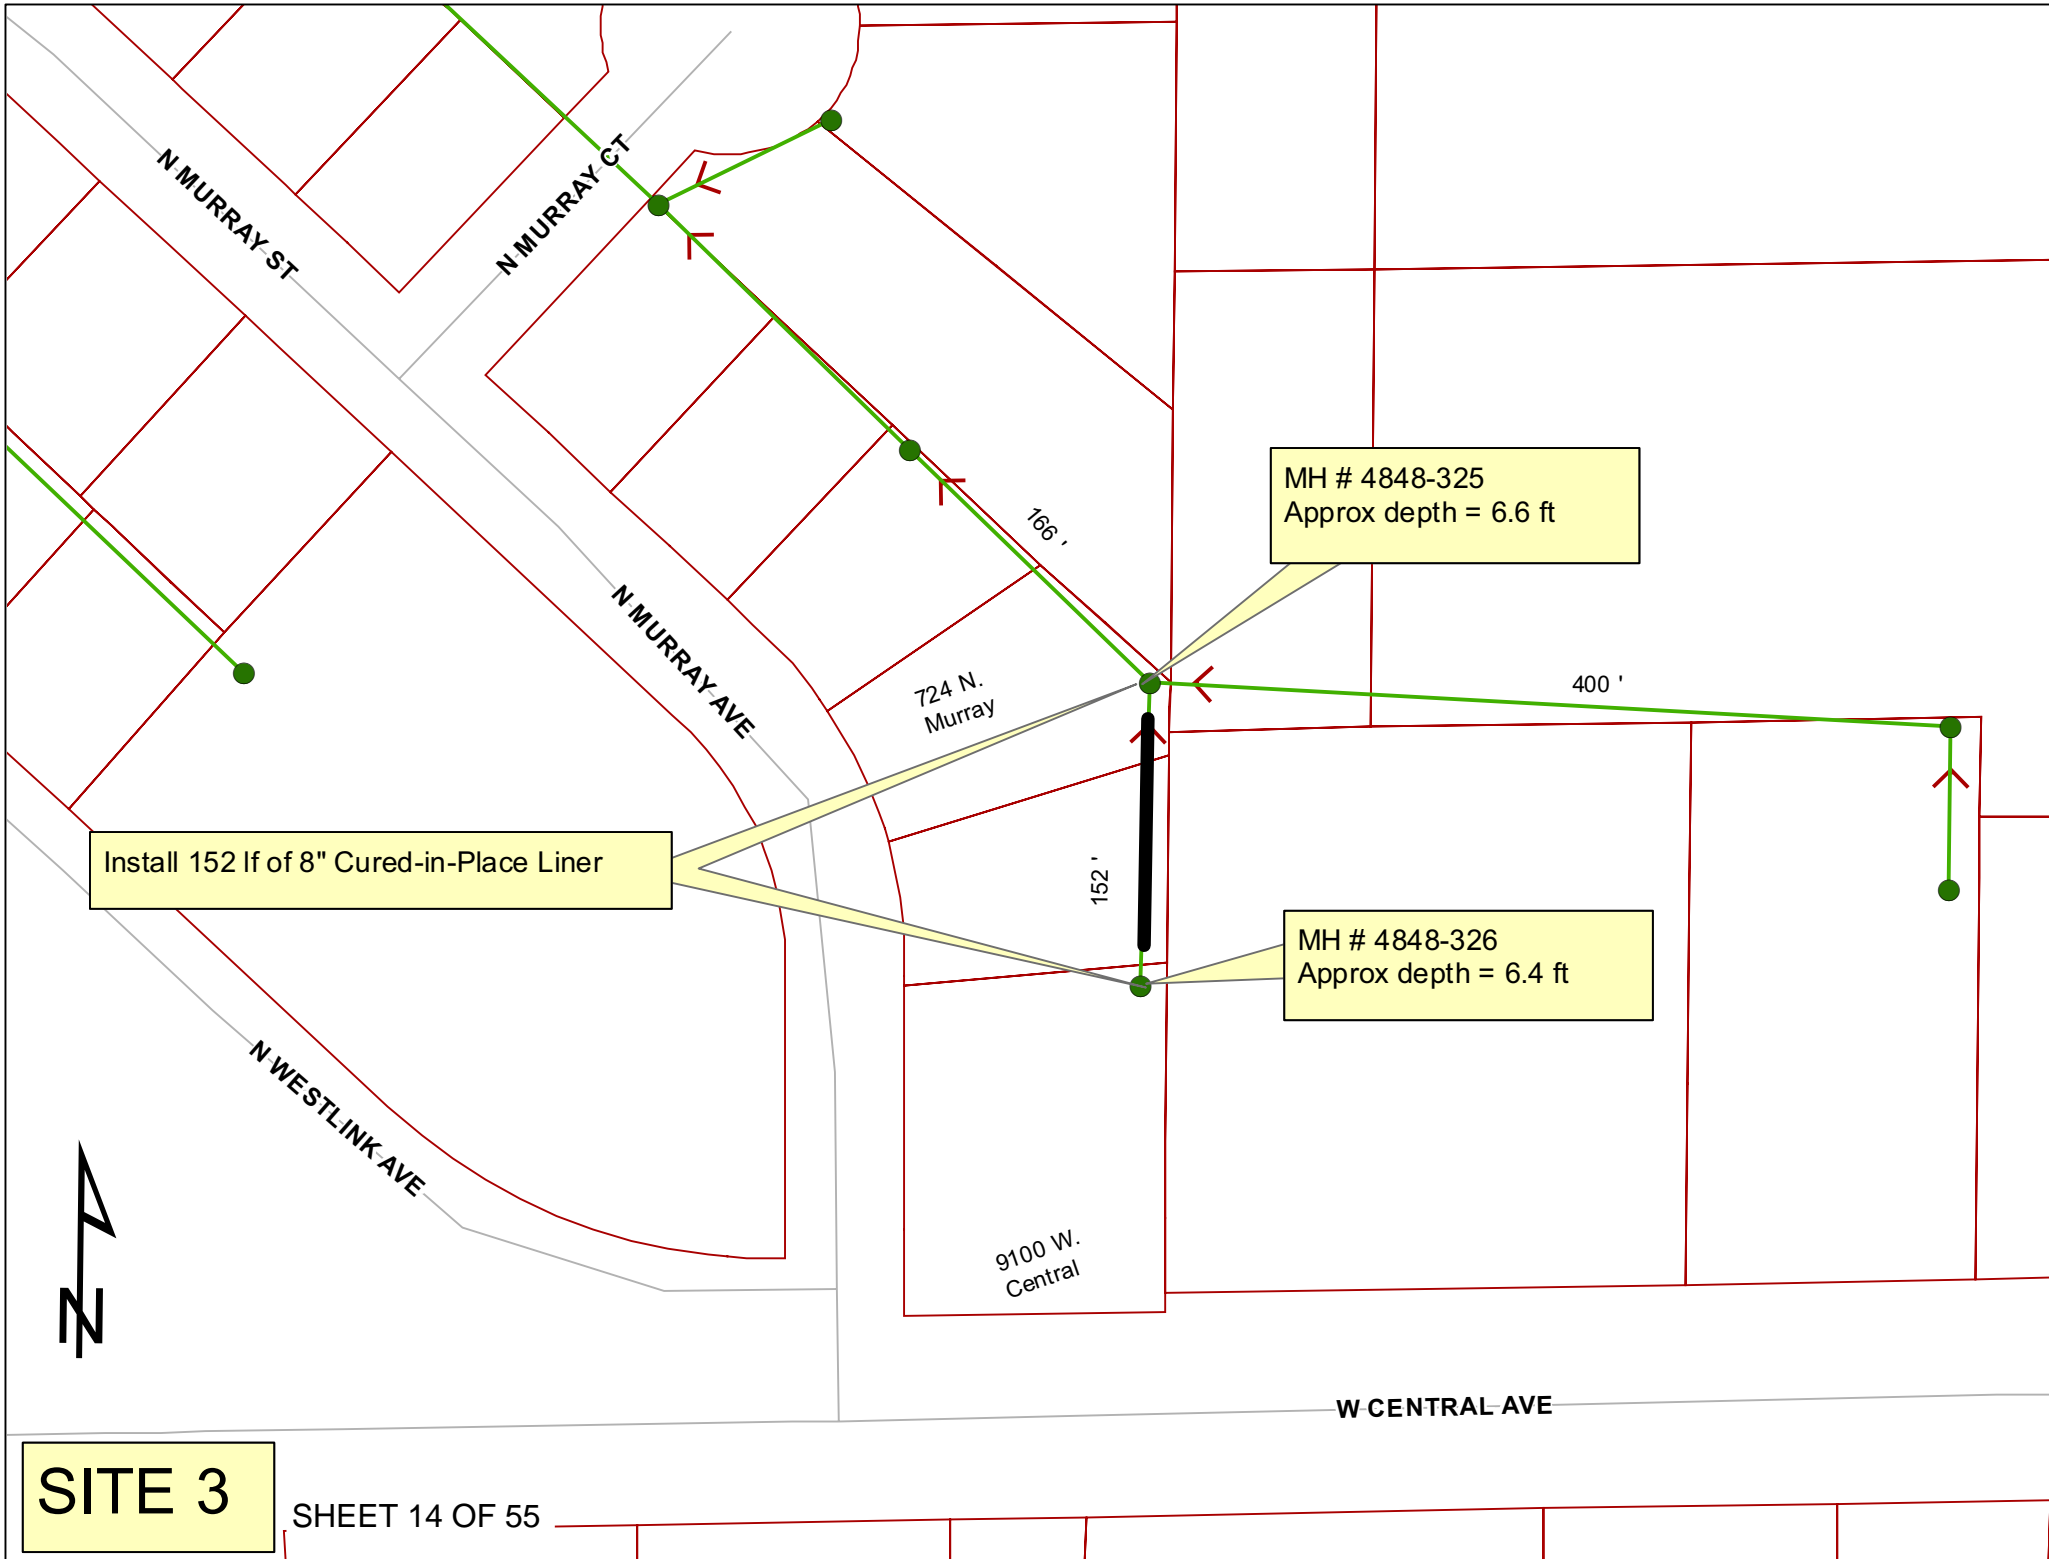
SITE 3

MH # 4848-325
Approx depth = 6.6 ft

MH # 4848-326
Approx depth = 6.4 ft

Install 152 lf of 8" Cured-in-Place Liner
