SITE 1

PAGE 3 OF 22

Video Inspection Master Report

US Structure: 5747-572 3700 E DOUGLAS AVE Date Insp: 5/16/2012 Basin: EC02A
 DS Structure: 5747-570 3444 E DOUGLAS AVE Dir. Televised: Upstream To Downstream

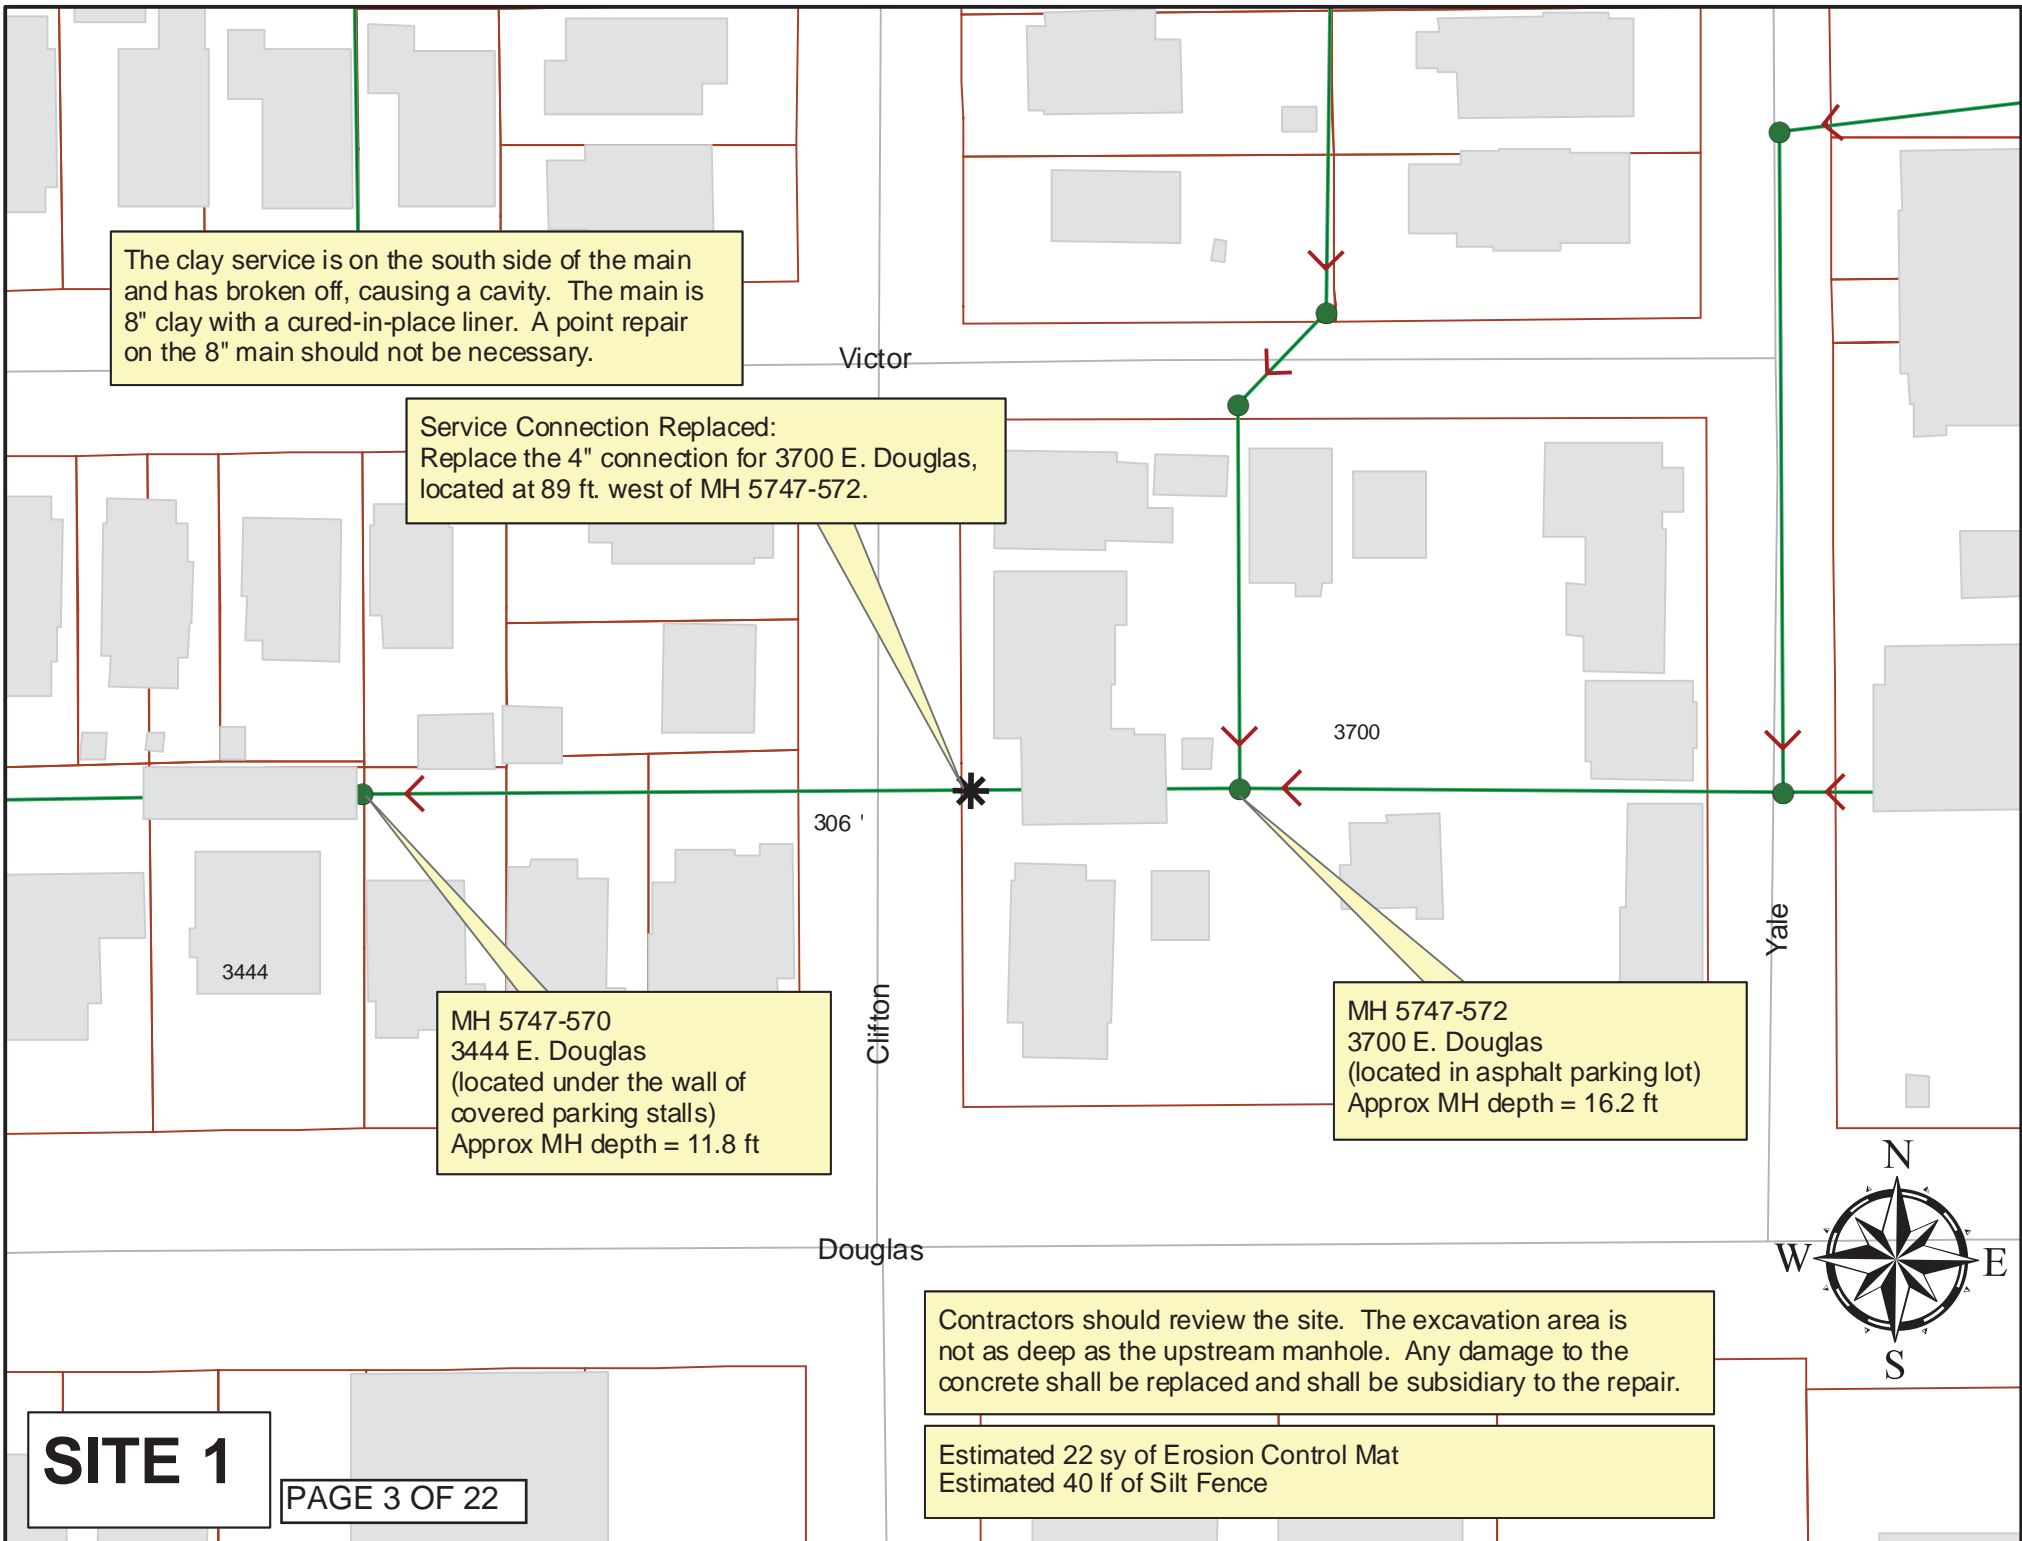
The clay service is on the south side of the main and has broken off, causing a cavity. The main is 8" clay with a cured-in-place liner. A point repair on the 8" main should not be necessary.

Service Connection Replaced:
Replace the 4" connection for 3700 E. Douglas,
located at 89 ft. west of MH 5747-572.

Contractors should review the site. The excavation area is not as deep as the upstream manhole. Any damage to the concrete shall be replaced and shall be subsidiary to the repair.

Estimated 22 sy of Erosion Control Mat
Estimated 40 lf of Silt Fence
