Install 275 lf of 8"
Cured-in-Place Liner

SITE 1

Sheet 3 of 42

Video Inspection Master Report

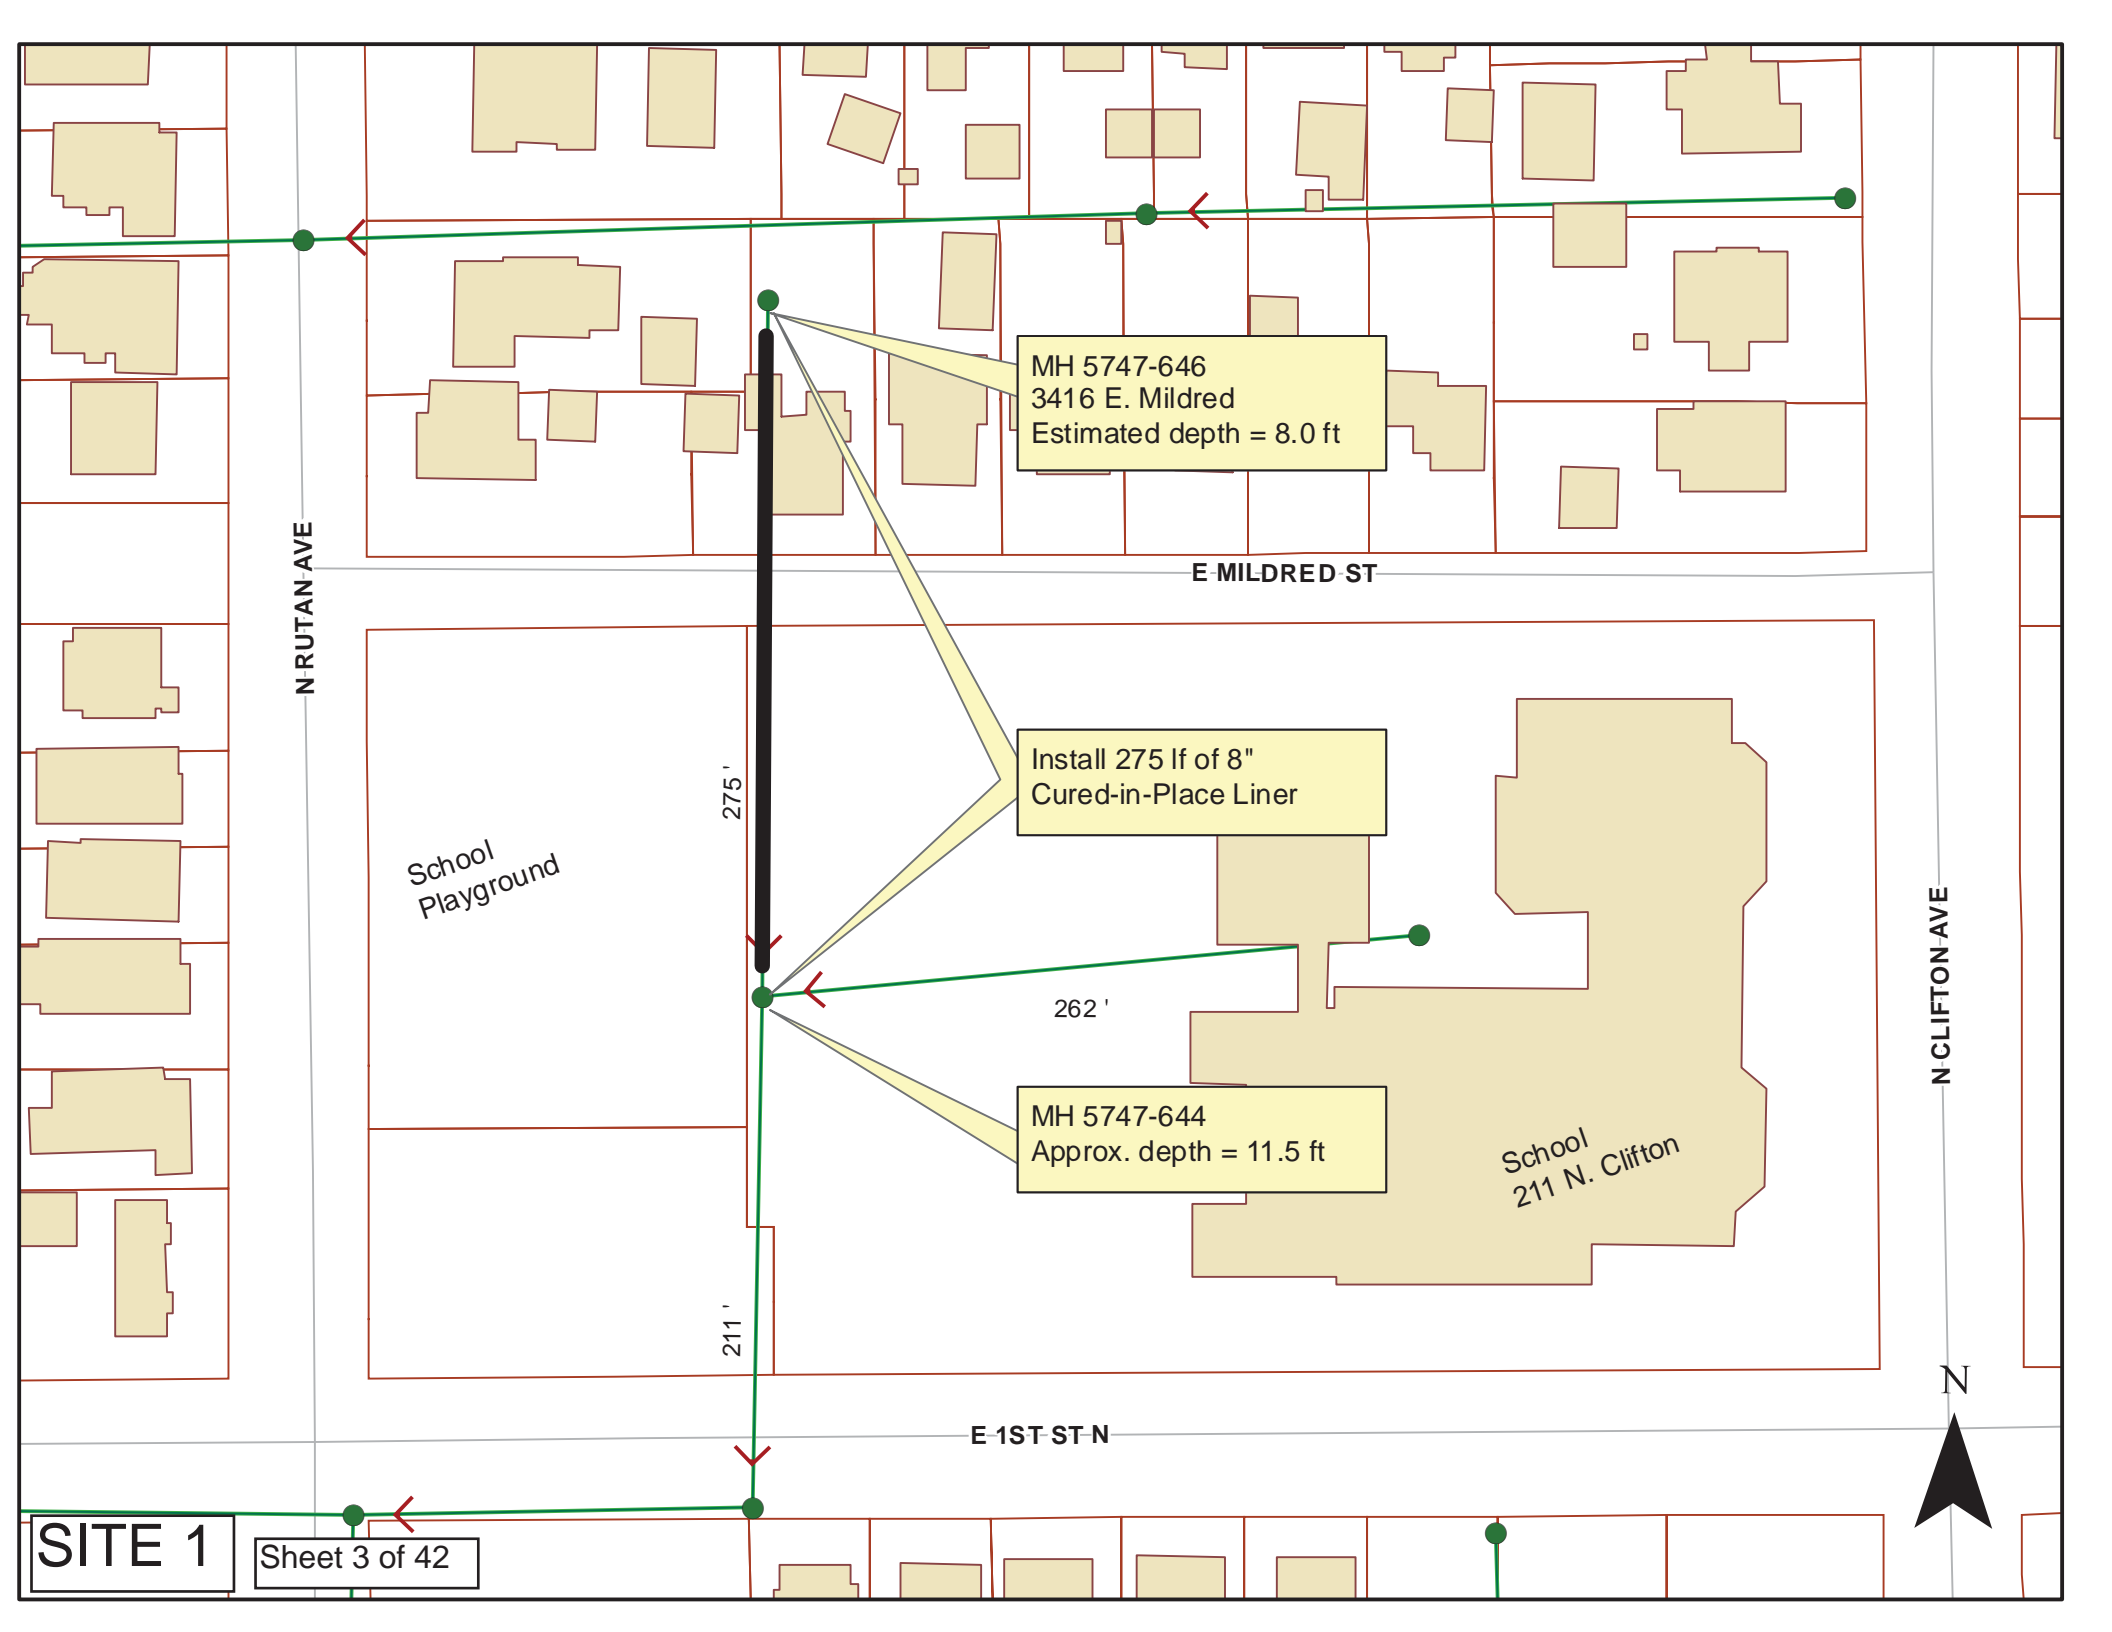
MH 5747-646
3416 E. Mildred
Estimated depth = 8.0 ft

MH 5747-644
Approx. depth = 11.5 ft
