Install 807 lf of 8" Cured-in-Place Liner
from MH 5747-639 to MH 5747-633

SITE 2

Sheet 6 of 42

Video Inspection Master Report

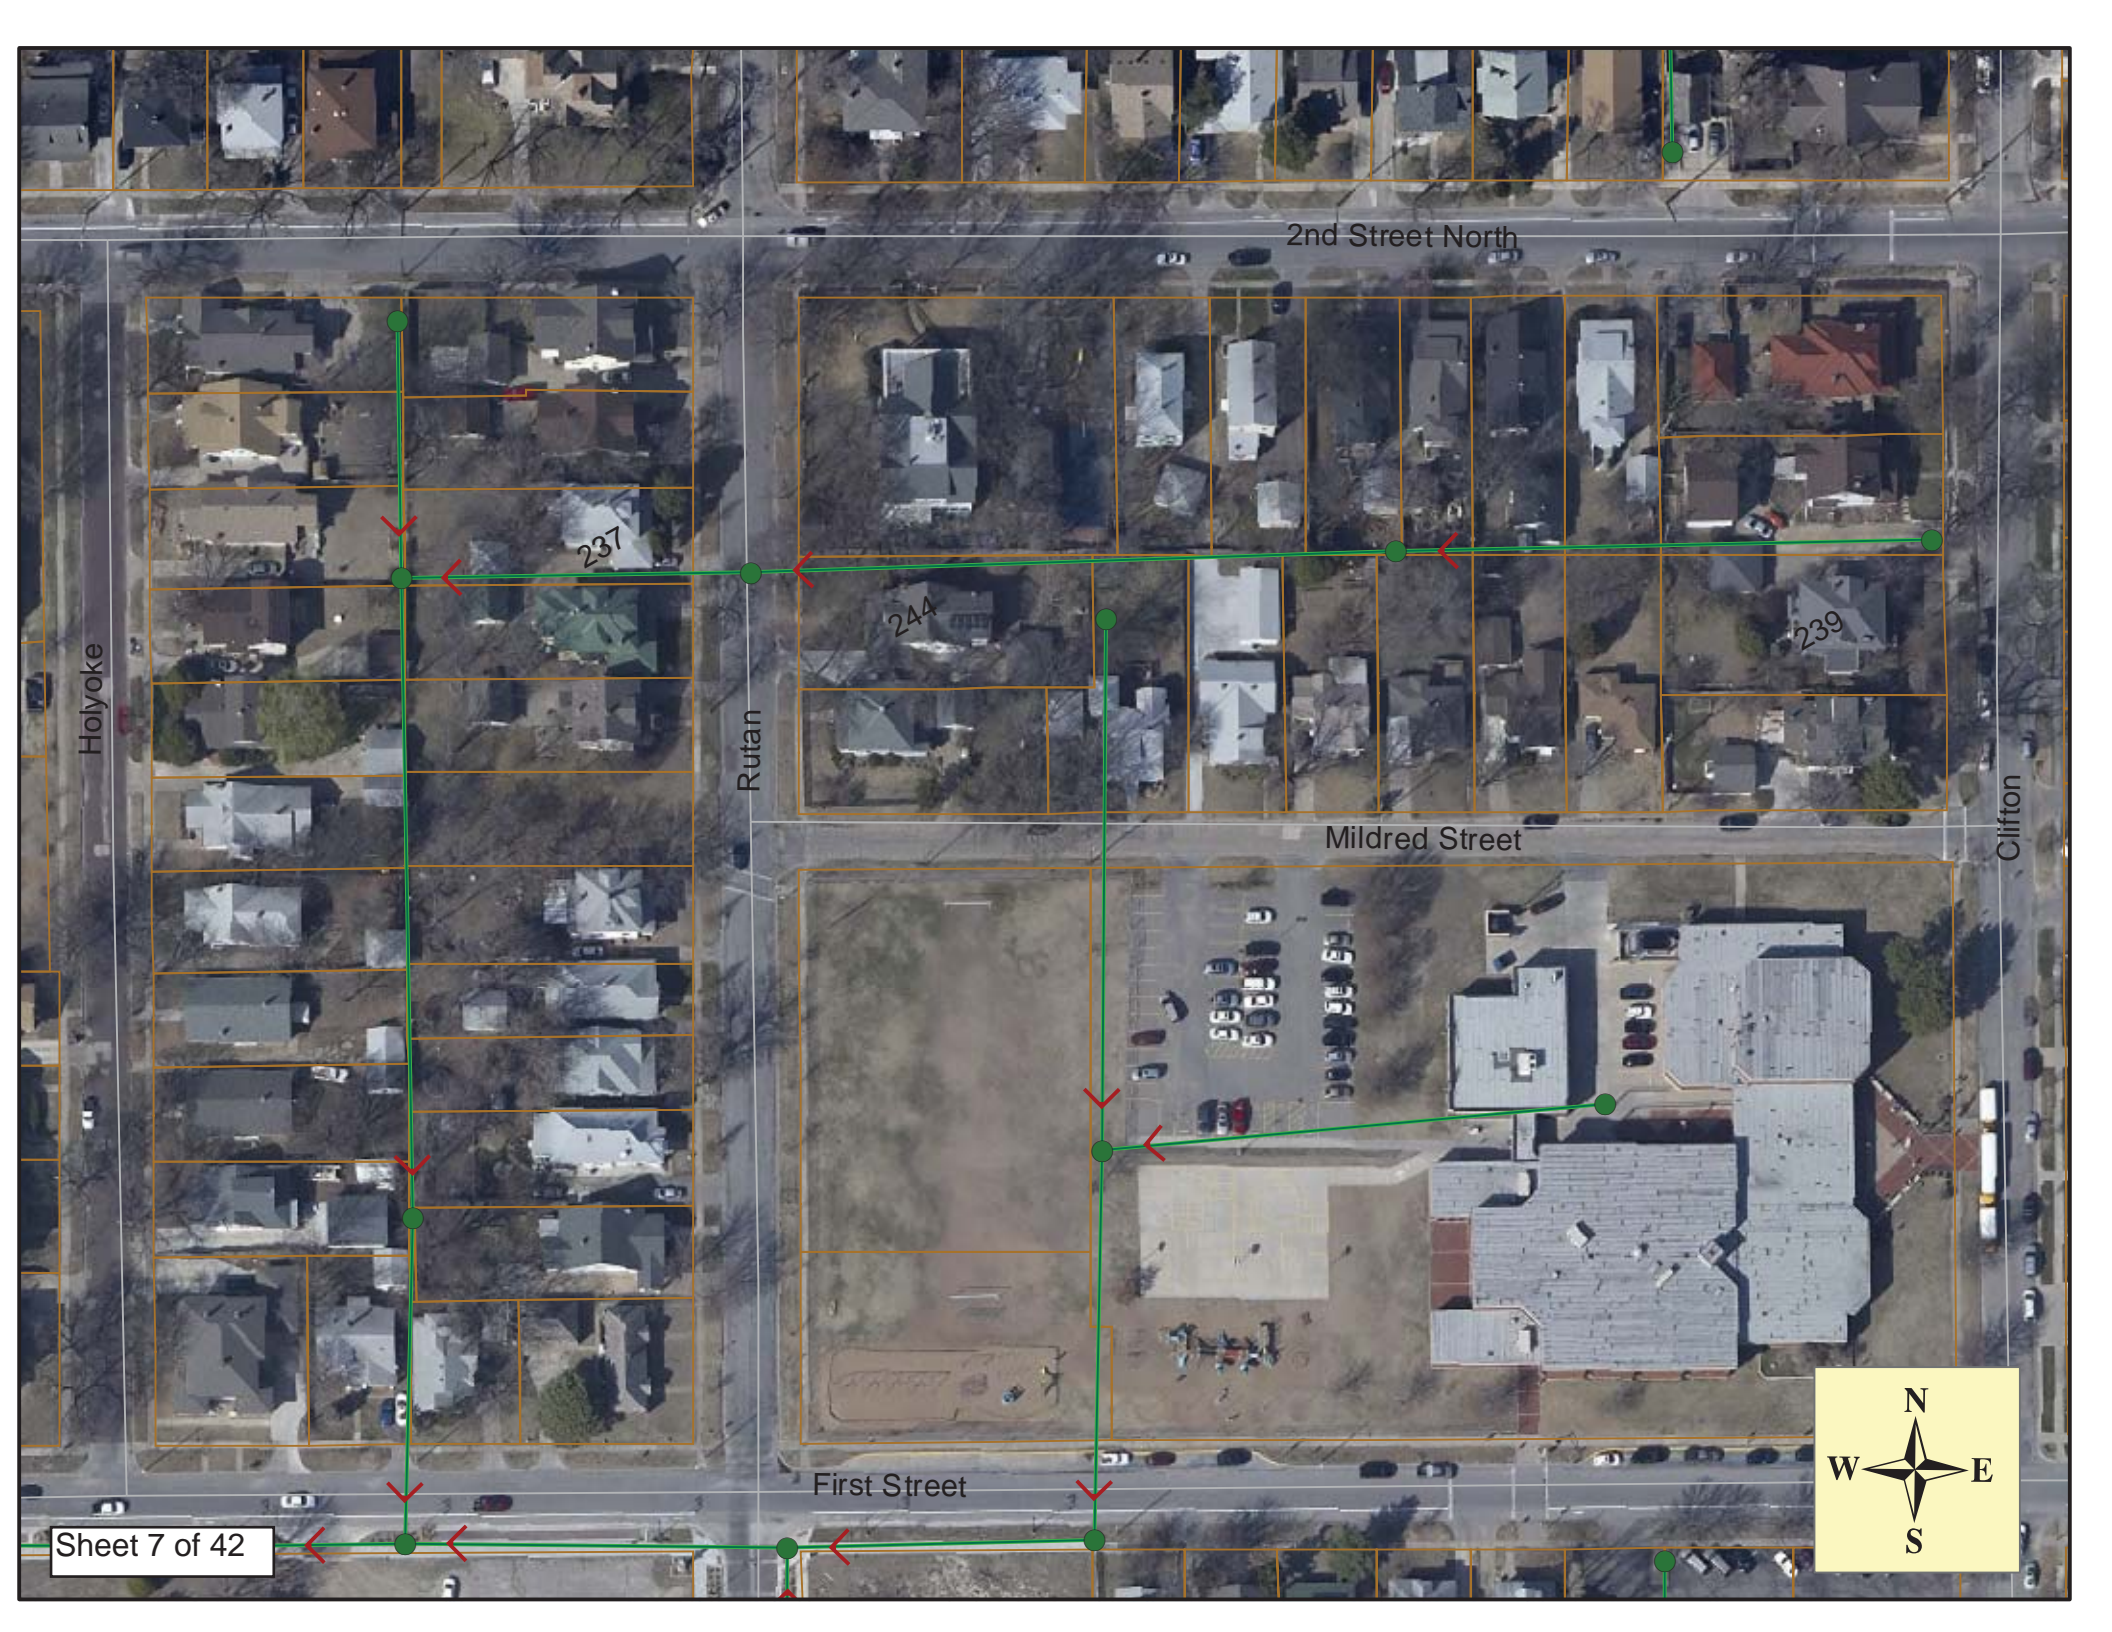
MH 5747-633
250 N. Holyoke
Approx depth = 10.6 ft

MH 5747-635
Approx depth = 9.5 ft

MH 5747-637
3501 E. 2nd St.
(under fence)
Approx depth = 12.3 ft

MH 5747-639
245 N. Clifton
Approx depth = 9.2 ft
