SITE 3

Sheet 11 of 42

US Structure: 5747-630 210 N HOLYOKE AVE Date Insp: 5/18/2011 Basin: EC02A
 DS Structure: 5747-065 3236 E 1ST ST Dir Televised: Upstream To Downstream

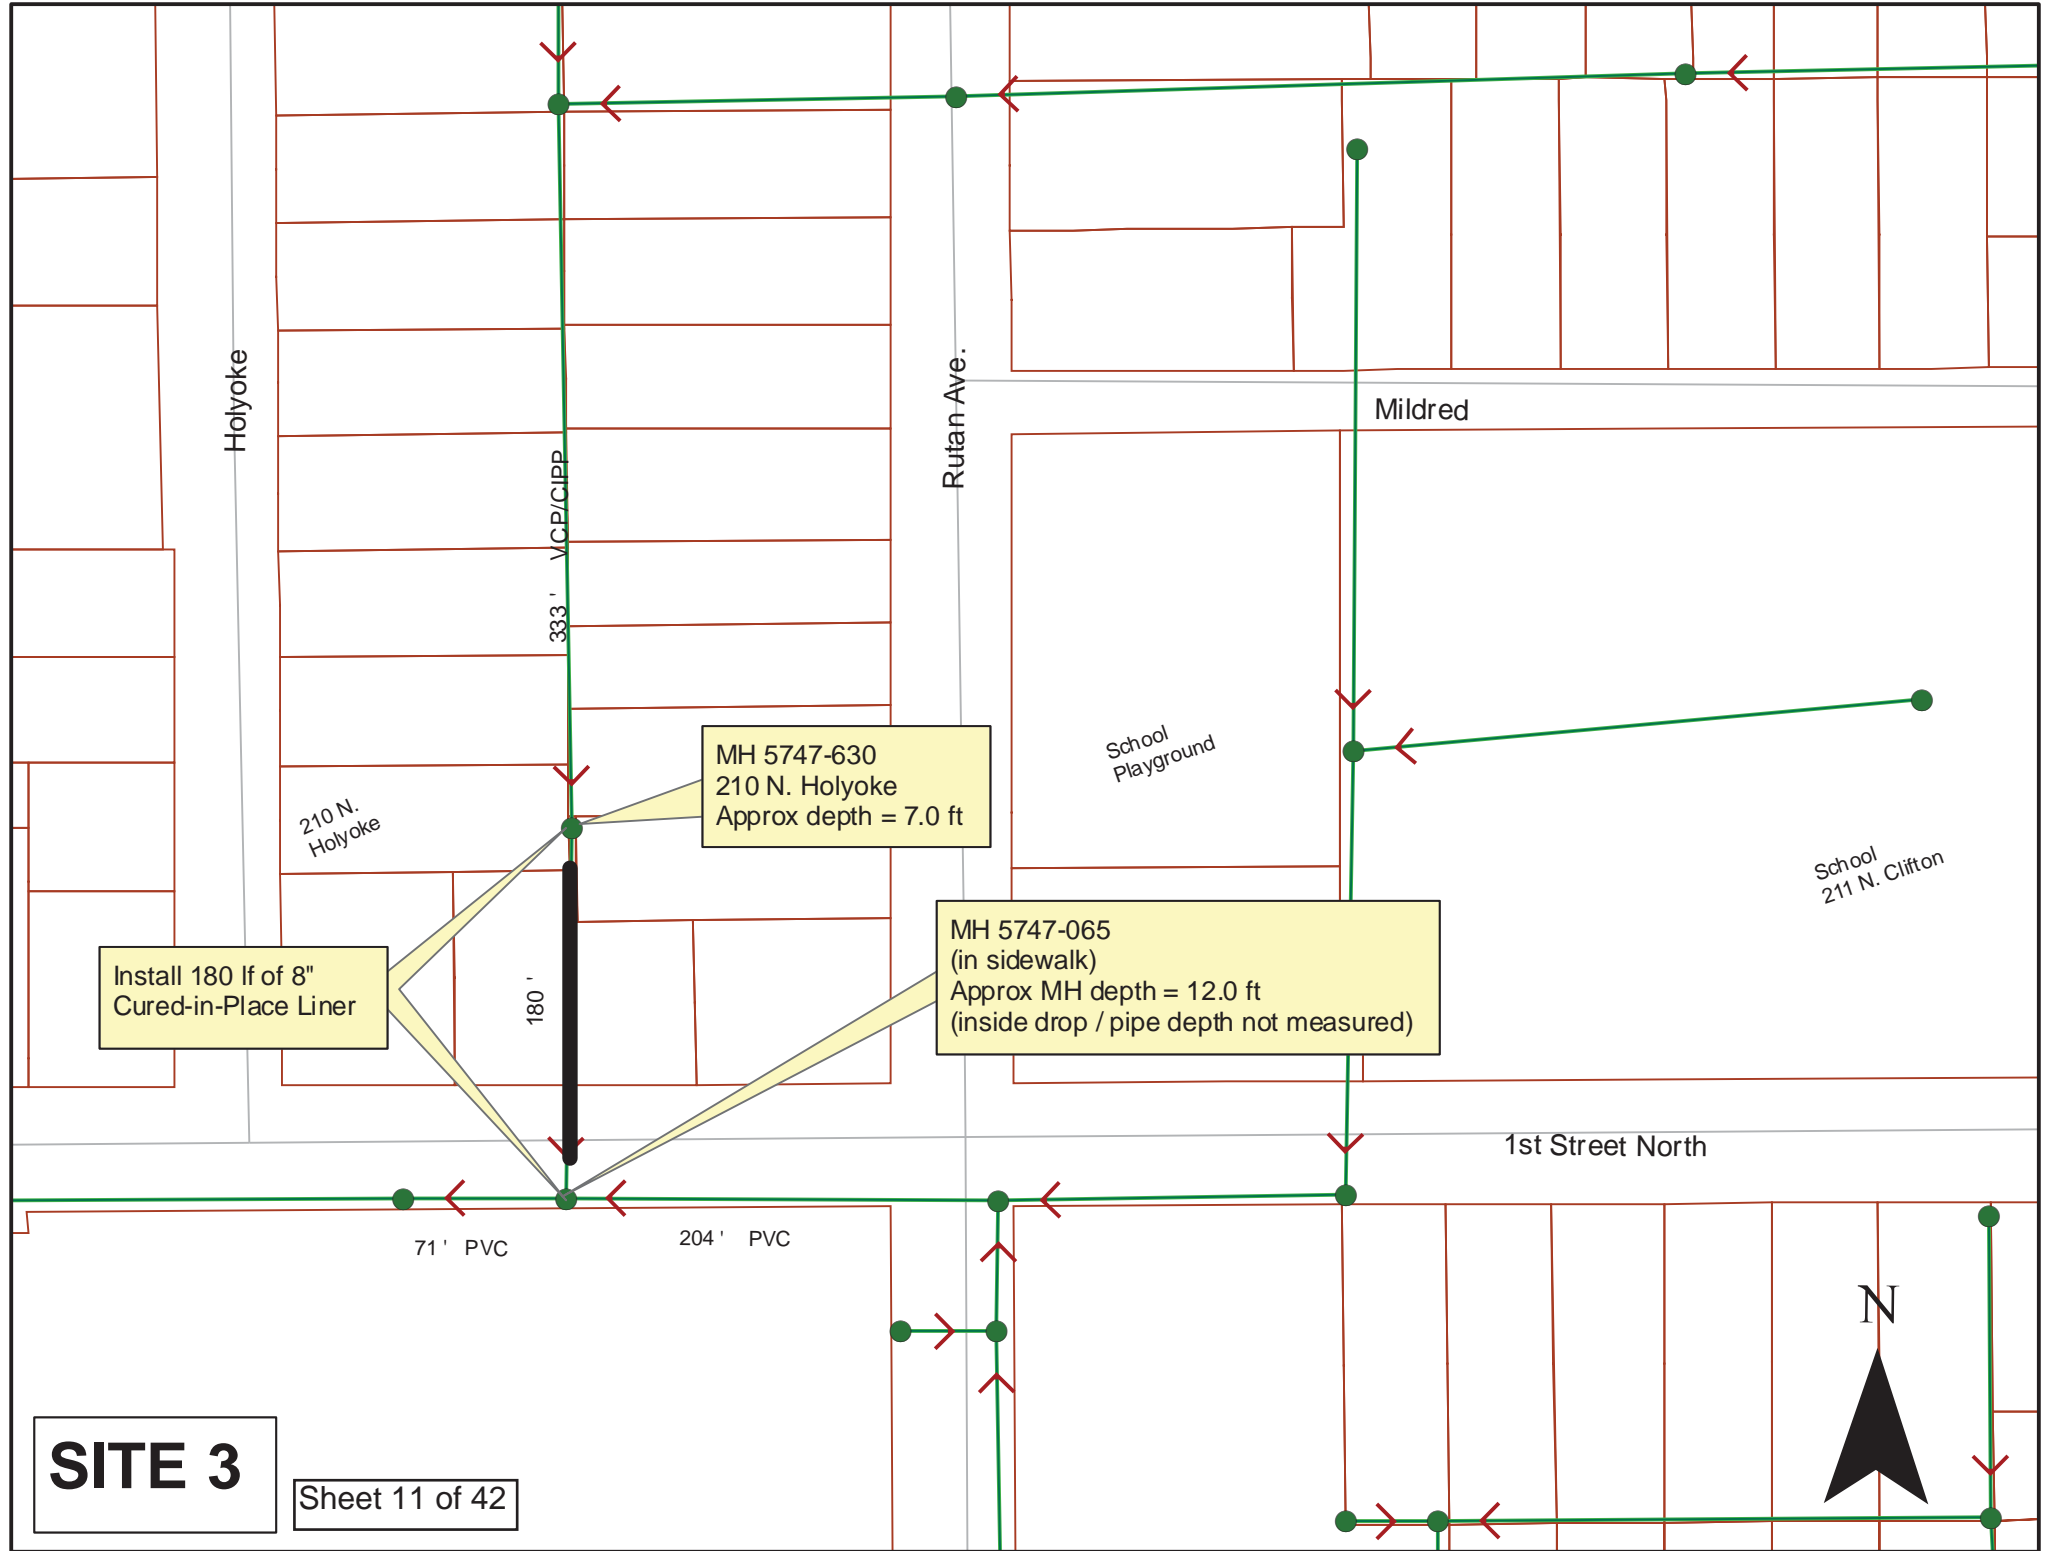
MH 5747-630
210 N. Holyoke
Approx depth = 7.0 ft

MH 5747-065
(in sidewalk)
Approx MH depth = 12.0 ft
(inside drop / pipe depth not measured)

Install 180 lf of 8" Cured-in-Place Liner

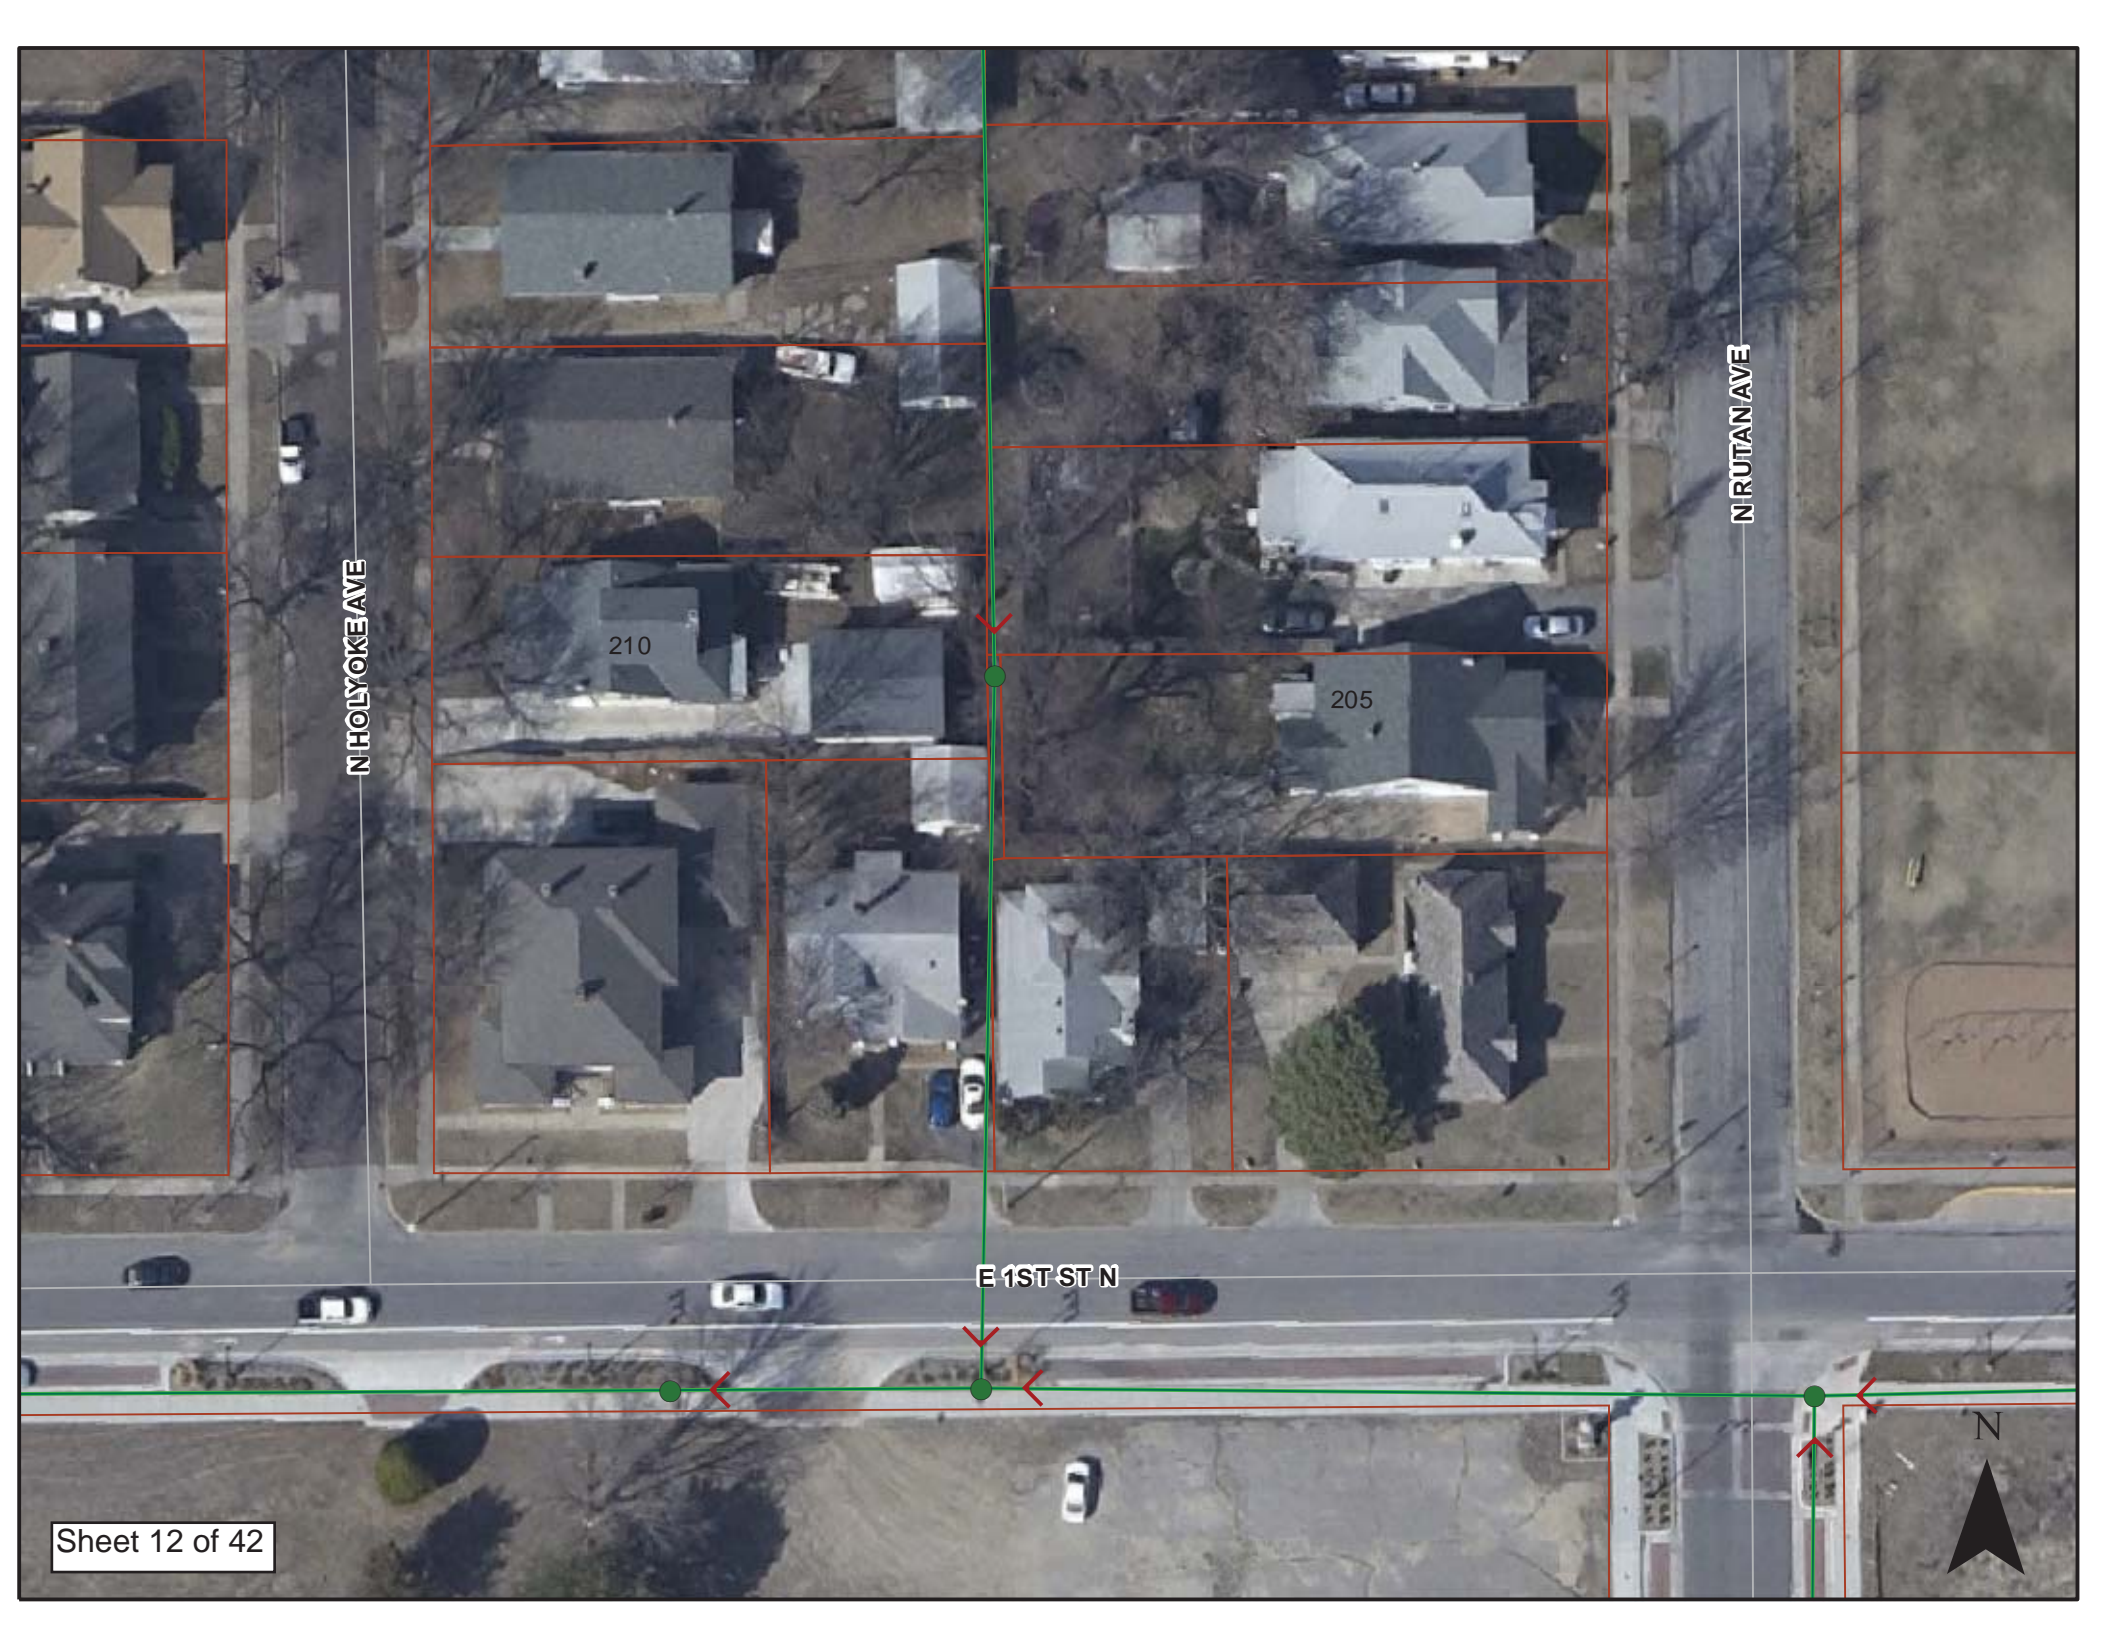
Obs. #	VTR Counter	Distance	Location	Description	Rating	Ratings			
						Obsrvd (gpm)	Est. (gpm)	Struct Clean	Remain (gpm)
1		0.0		5747-630 US Manhole	1	0.000	0	0	0.000
2		0.1		Crack-Horizontal	2	0.002	2	0	0.002
3		3.0		Crack-Horizontal	3	0.004	5	0	0.004
4		5.8		Crack-Horizontal	3	0.004	5	0	0.004
5		8.2		Crack-Horizontal	3	0.004	5	0	0.004
6		9.5		Wye Service	1	0.000	0	0	0.000
7		10.9		Crack-Horizontal	4	0.008	10	0	0.008
8		11.9		Wye Service	1	0.000	0	0	0.000
9		13.5		Crack-Horizontal	3	0.004	5	0	0.004
10		15.9		Crack-Horizontal	3	0.004	5	0	0.004
11		18.7		Crack-Horizontal	3	0.004	5	0	0.004
12		20.6	205 N RUTAN	Break-In Conn	4	0.008	60	0	0.008
13		21.0	(the first 22 ft is all cracked)	Broken Pipe	3	0.010	60	0	0.010
14		34.1	210 N HOLYOKE? / roots	Wye Service	2	0.000	0	0	0.000
15		37.4		Wye Service	1	0.000	0	0	0.000
16		45.1	203 N RUTAN	Break-In Conn	2	0.002	0	0	0.002
17		50.2	201 N RUTAN / roots	Break-In Conn	2	0.002	0	0	0.002

18		60.4	3230 E 1ST ST N / roots	Break-In Conn	2	0.002	0	0	0.002
19		61.5		Broken Pipe	3	0.010	60	0	0.010
20		62.7	3238 E 1ST ST N	Wye Service	3	0.000	2	0	0.000
21		85.9		Wye Service	1	0.000	0	0	0.000
22		88.2		Wye Service	1	0.000	0	0	0.000
23		109.4	small hole in invert	Crack-Radial	3	0.004	5	0	0.004
24		111.2		Wye Service	1	0.000	0	0	0.000
25		113.5		Wye Service	1	0.000	0	0	0.000
26		137.6	infiltration at cracks	Crack-Horizontal	3	0.004	5	0	0.004
27		141.2		Crack-Horizontal	2	0.002	2	0	0.002
28		143.6		Crack-Horizontal	2	0.002	2	0	0.002
29		175.2		PVC pipe begins	1	0.000	0	0	0.000
30		178.1	(precast manhole)	5747-065 DS Manhole	1		Inside Drop into the manhole
