**SITE 5**

Sheet 22 of 42

# Video Inspection Master Report

US Structure: 5747-268      422 S ROOSEVELT ST      Date Insp: 6/11/2012      Basin: EC01G  
 DS Structure: 5747-266      409 S BLUFF ST      Dir Televised: Upstream To Downstream

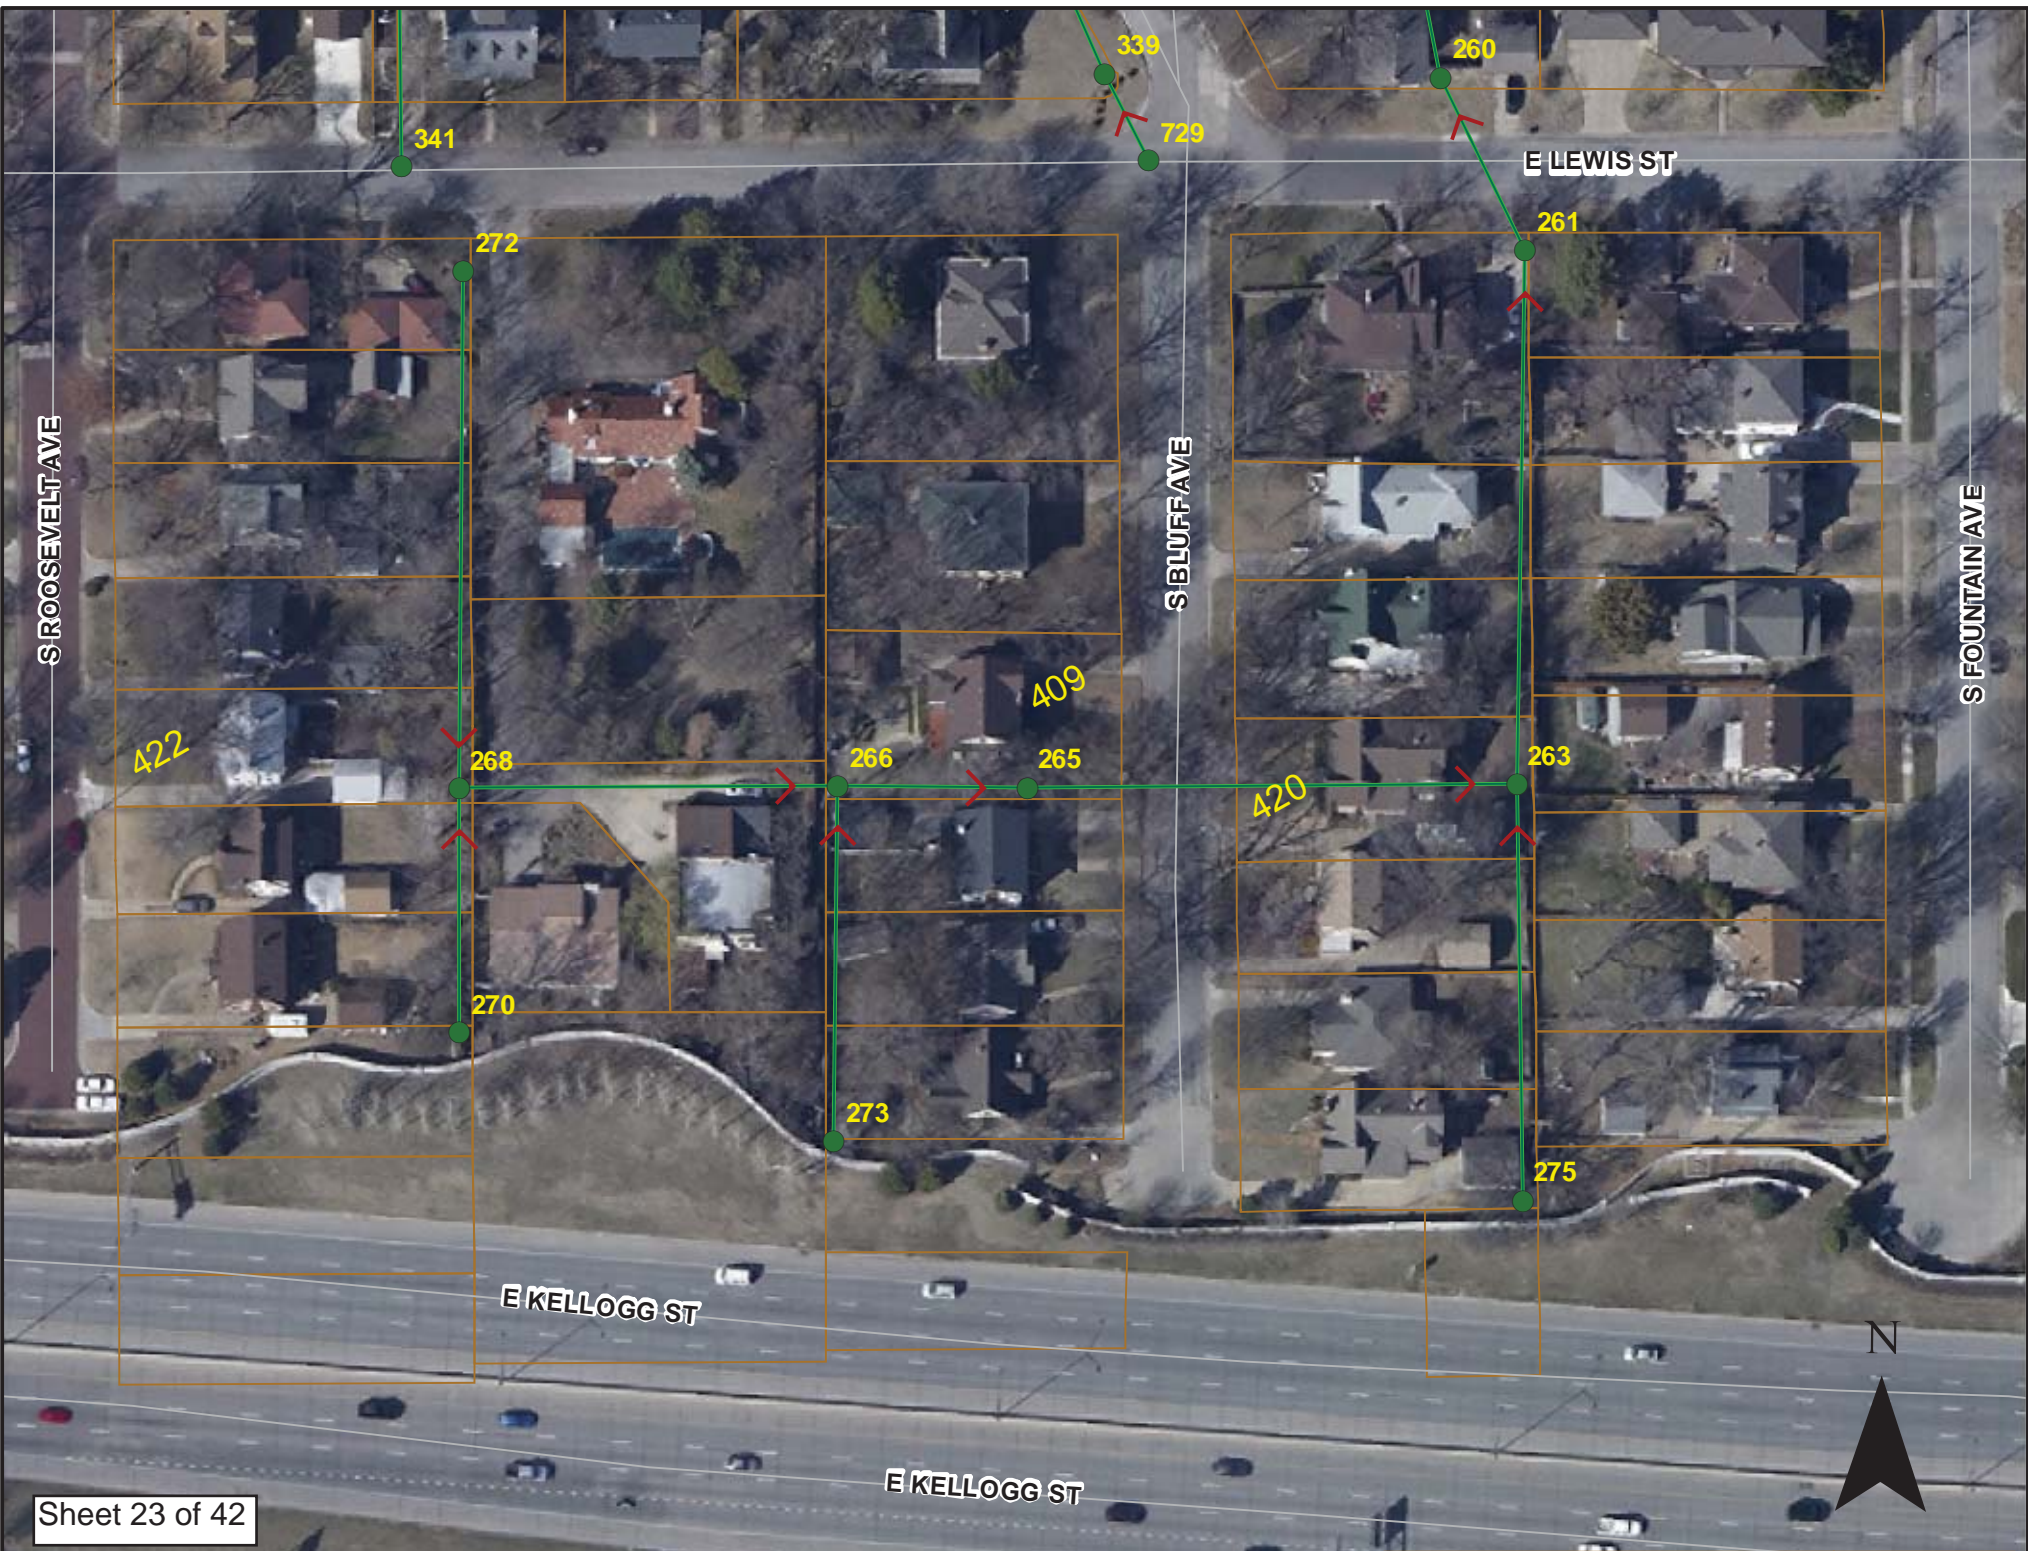
Comments: POINT REPAIR 113 FEET EAST OF M.H 5747-268 FOR BROKEN PIPE. LINE SEGMENT 3
