Install 235 lf of 8"  
Cured-in-Place Liner  
from MH 5747-057  
to MH 5747-056

**SITE 7**

Sheet 31 of 42

**Pipe Information**  
 Project No. : **C-234**      Dia: **8**      Material: **VCP**      Length: **235.0**      Slope: **0.002**      Surface:      Rear Easement

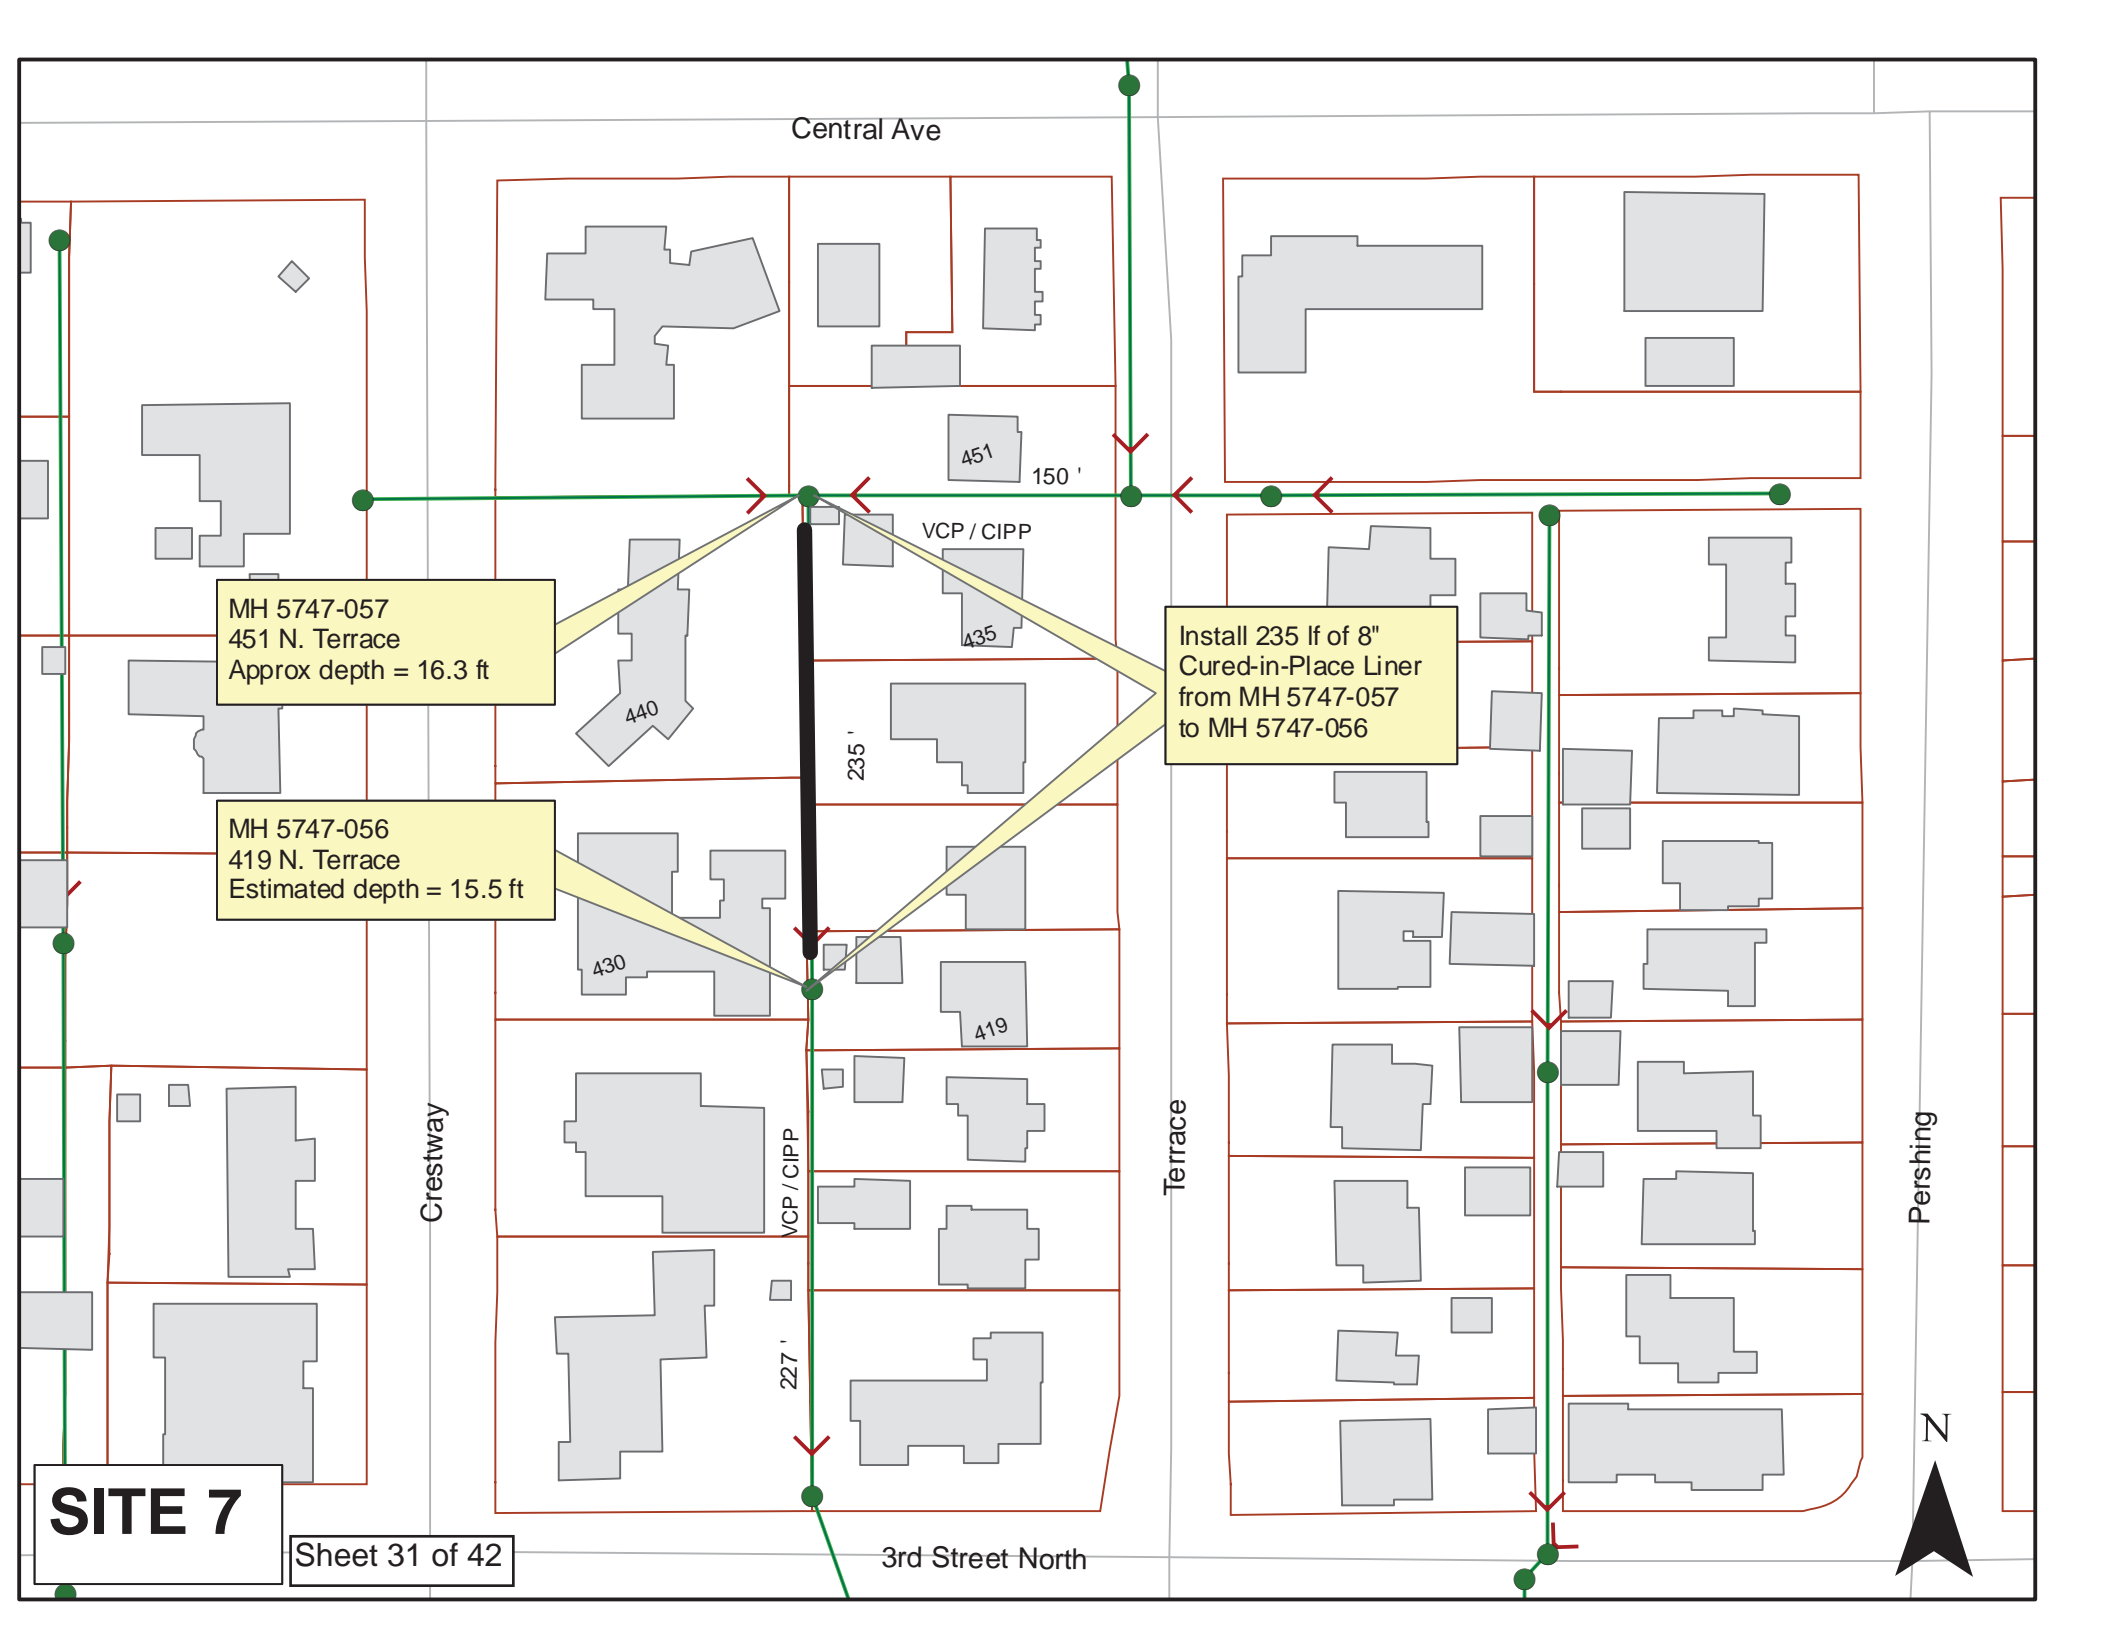
MH 5747-057  
451 N. Terrace  
Approx depth = 16.3 ft

MH 5747-056  
419 N. Terrace  
Estimated depth = 15.5 ft
