**SITE 8**

Sheet 35 of 42

# Television Inspection Master Report

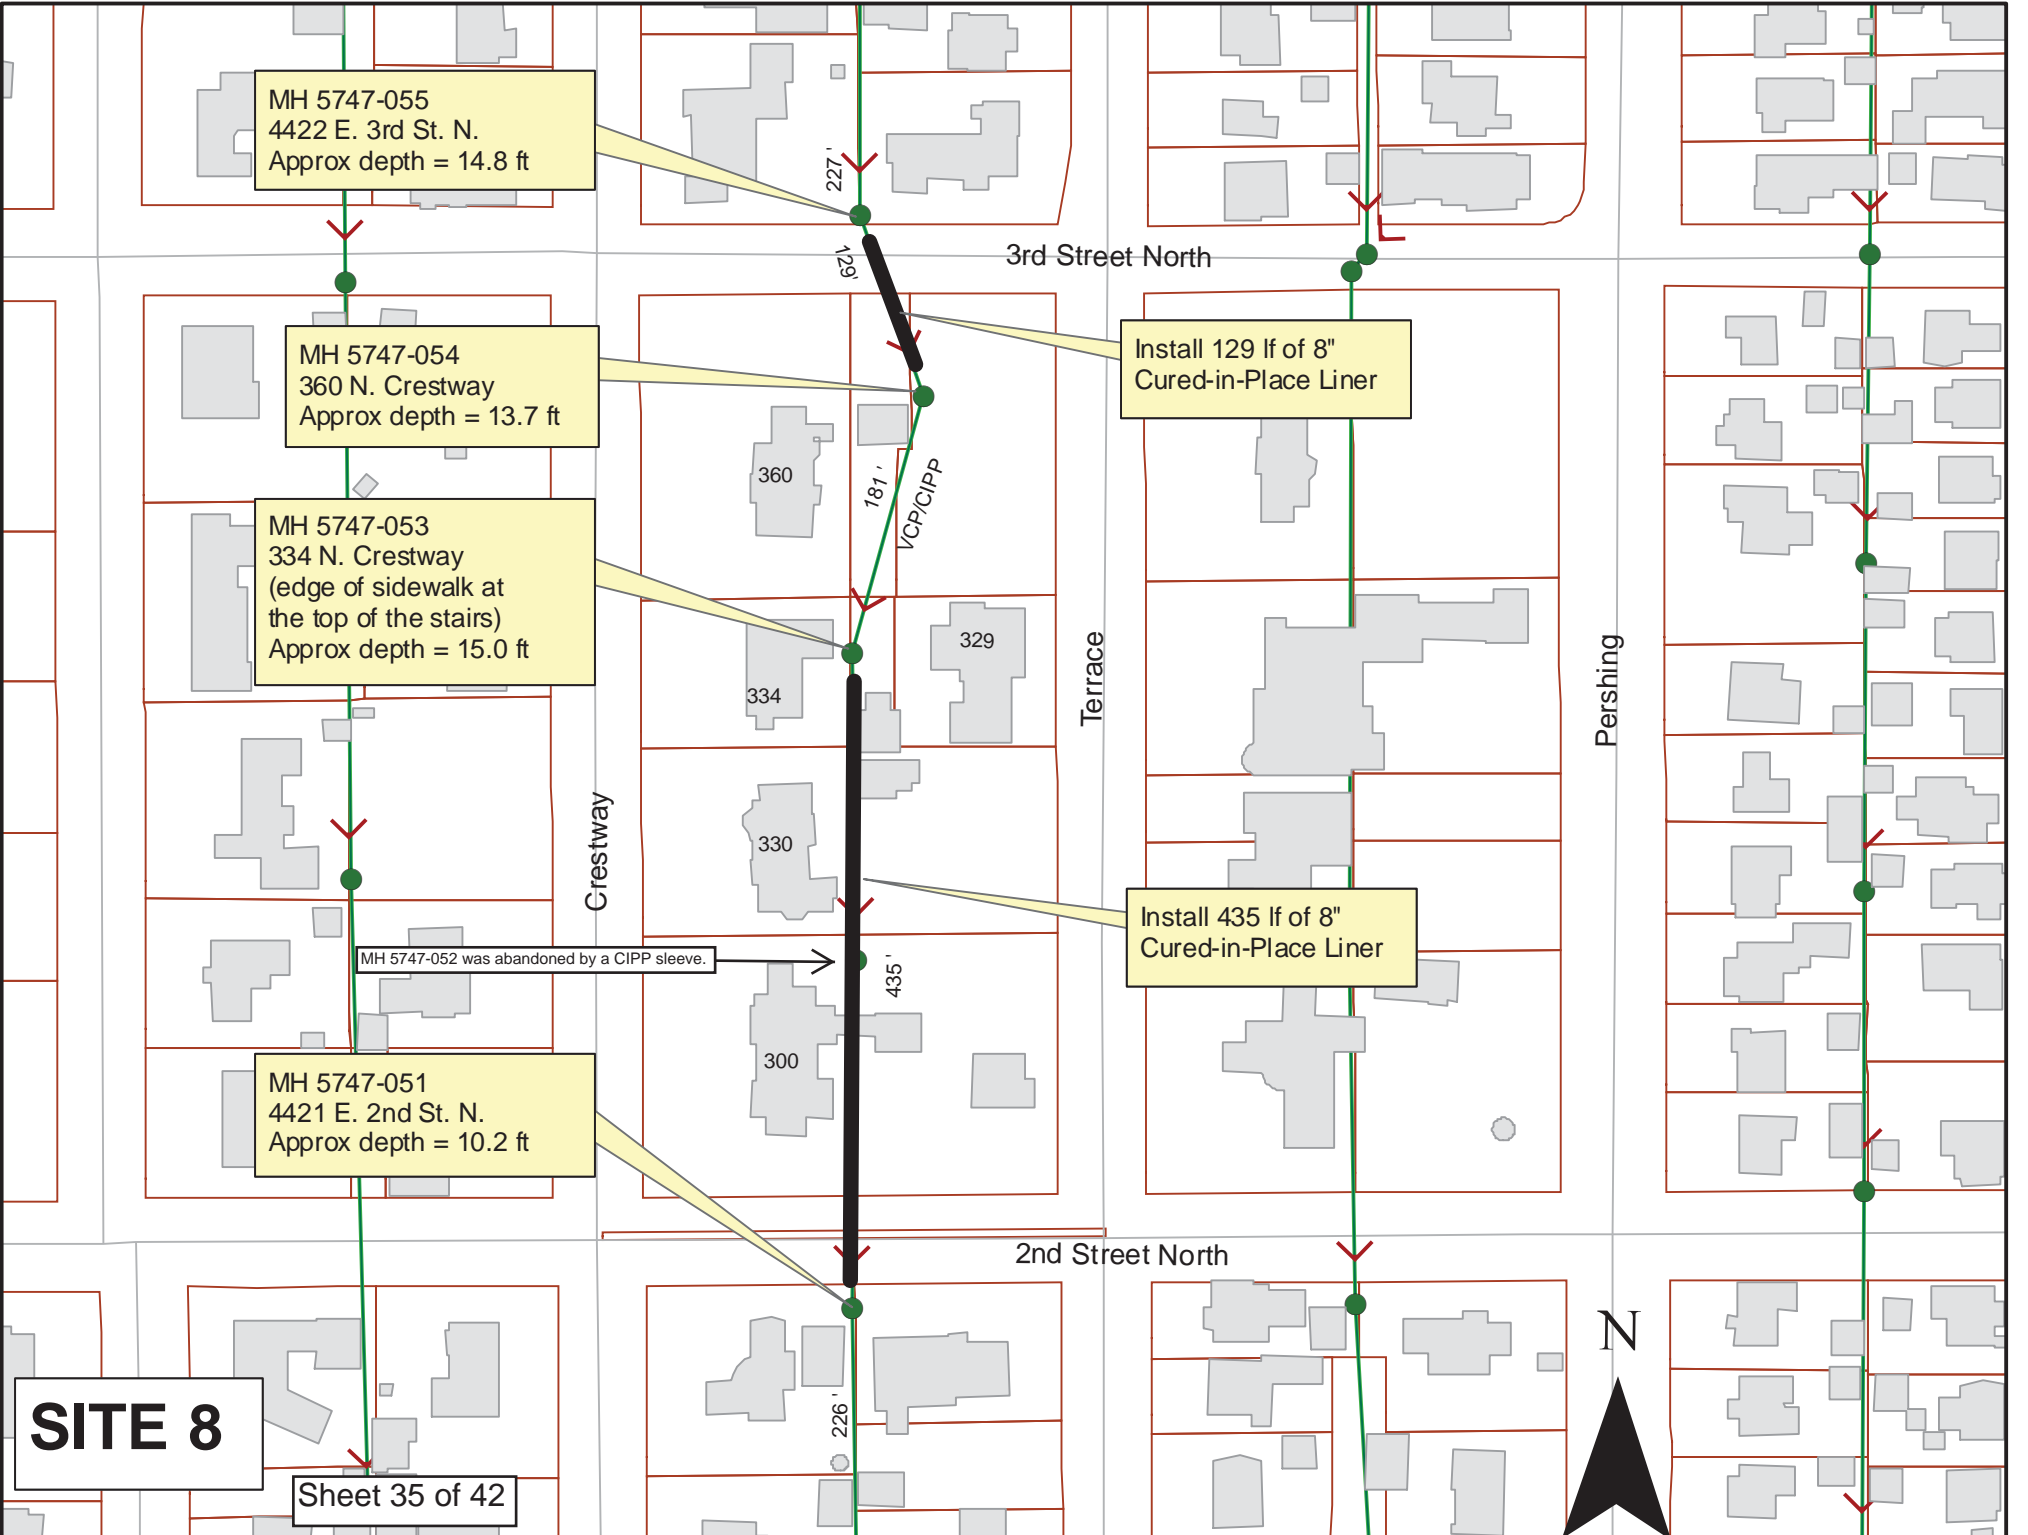
MH 5747-055  
4422 E. 3rd St. N.  
Approx depth = 14.8 ft

MH 5747-054  
360 N. Crestway  
Approx depth = 13.7 ft

MH 5747-053  
334 N. Crestway  
(edge of sidewalk at the top of the stairs)  
Approx depth = 15.0 ft

MH 5747-052 was abandoned by a CIPP sleeve.

MH 5747-051  
4421 E. 2nd St. N.  
Approx depth = 10.2 ft

Install 129 lf of 8" Cured-in-Place Liner

Install 435 lf of 8" Cured-in-Place Liner

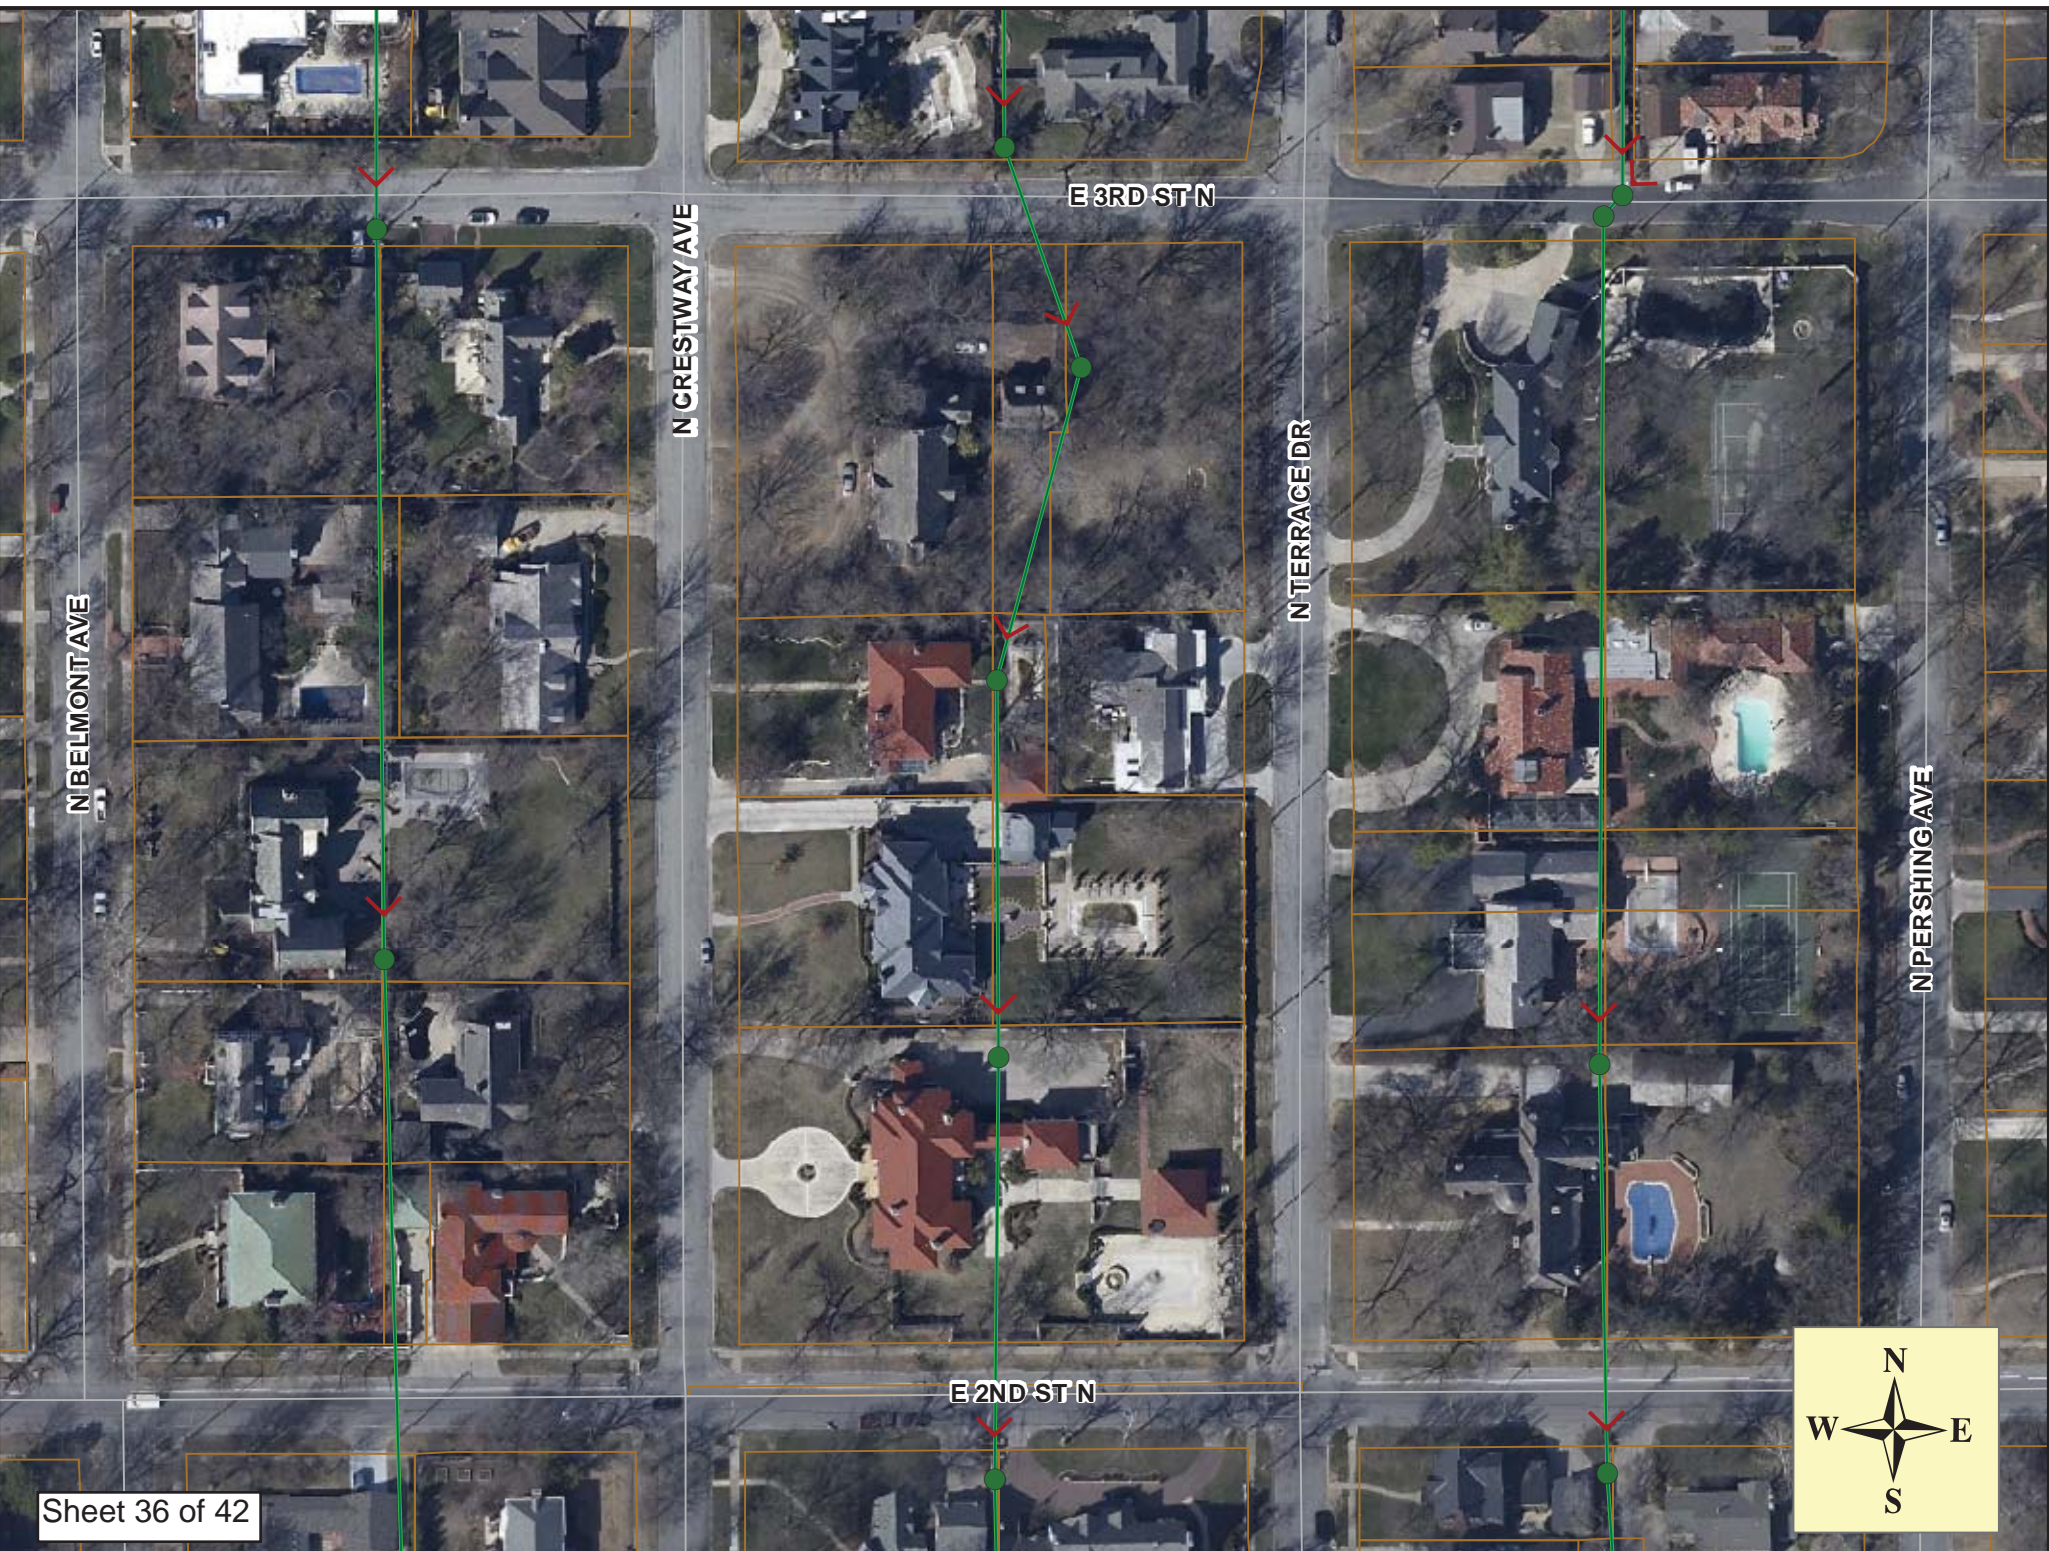
Line has some short and shallow sags.  
Sag from 92' to 125' - line through this anyway
