Install 171 lf of 8" Cured-in-Place Liner

**SITE 9**

Sheet 40 of 42

# Video Inspection Master Report

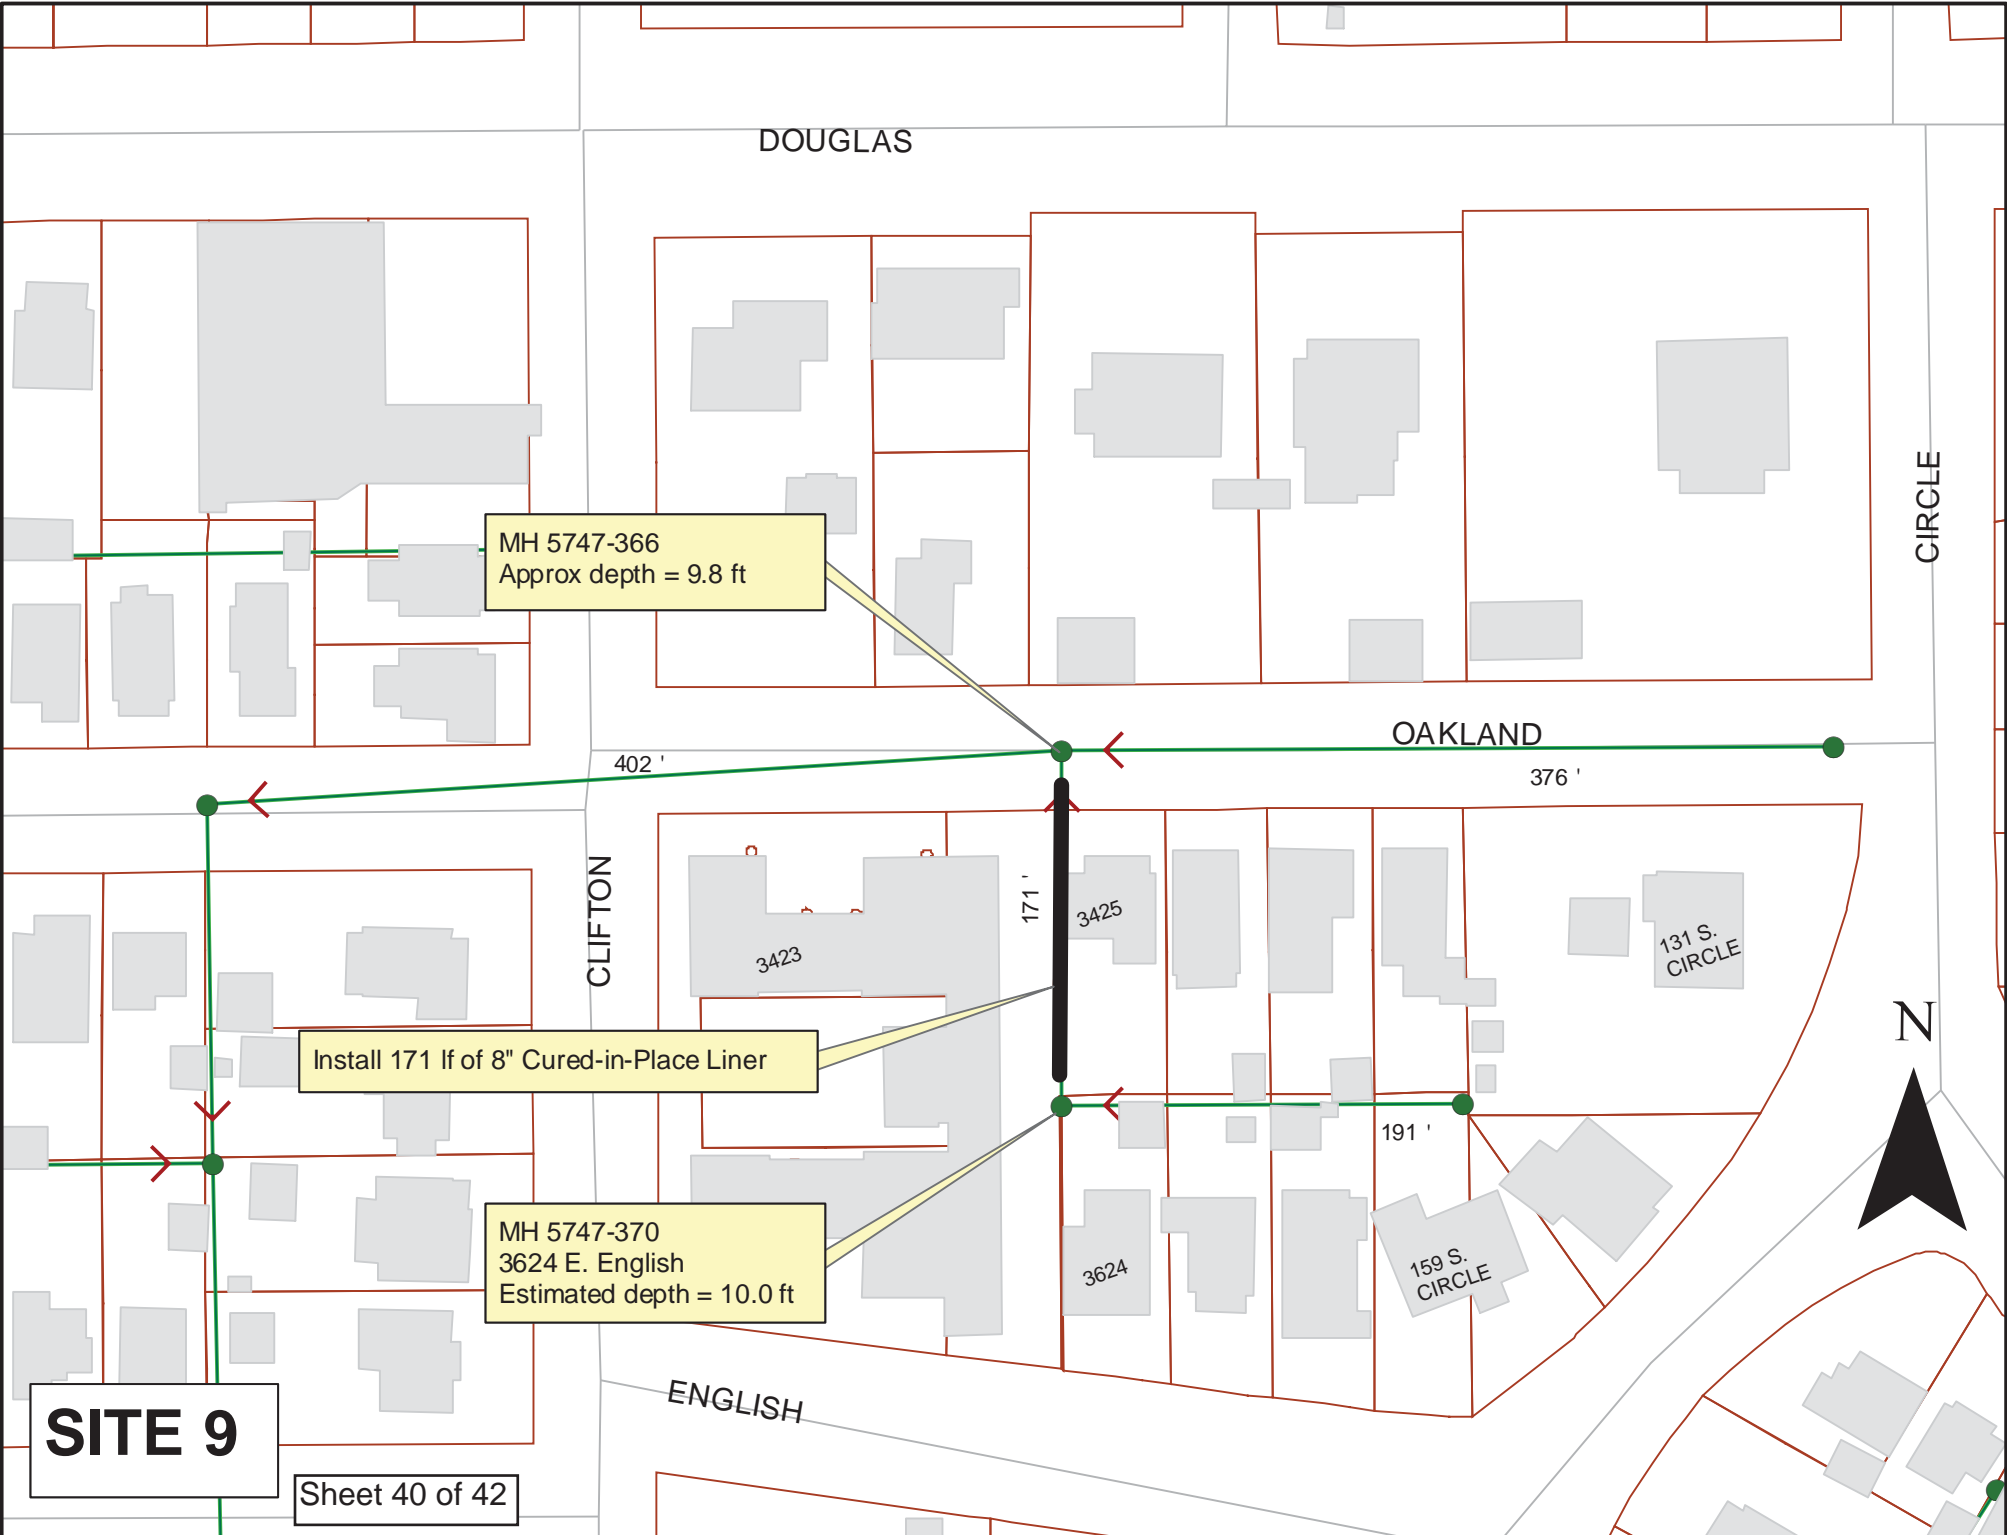
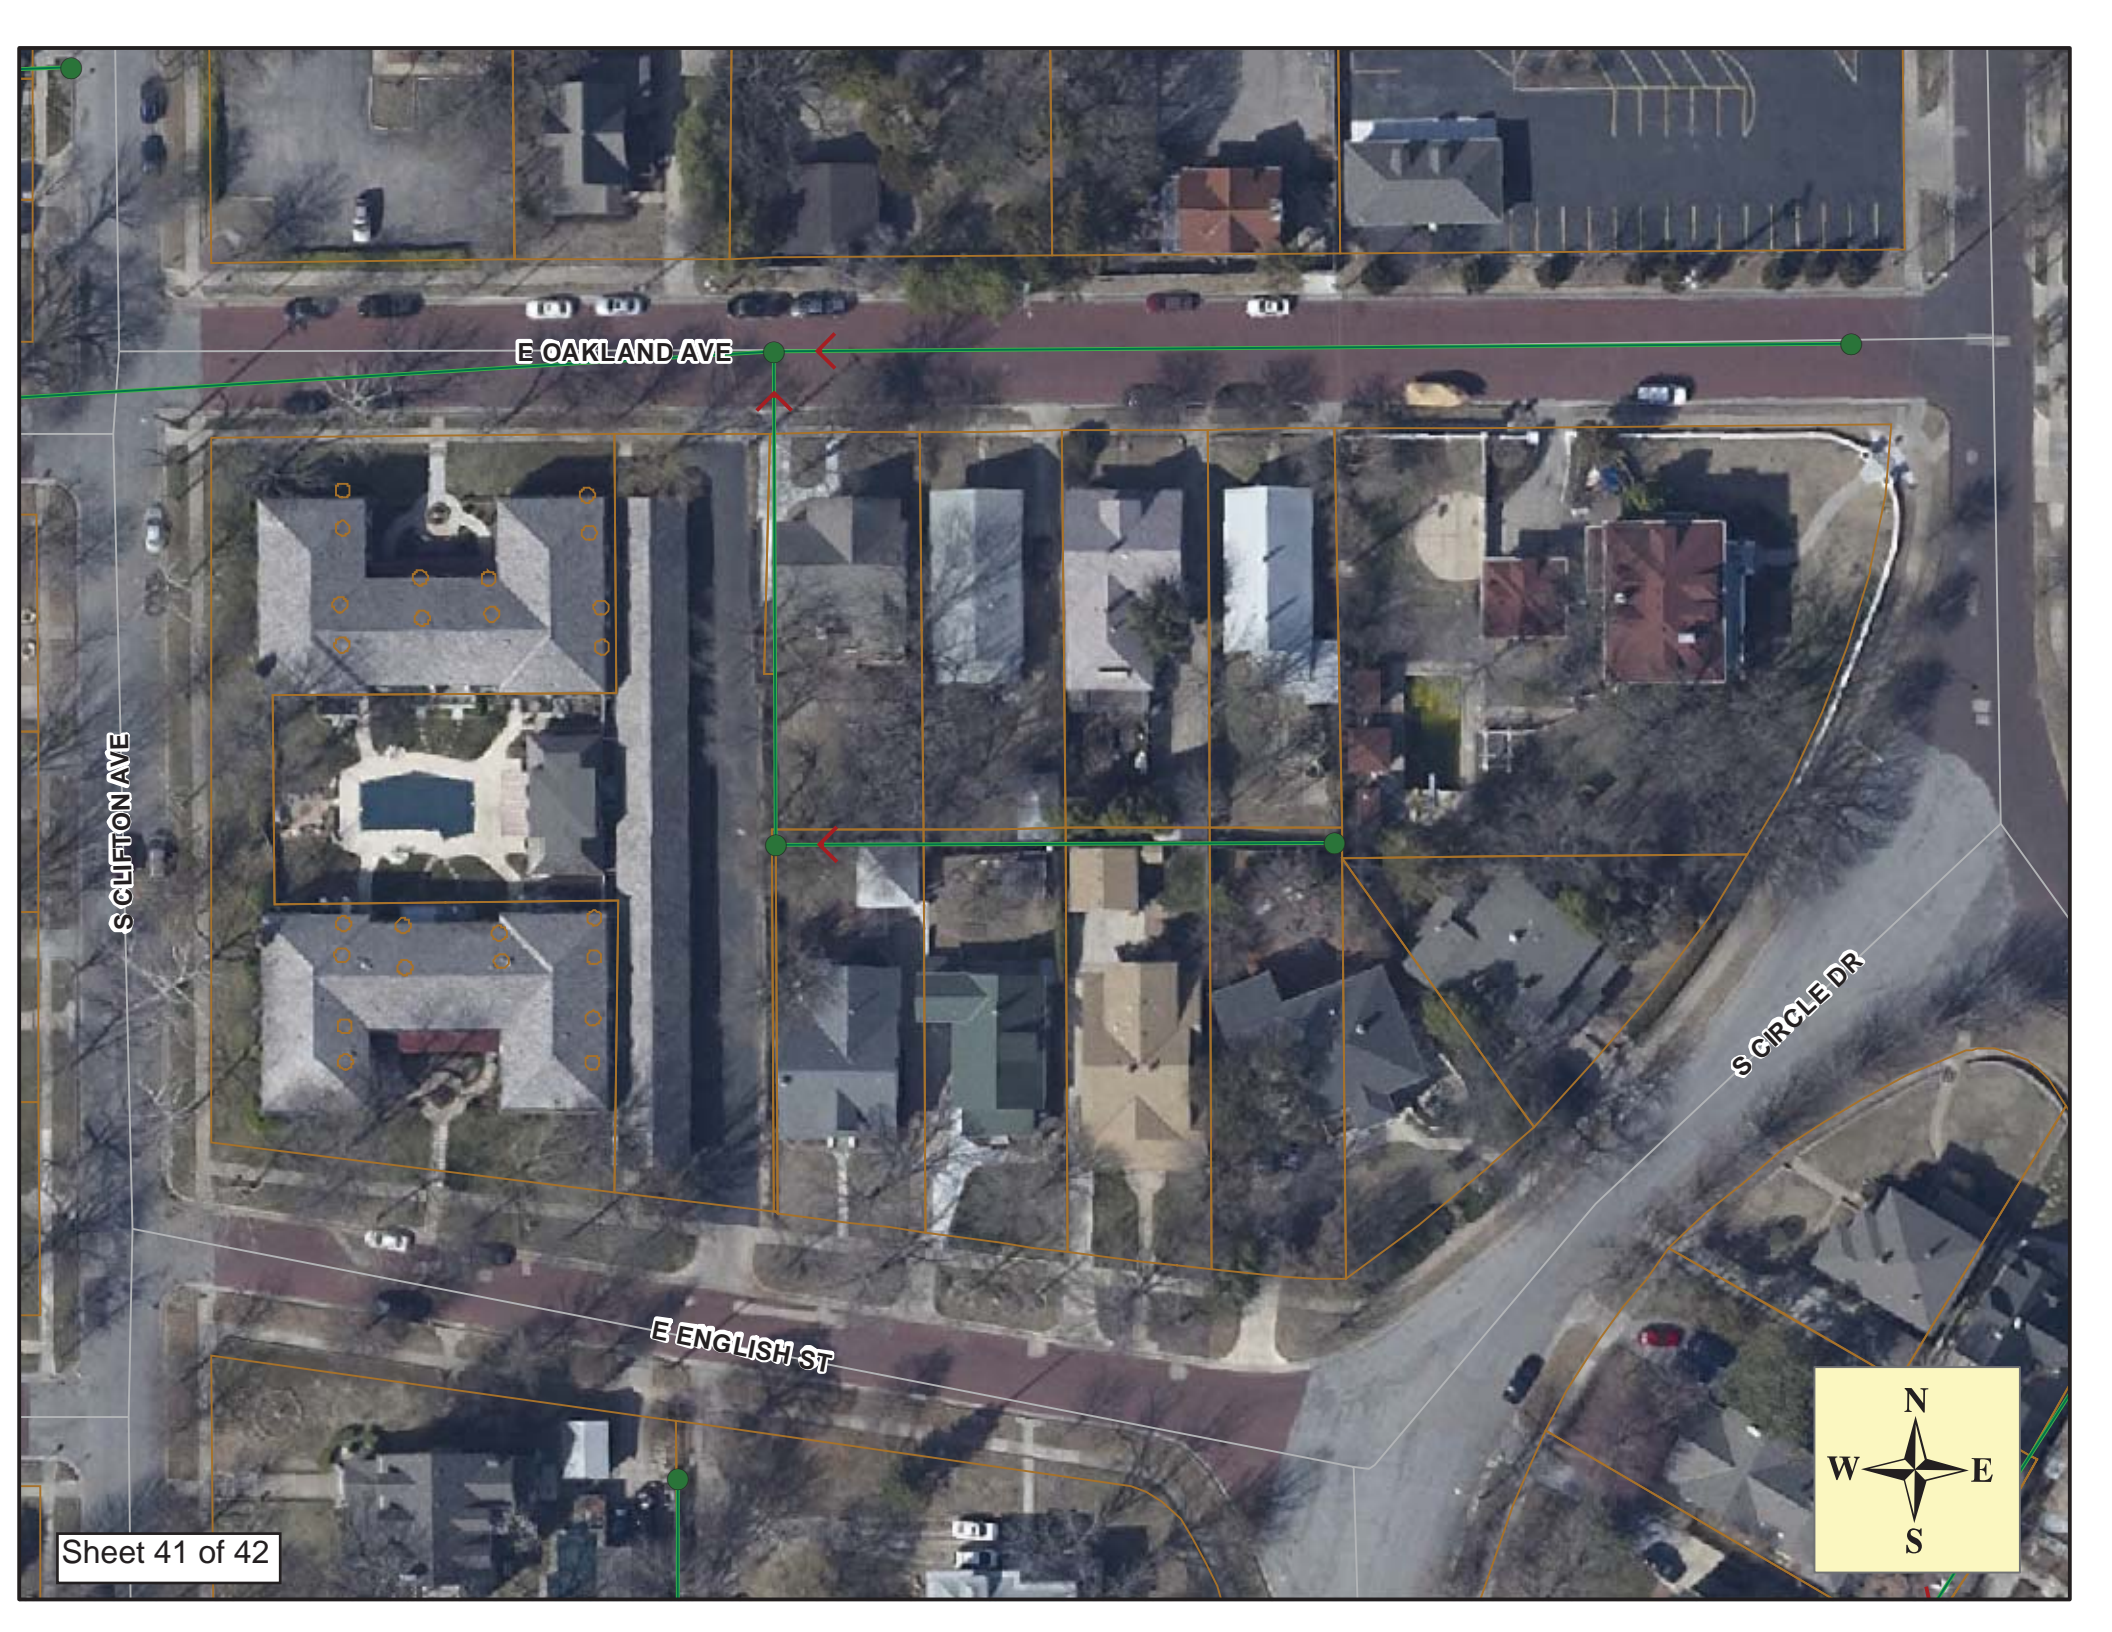
MH 5747-366  
Approx depth = 9.8 ft

MH 5747-370  
3624 E. English  
Estimated depth = 10.0 ft
