SITE 2

Sheet 7 of 22

Video Inspection Master Report

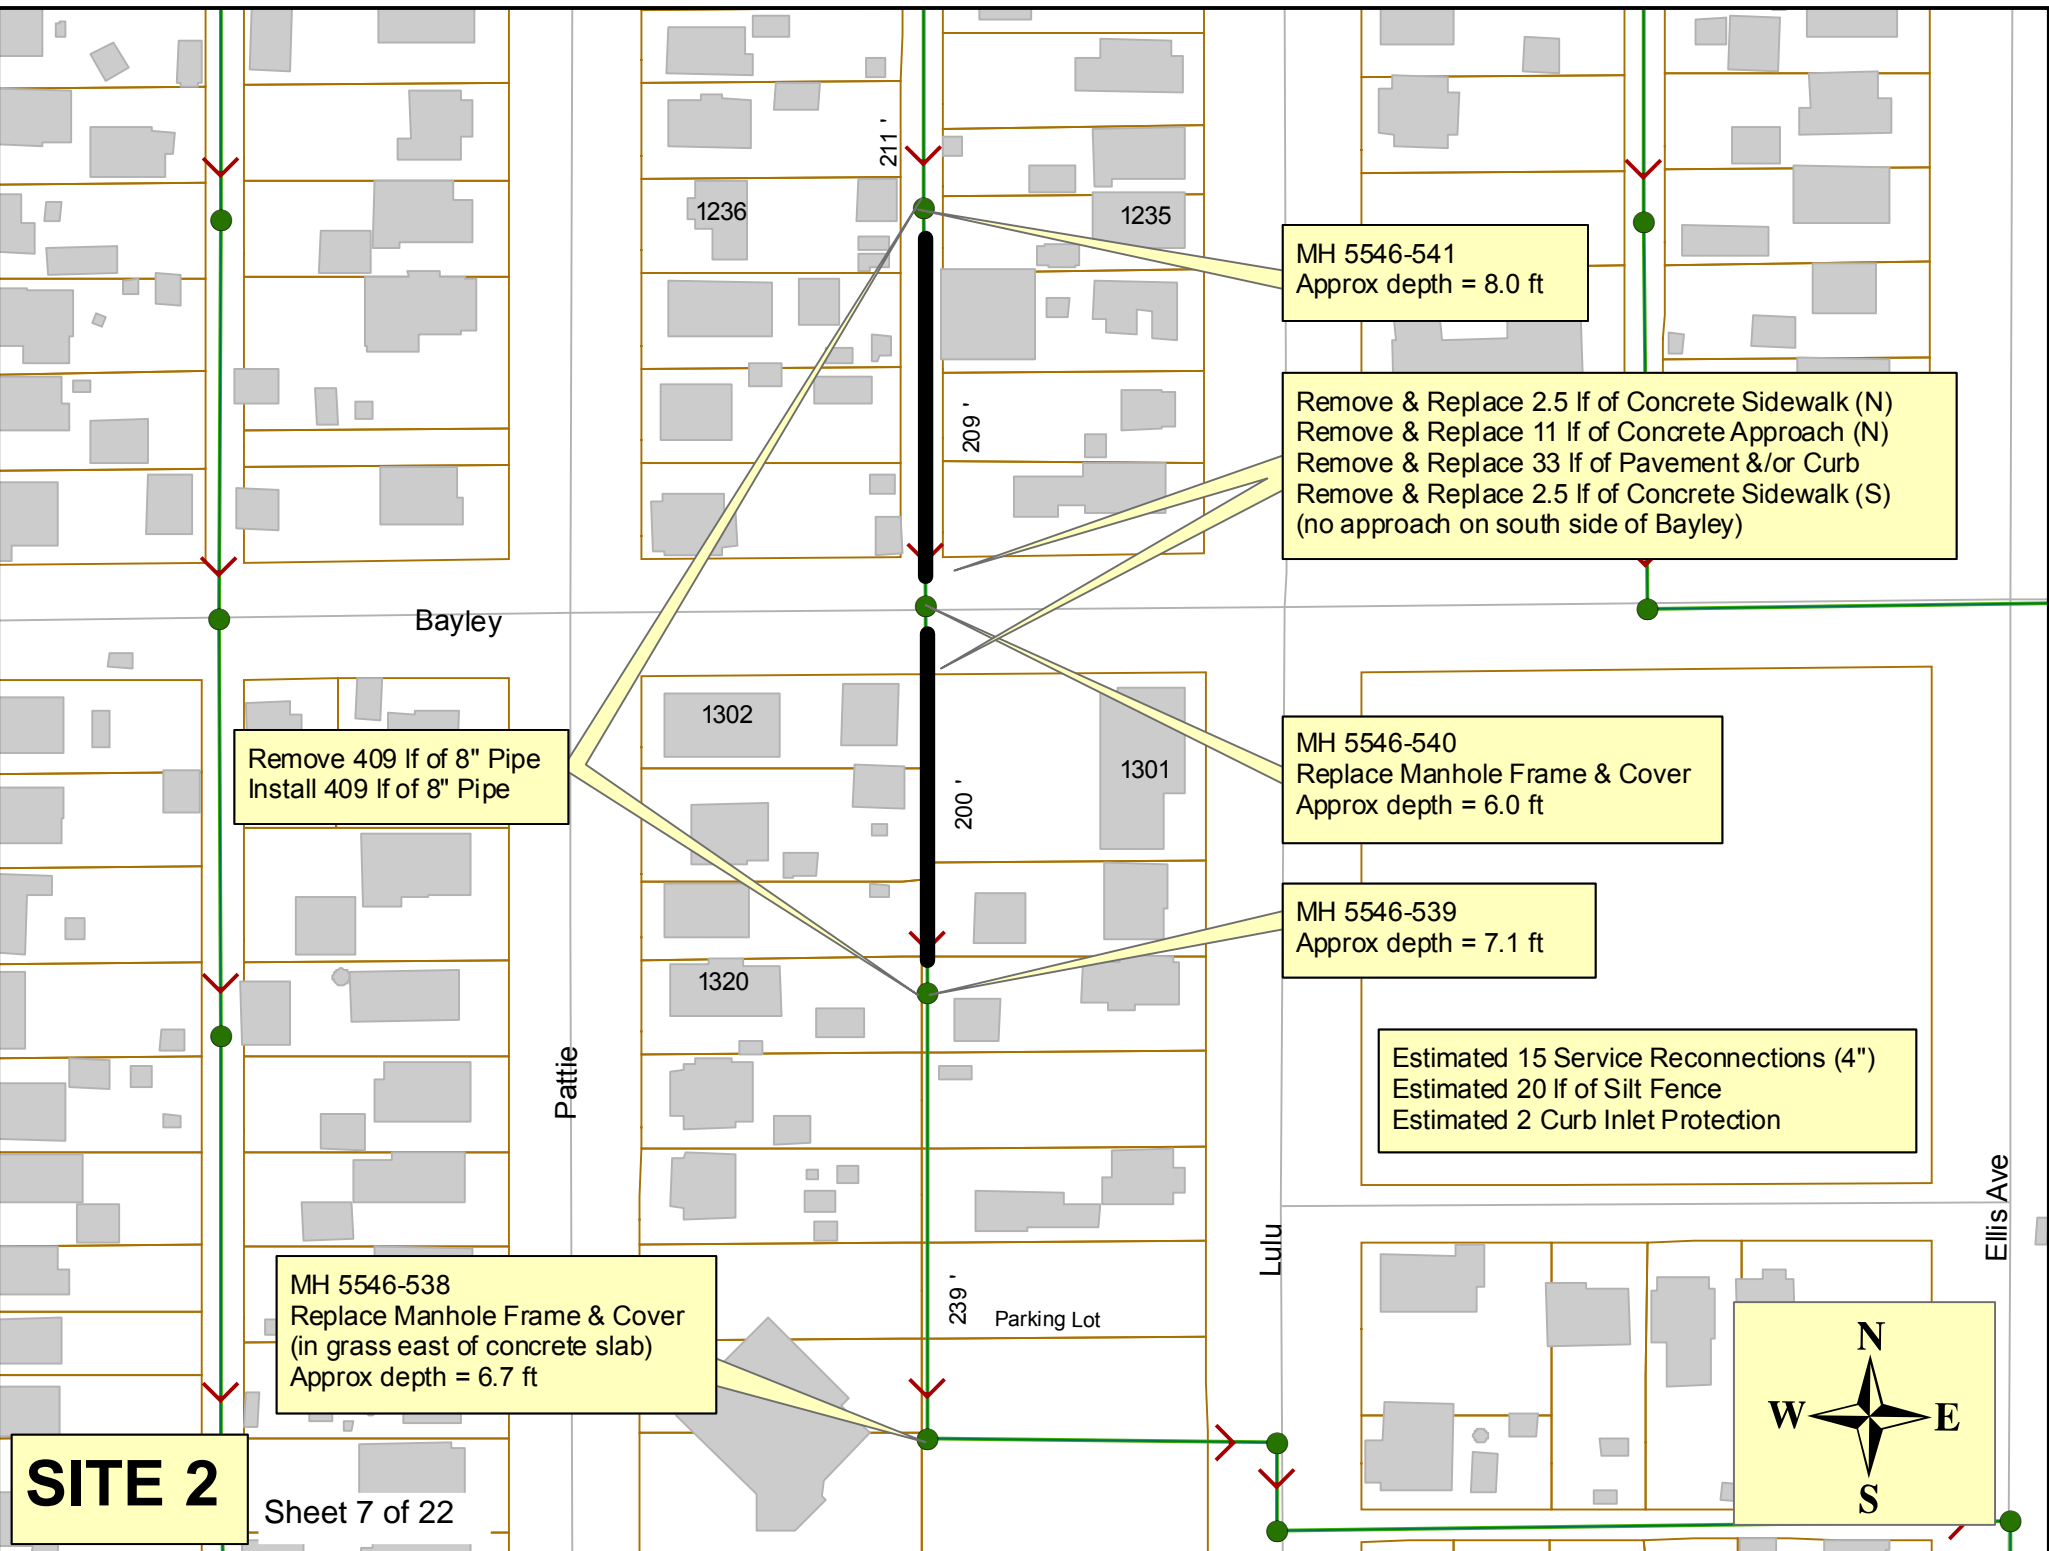
MH 5546-541
Approx depth = 8.0 ft

MH 5546-540
Replace Manhole Frame & Cover
Approx depth = 6.0 ft

MH 5546-539
Approx depth = 7.1 ft

MH 5546-538
Replace Manhole Frame & Cover
(in grass east of concrete slab)
Approx depth = 6.7 ft

Remove & Replace 2.5 lf of Concrete Sidewalk (N)
Remove & Replace 11 lf of Concrete Approach (N)
Remove & Replace 33 lf of Pavement &/or Curb
Remove & Replace 2.5 lf of Concrete Sidewalk (S)
(no approach on south side of Bayley)

Estimated 15 Service Reconnections (4")
Estimated 20 lf of Silt Fence
Estimated 2 Curb Inlet Protection

Remove 409 lf of 8" Pipe
Install 409 lf of 8" Pipe
