SITE 3

Sheet 11 of 22

Television Inspection Master Report

US Structure: 5748-371 555 N TERRACE DR Date Insp: 4/16/2010 Basin: E04E
 DS Structure: 5748-370 537 N TERRACE DR Dir Televised: Upstream To Downstream

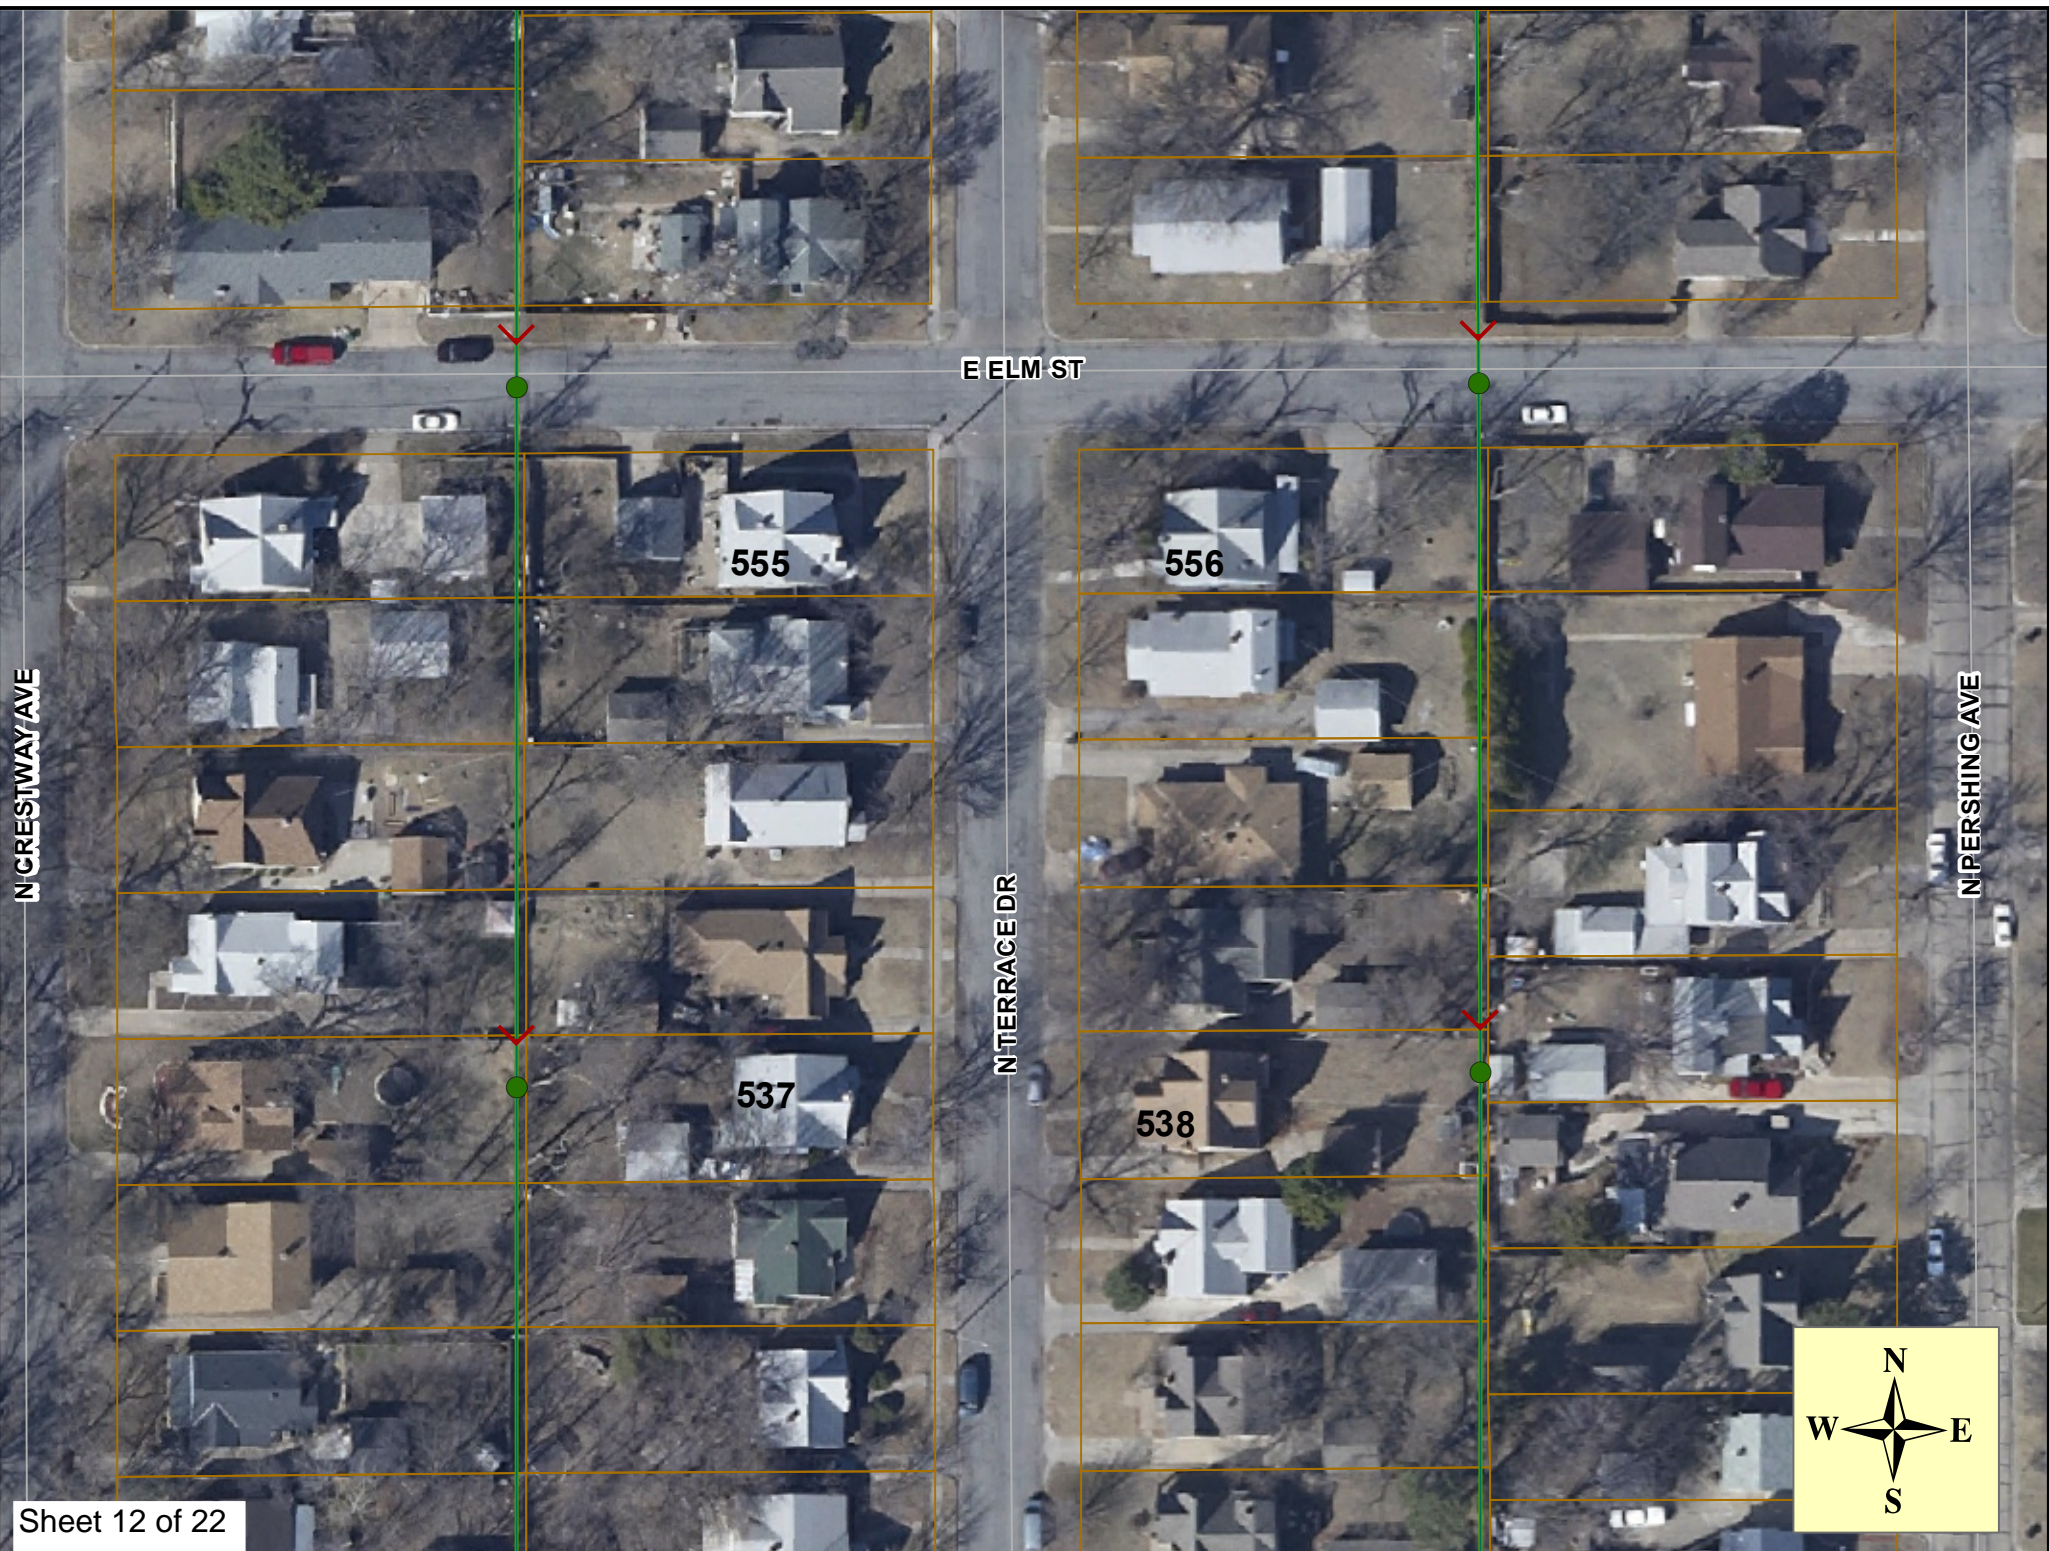
Reconstruct Outside Drop
Approx pipe depth = 9.3 ft
Approx MH depth = 15.3 ft

(no water or storm water sewer in Elm)

Point Repair: Remove and replace
70 lf of 8" pipe from MH 5748-382 to
70 lf south, including two service
connection replacements for 555 N.
Pershing and 556 N. Terrace
(see tv log)

Remove and replace 16 lf
of pavement and/or curb
Install 16 lf of Flowable Fill

Remove 240 lf of 8" pipe
Install 240 lf of 8" pipe

MH 5748-370
Replace Manhole Frame & Cover

Estimated 9 Service Reconnections (4")
Estimated 40 lf Silt Fence
Estimated 44 sy Erosion Control Mat
Estimated 40 lf Back of Curb Protection
Estimated 1 Construction Entrance
