Install 650 If of 8" Cured-in-Place Liner:
196 lf from MH 5747-504 to MH 5747-454
454 lf from MH 5747-455 to MH 5747-452

SITE 1

Television Inspection Master Report

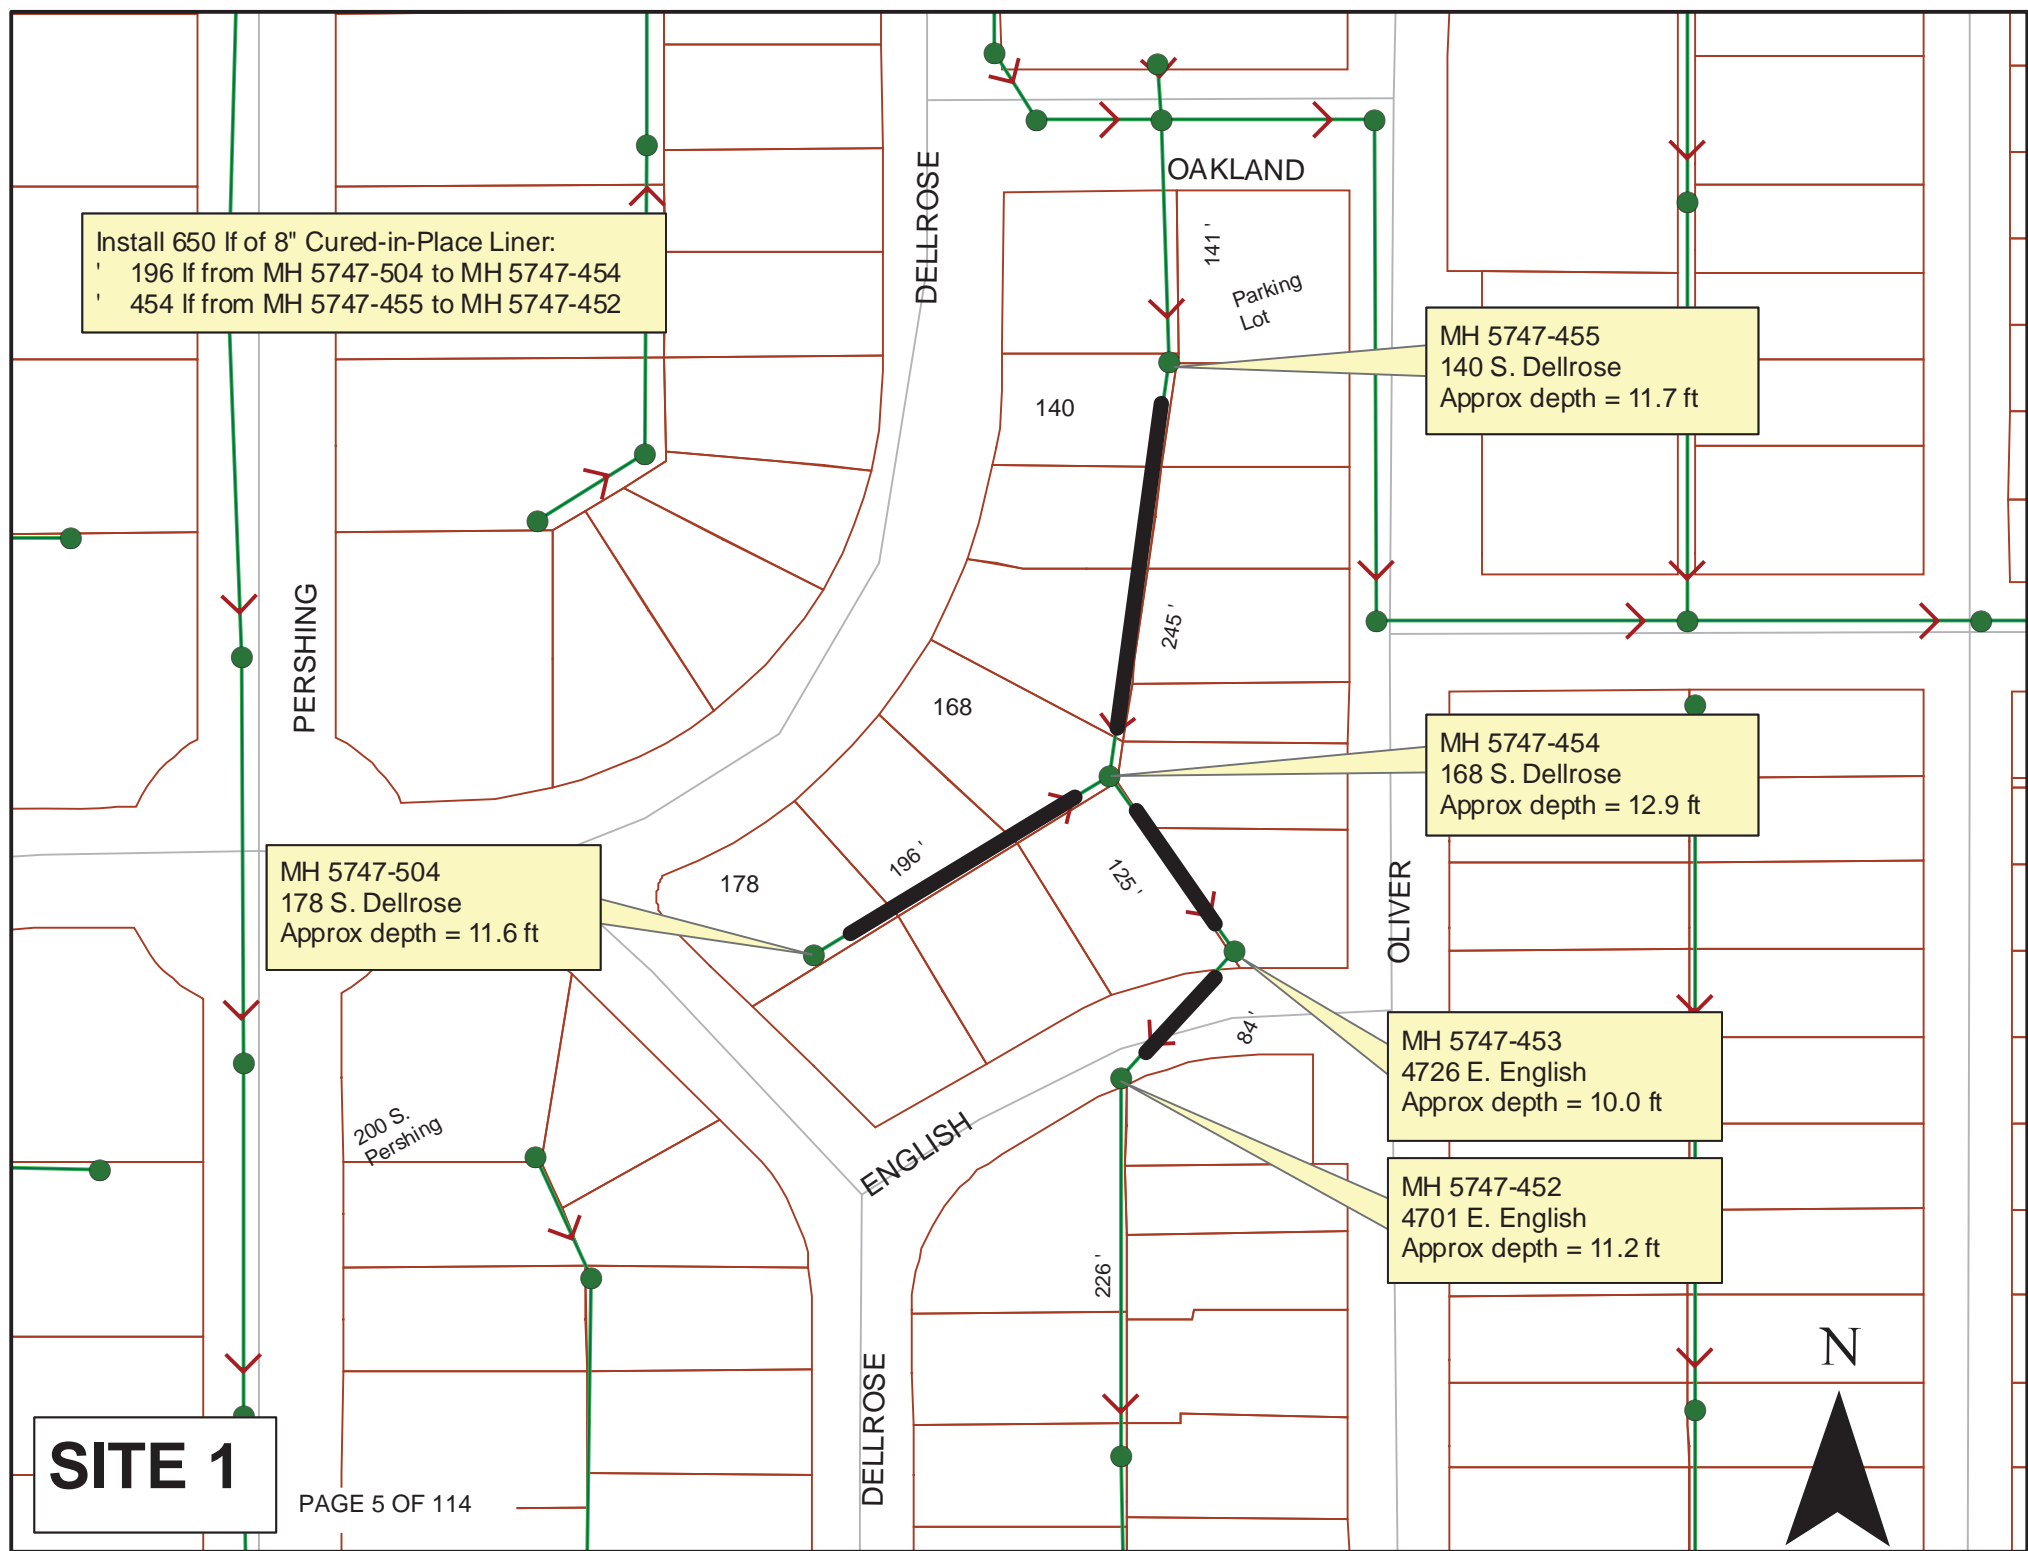
MH 5747-455
140 S. Dellrose
Approx depth = 11.7 ft

MH 5747-454
168 S. Dellrose
Approx depth = 12.9 ft

MH 5747-504
178 S. Dellrose
Approx depth = 11.6 ft

MH 5747-453
4726 E. English
Approx depth = 10.0 ft

MH 5747-452
4701 E. English
Approx depth = 11.2 ft
