# SITE 2

Install 888 lf of 8" Cured-in-Place Liner from MH 5747-452 to MH 5747-448

# Television Inspection Master Report

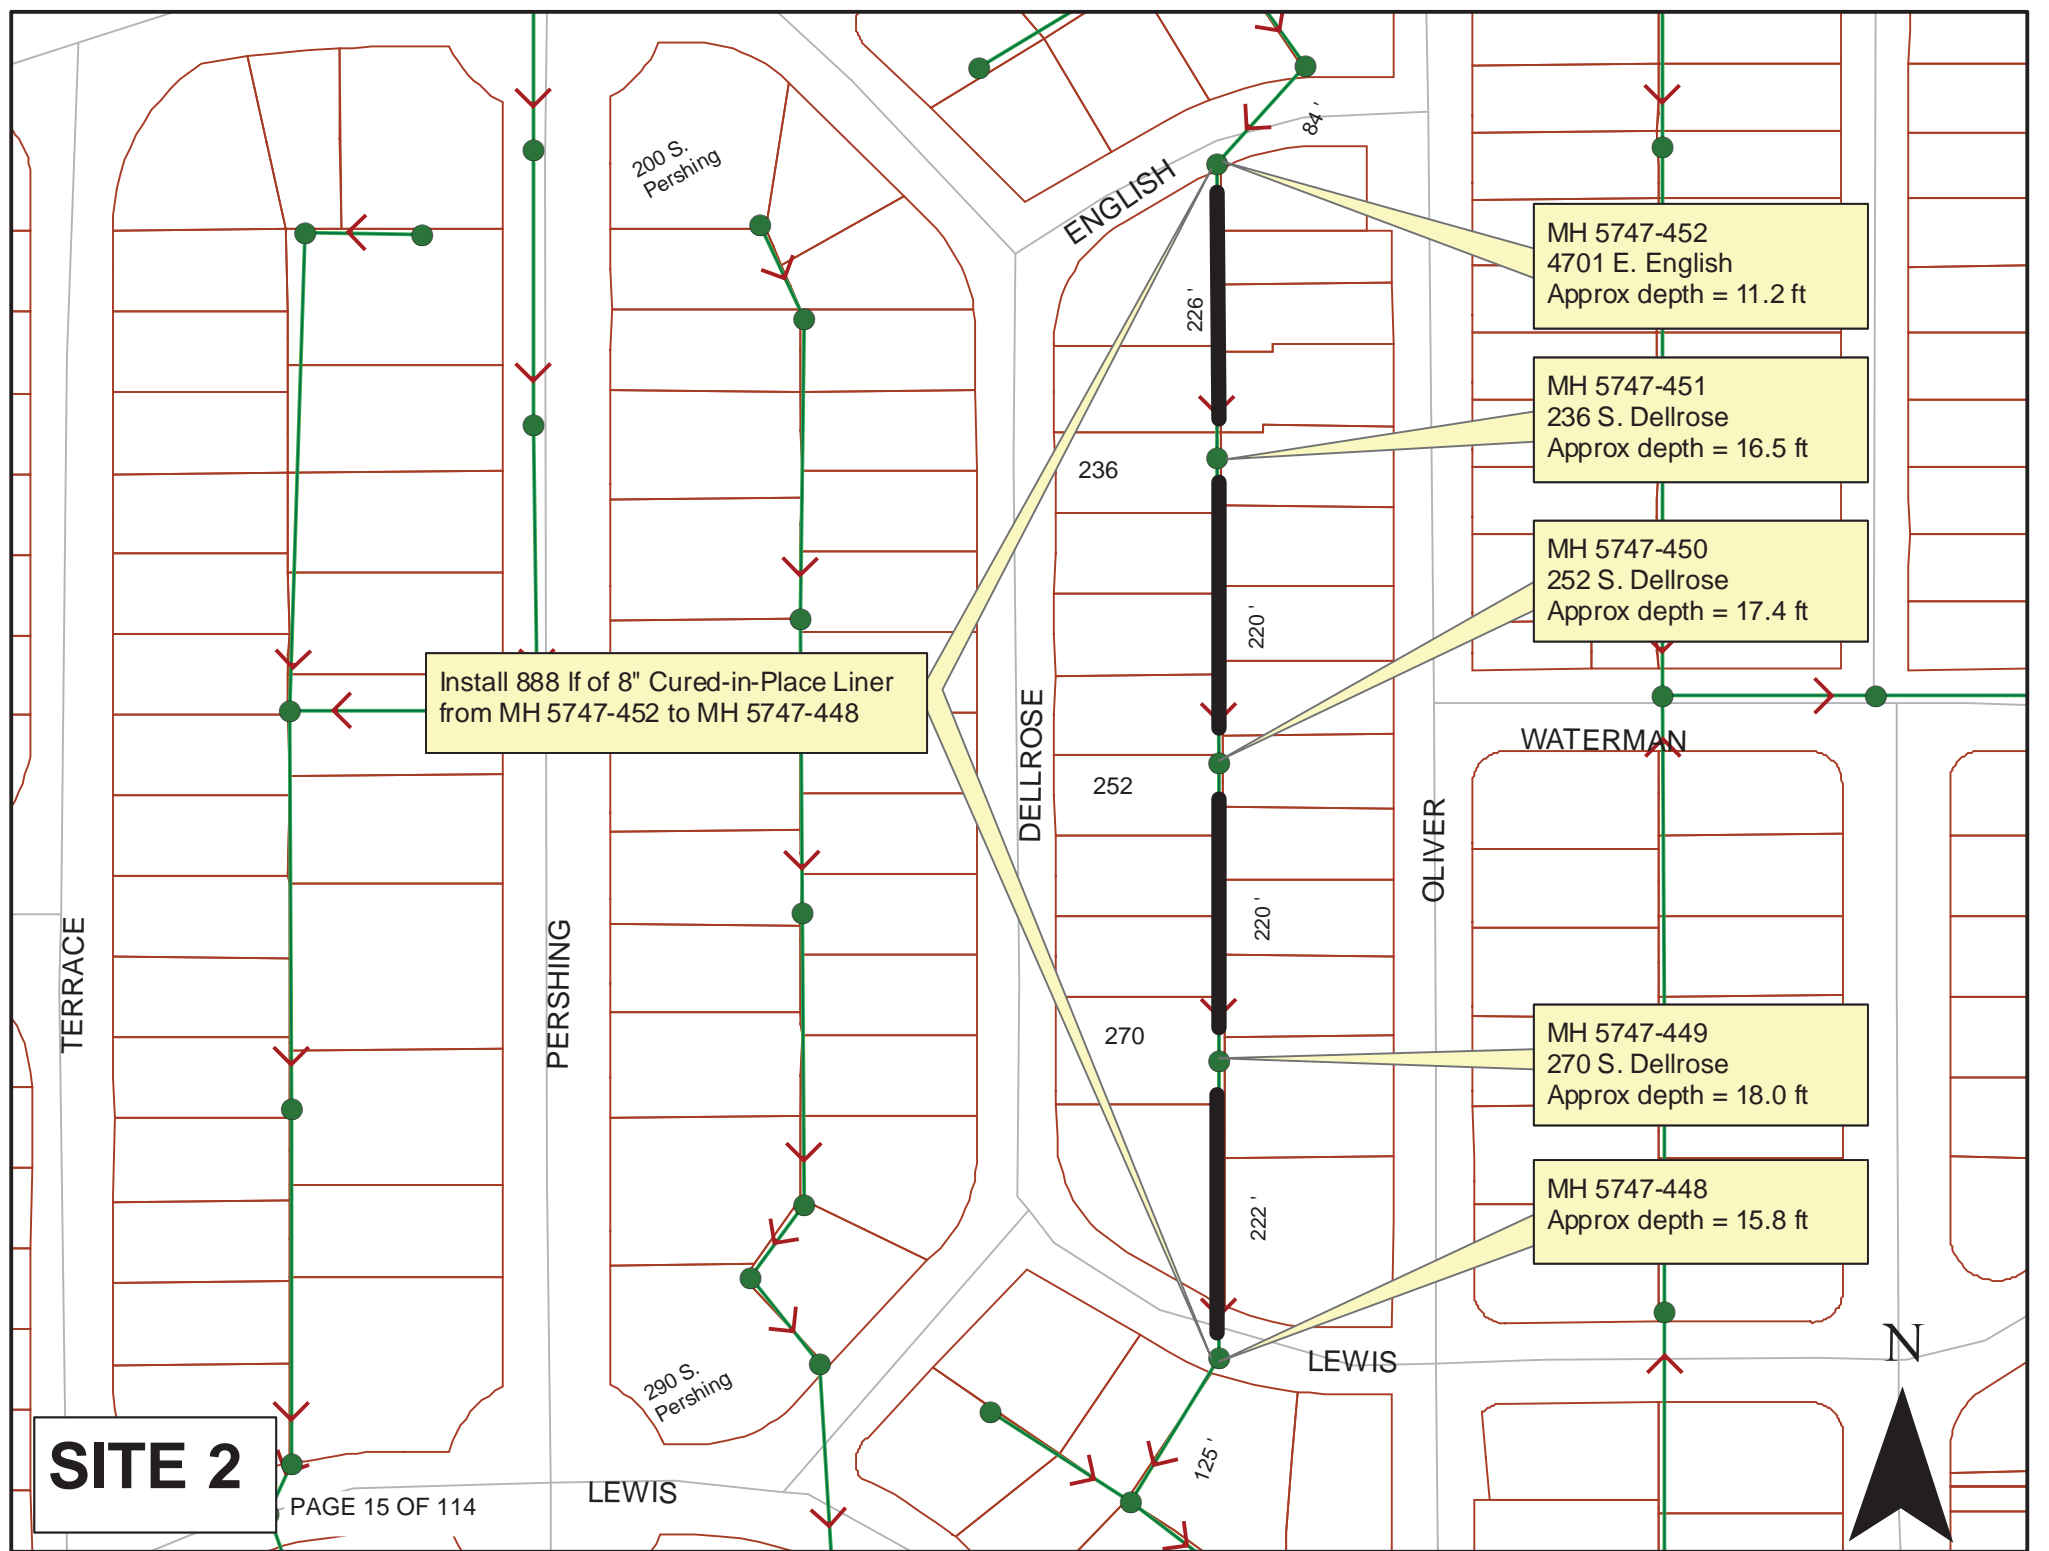
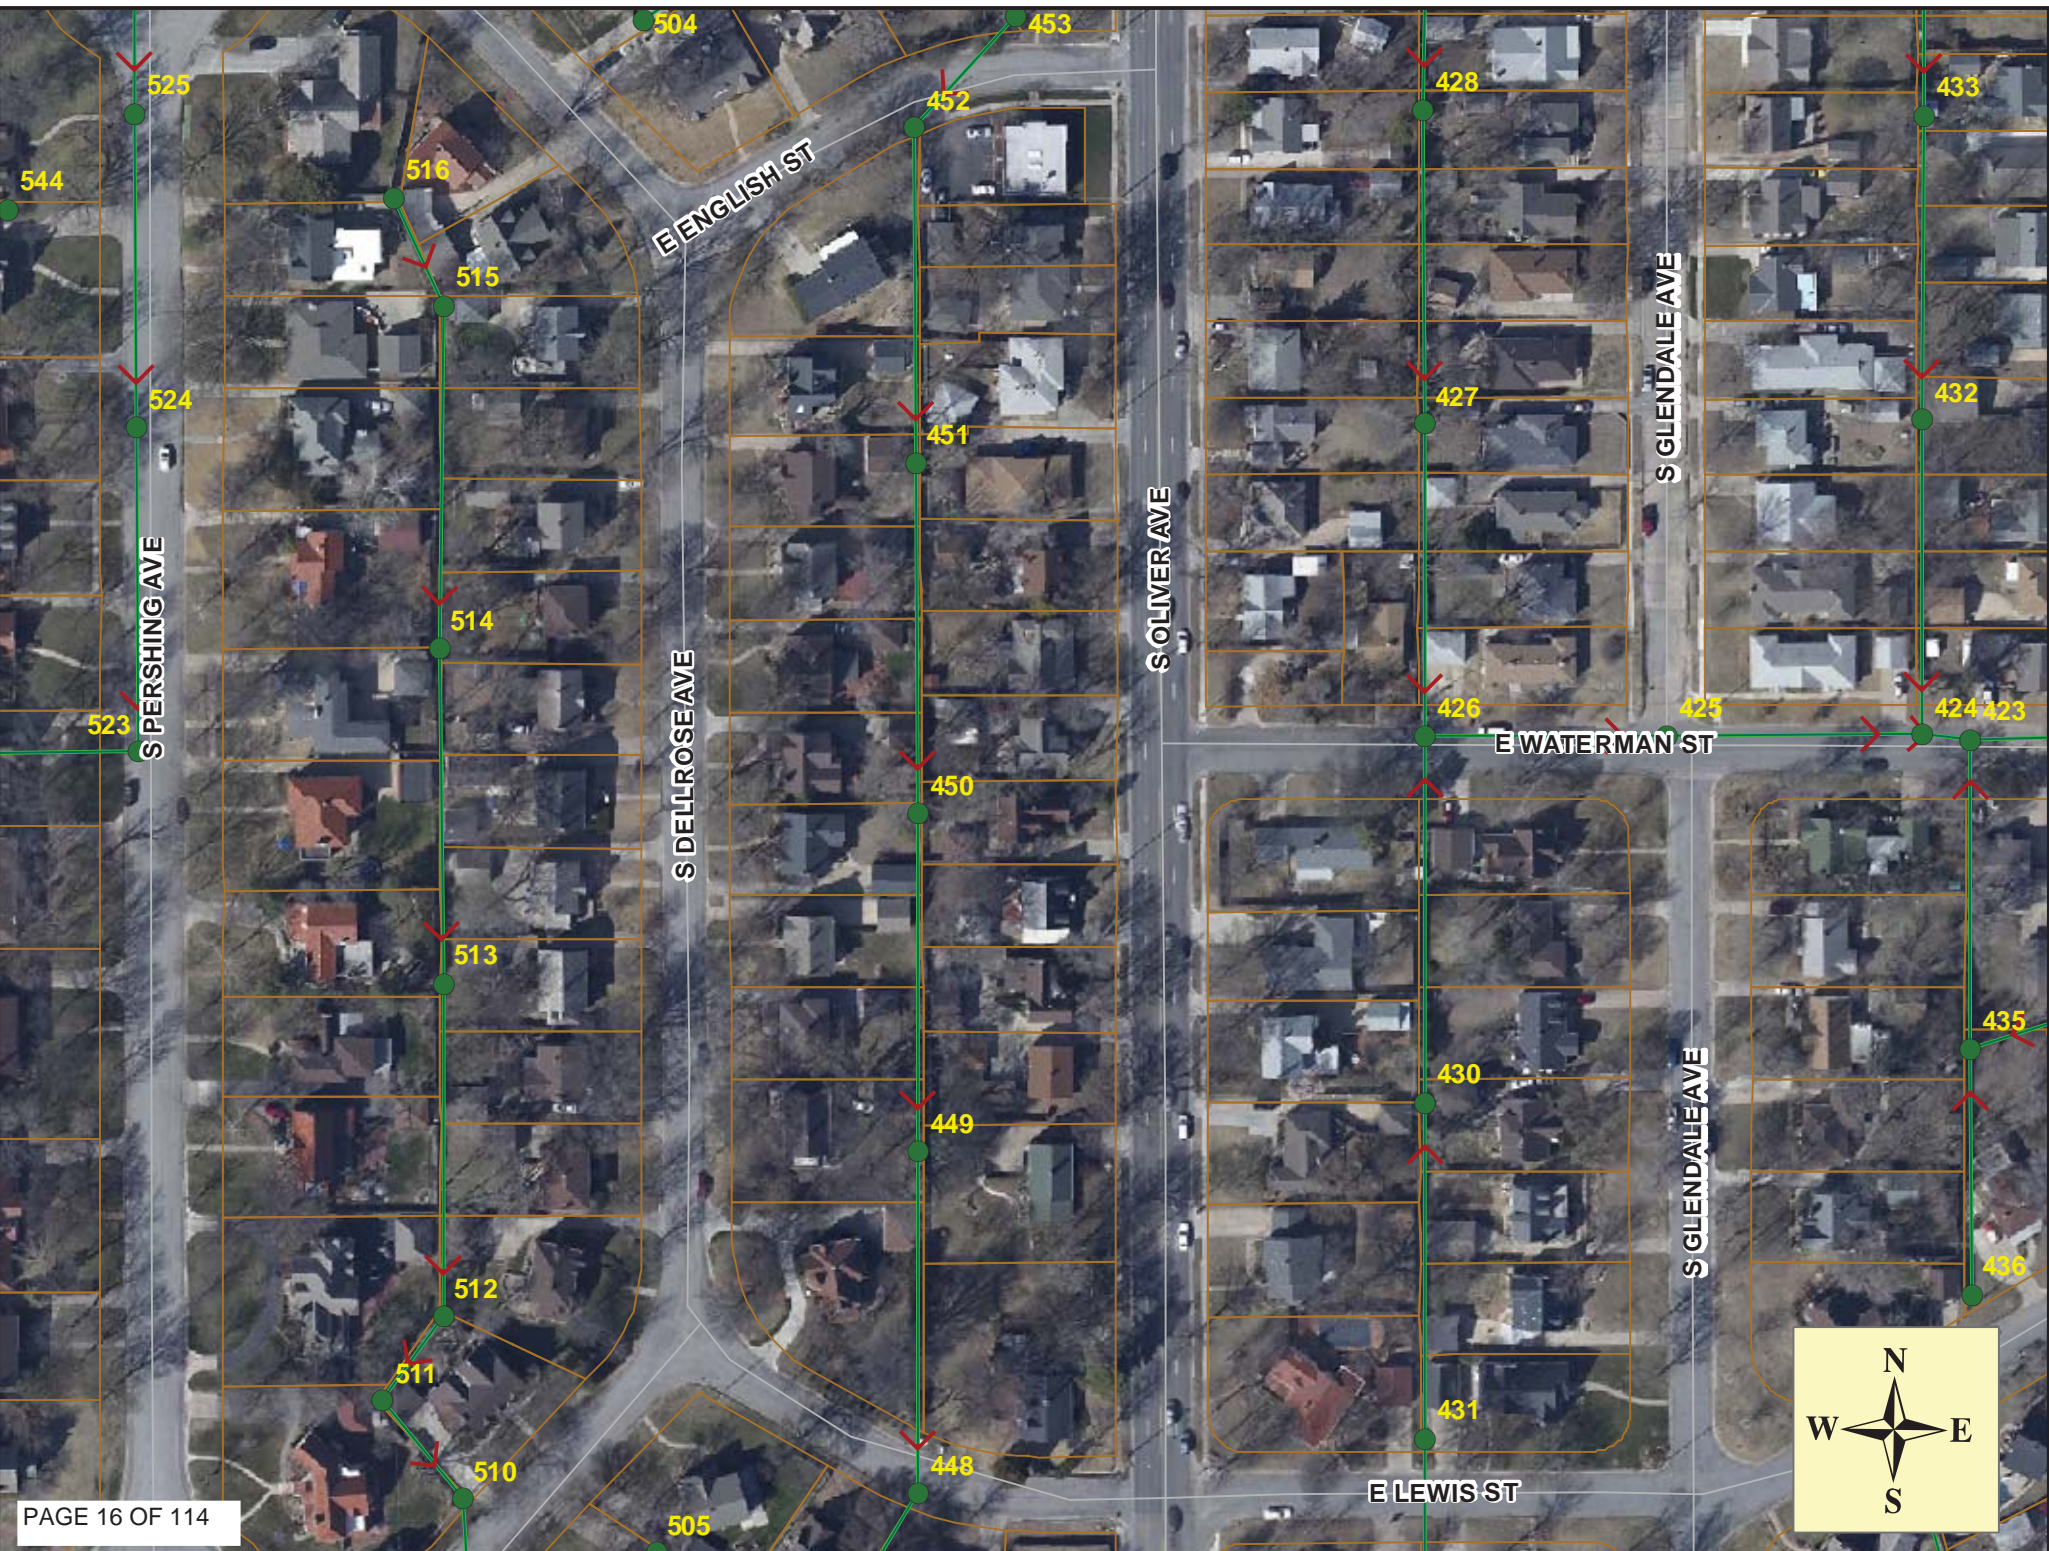
MH 5747-452  
4701 E. English  
Approx depth = 11.2 ft

MH 5747-451  
236 S. Dellrose  
Approx depth = 16.5 ft

MH 5747-450  
252 S. Dellrose  
Approx depth = 17.4 ft

MH 5747-449  
270 S. Dellrose  
Approx depth = 18.0 ft

MH 5747-448  
Approx depth = 15.8 ft
