Install 669 lf of 8" Cured-in-Place Liner,
from MH 5747-620 to MH 5747-614

SITE 8

Video Inspection Master Report

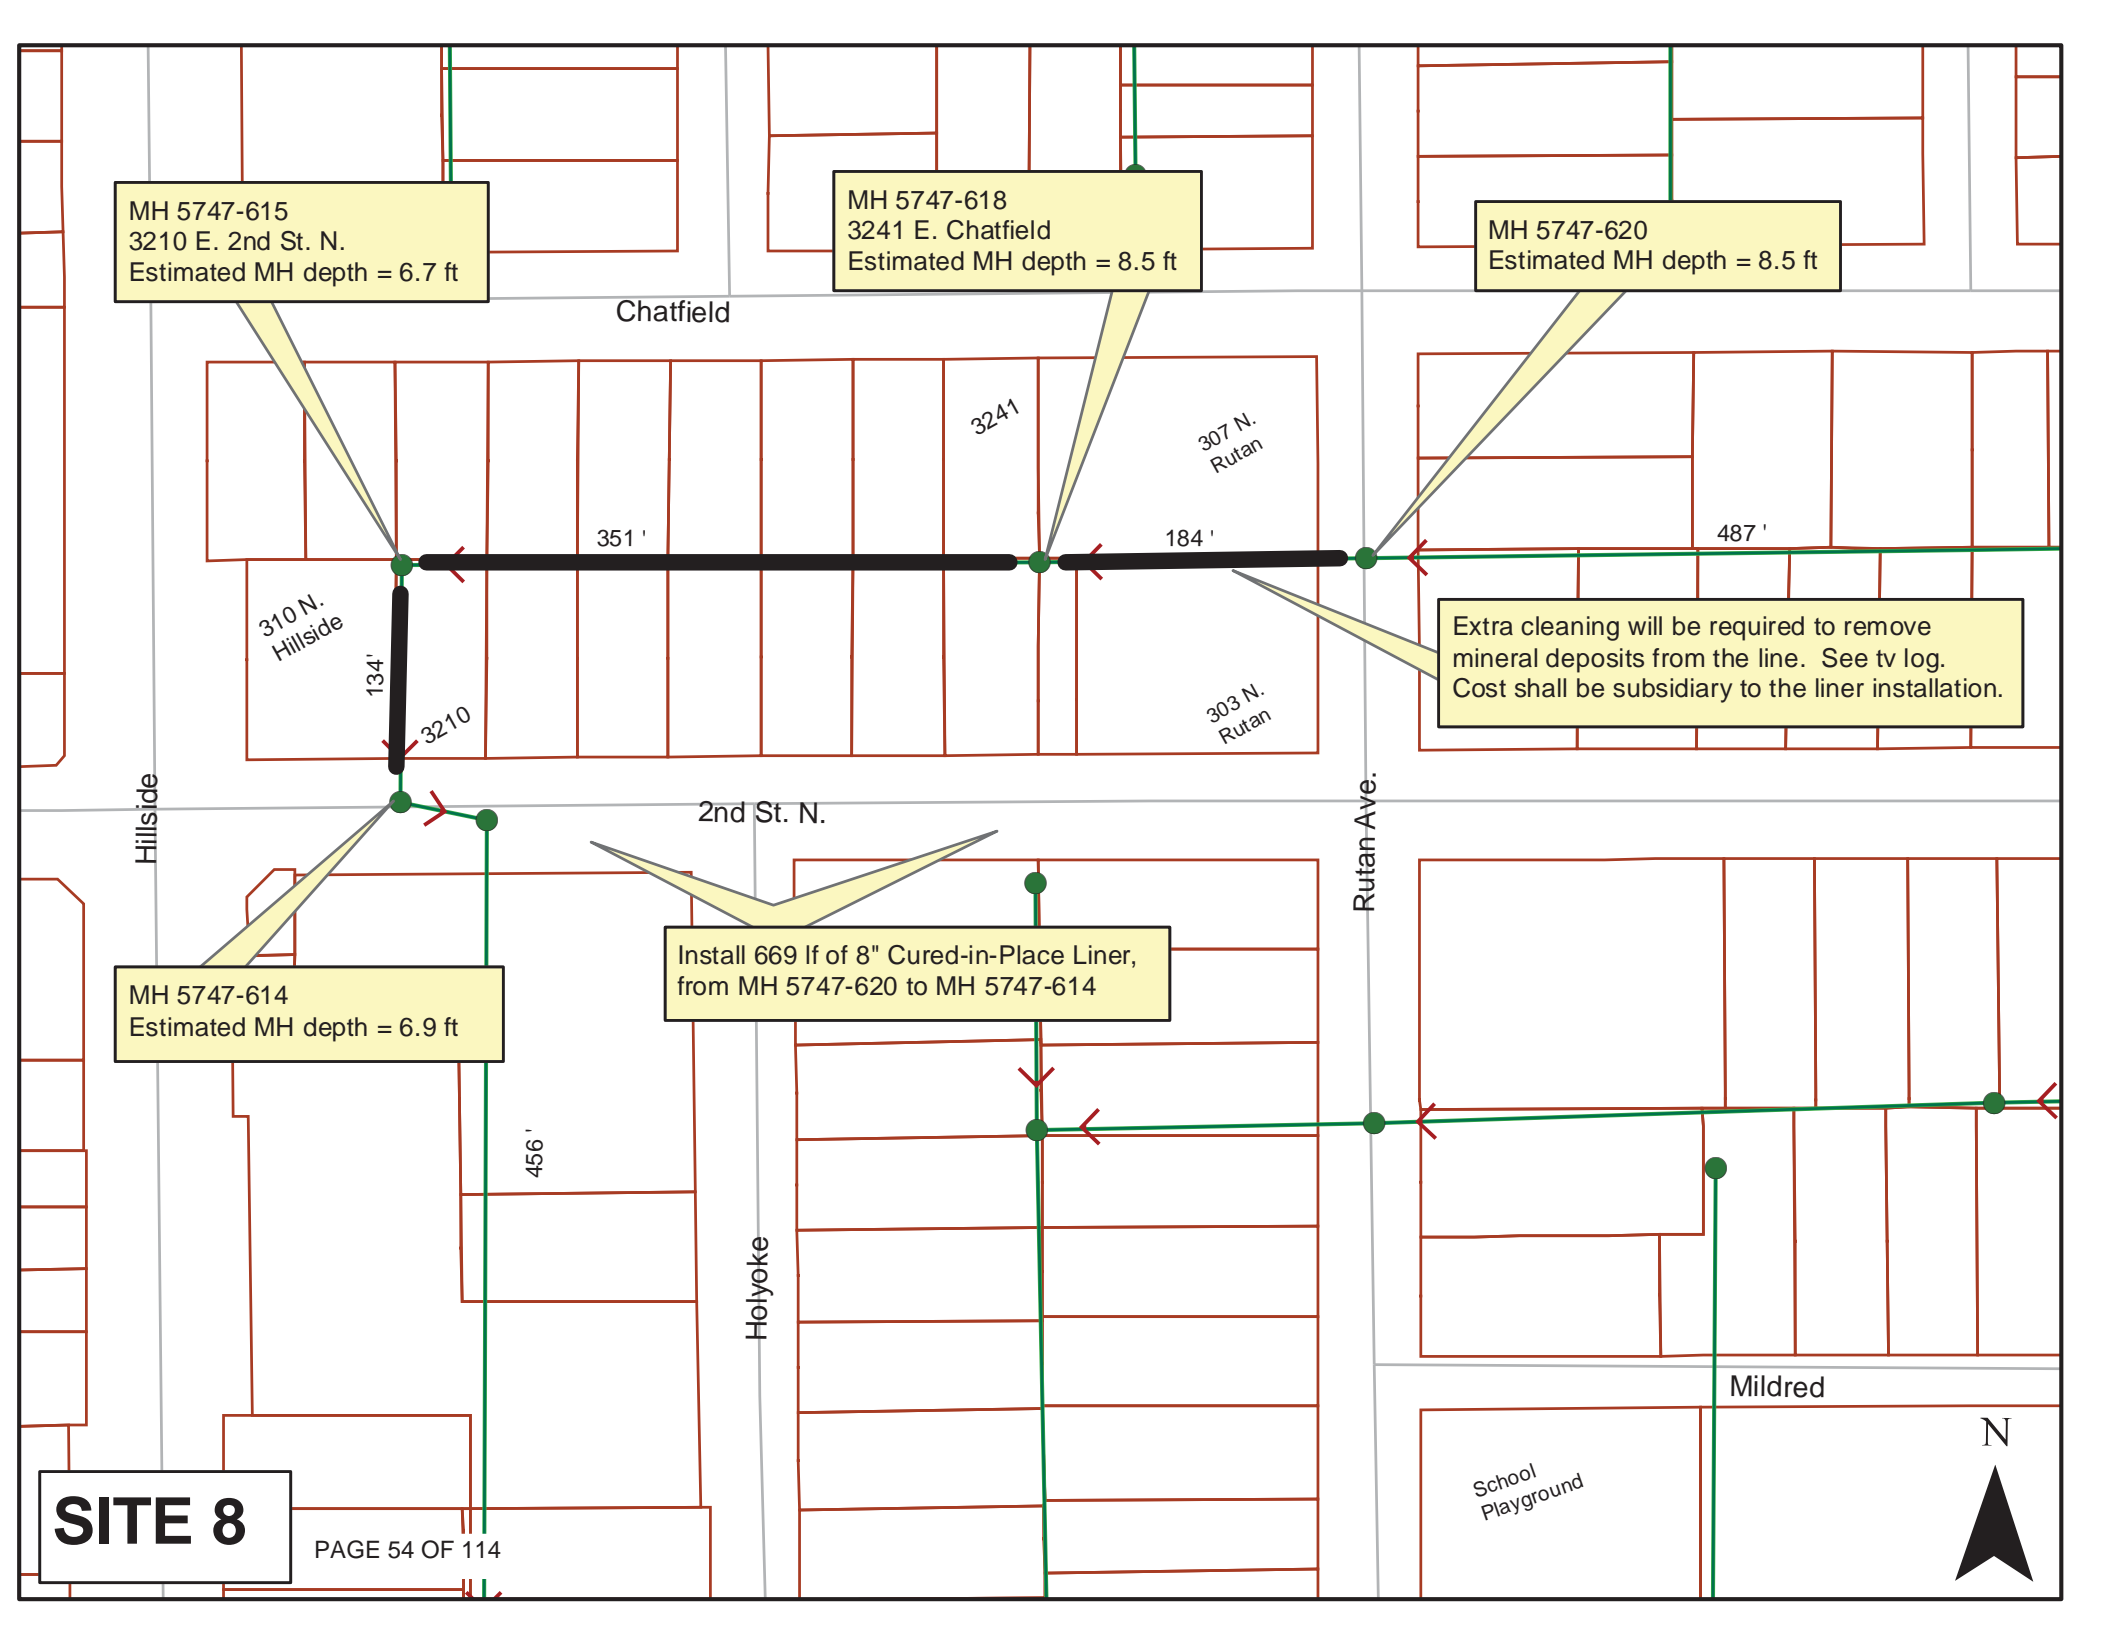
Camera cannot pass the observation hole. Infiltration has made mineral deposits so heavy at this location. The mineral deposits need to be knocked down or bladed down prior to liner installation. There is a tree at this location so excavation is not desirable.

Extra cleaning will be required to remove mineral deposits from the line. See tv log. Cost shall be subsidiary to the liner installation.

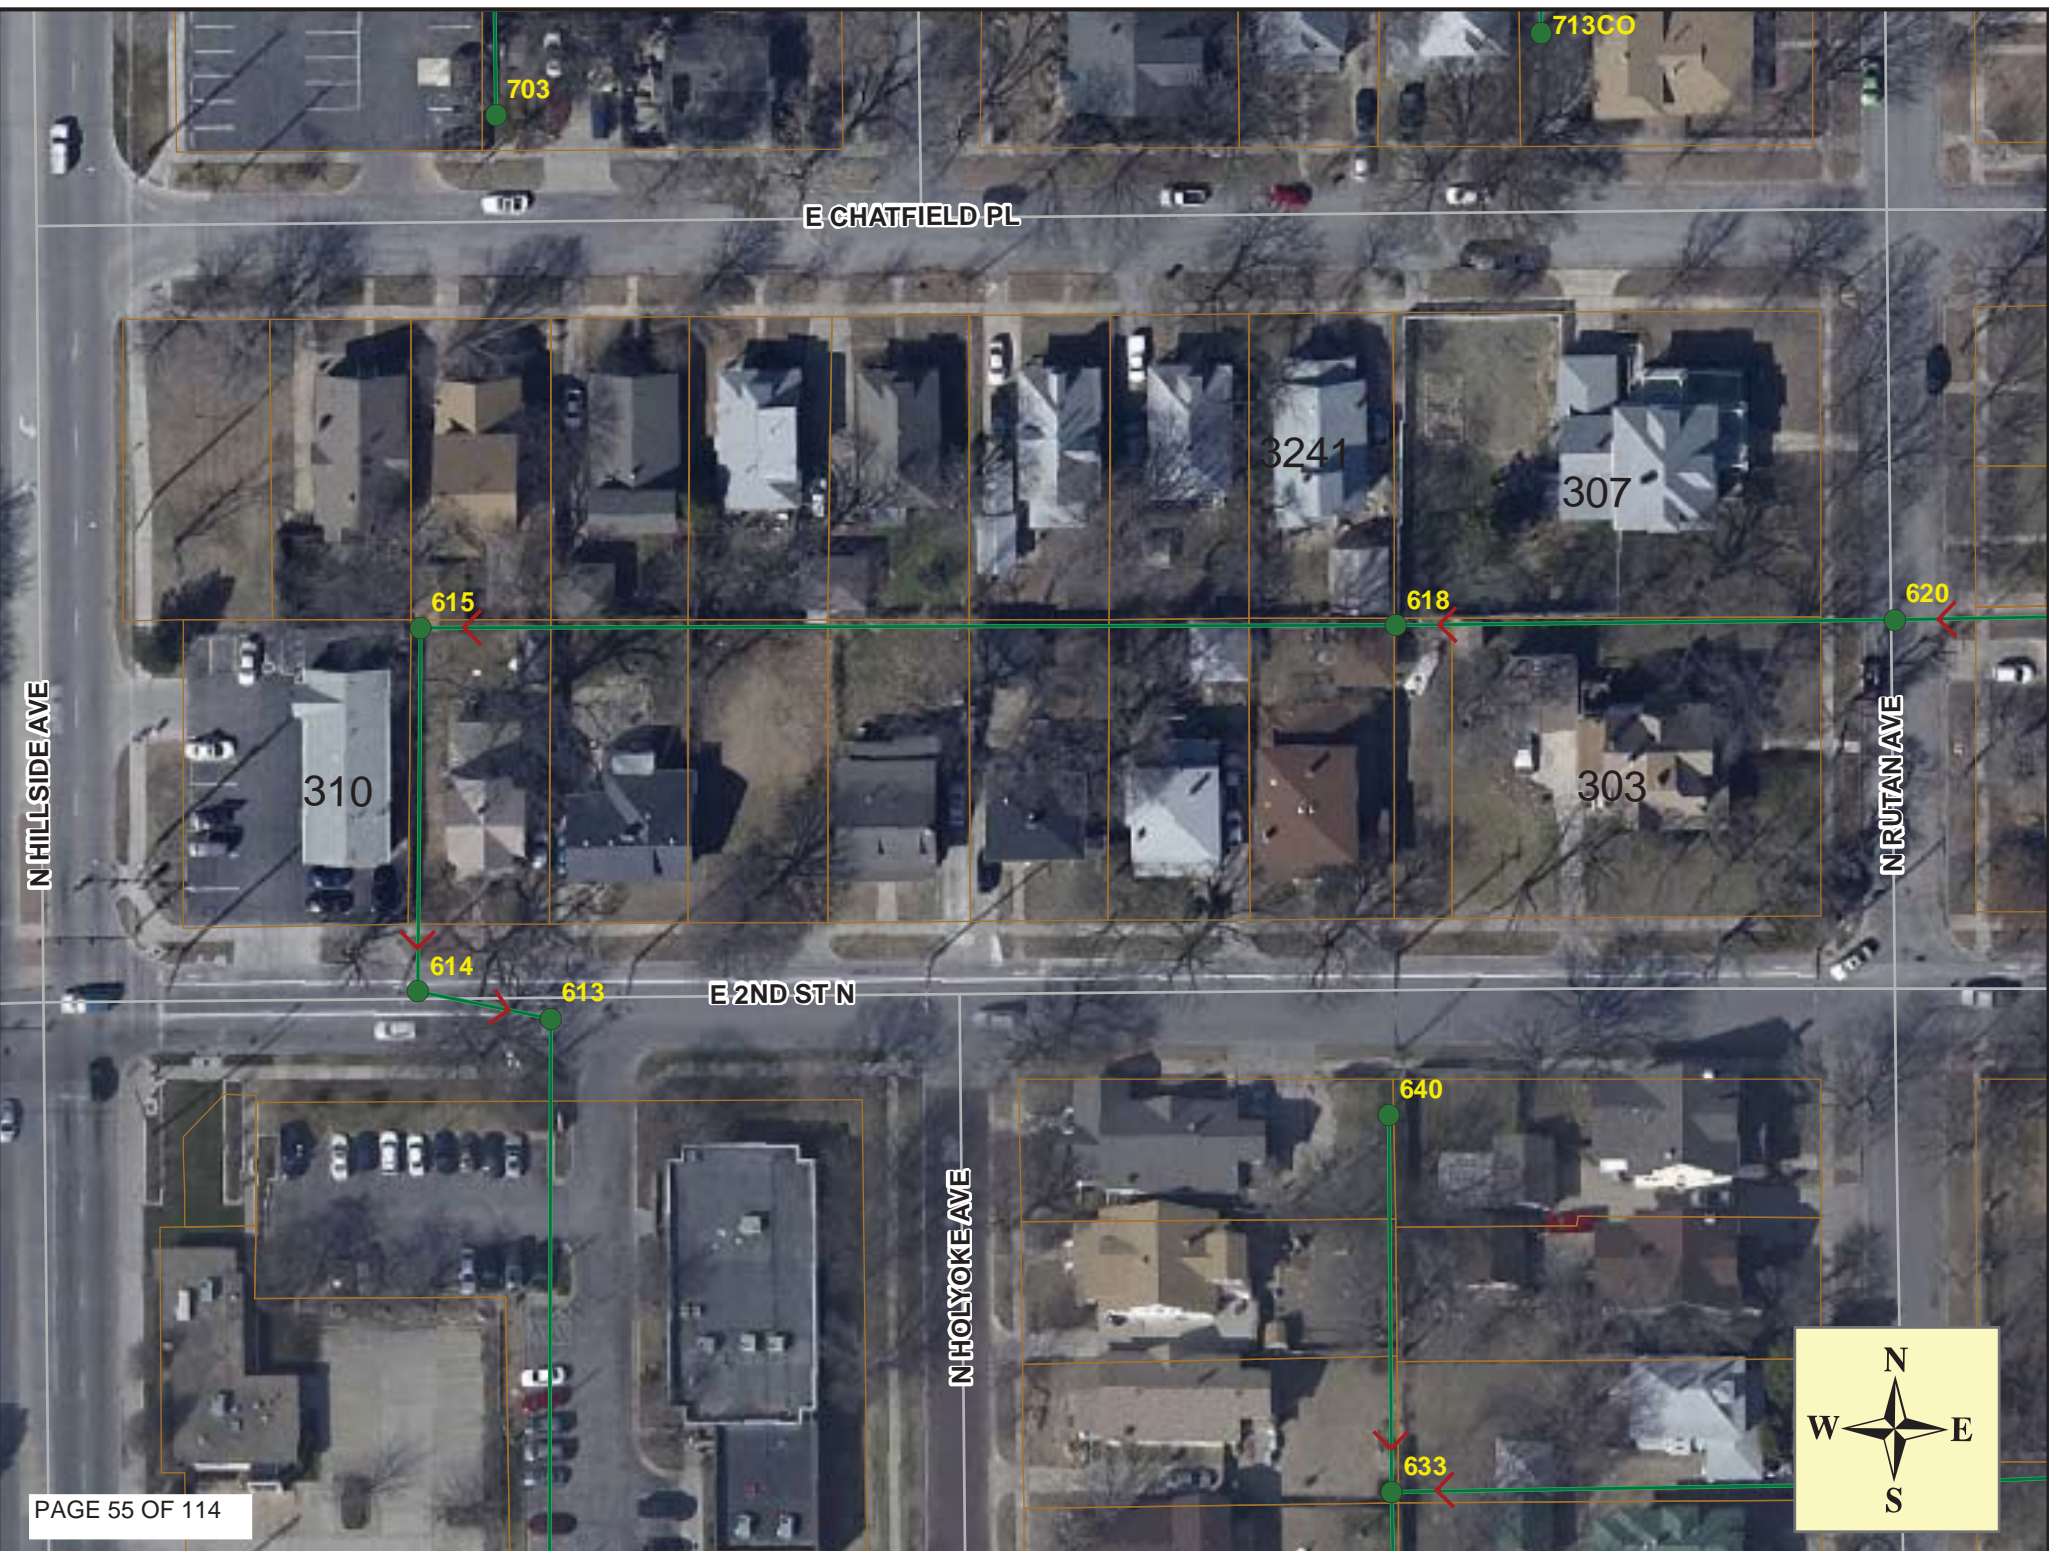
Same place as above. Mineral deposits at the observation hole are too heavy. Camera cannot pass.
