SITE 9

Video Inspection Master Report

US Structure: 5747-613 244 N HILLSIDE ST Date Insp: 4/13/2012 Basin: EC02A
 DS Structure: 5747-610 217 N HOLYOKE ST Dir Televised: Upstream To Downstream

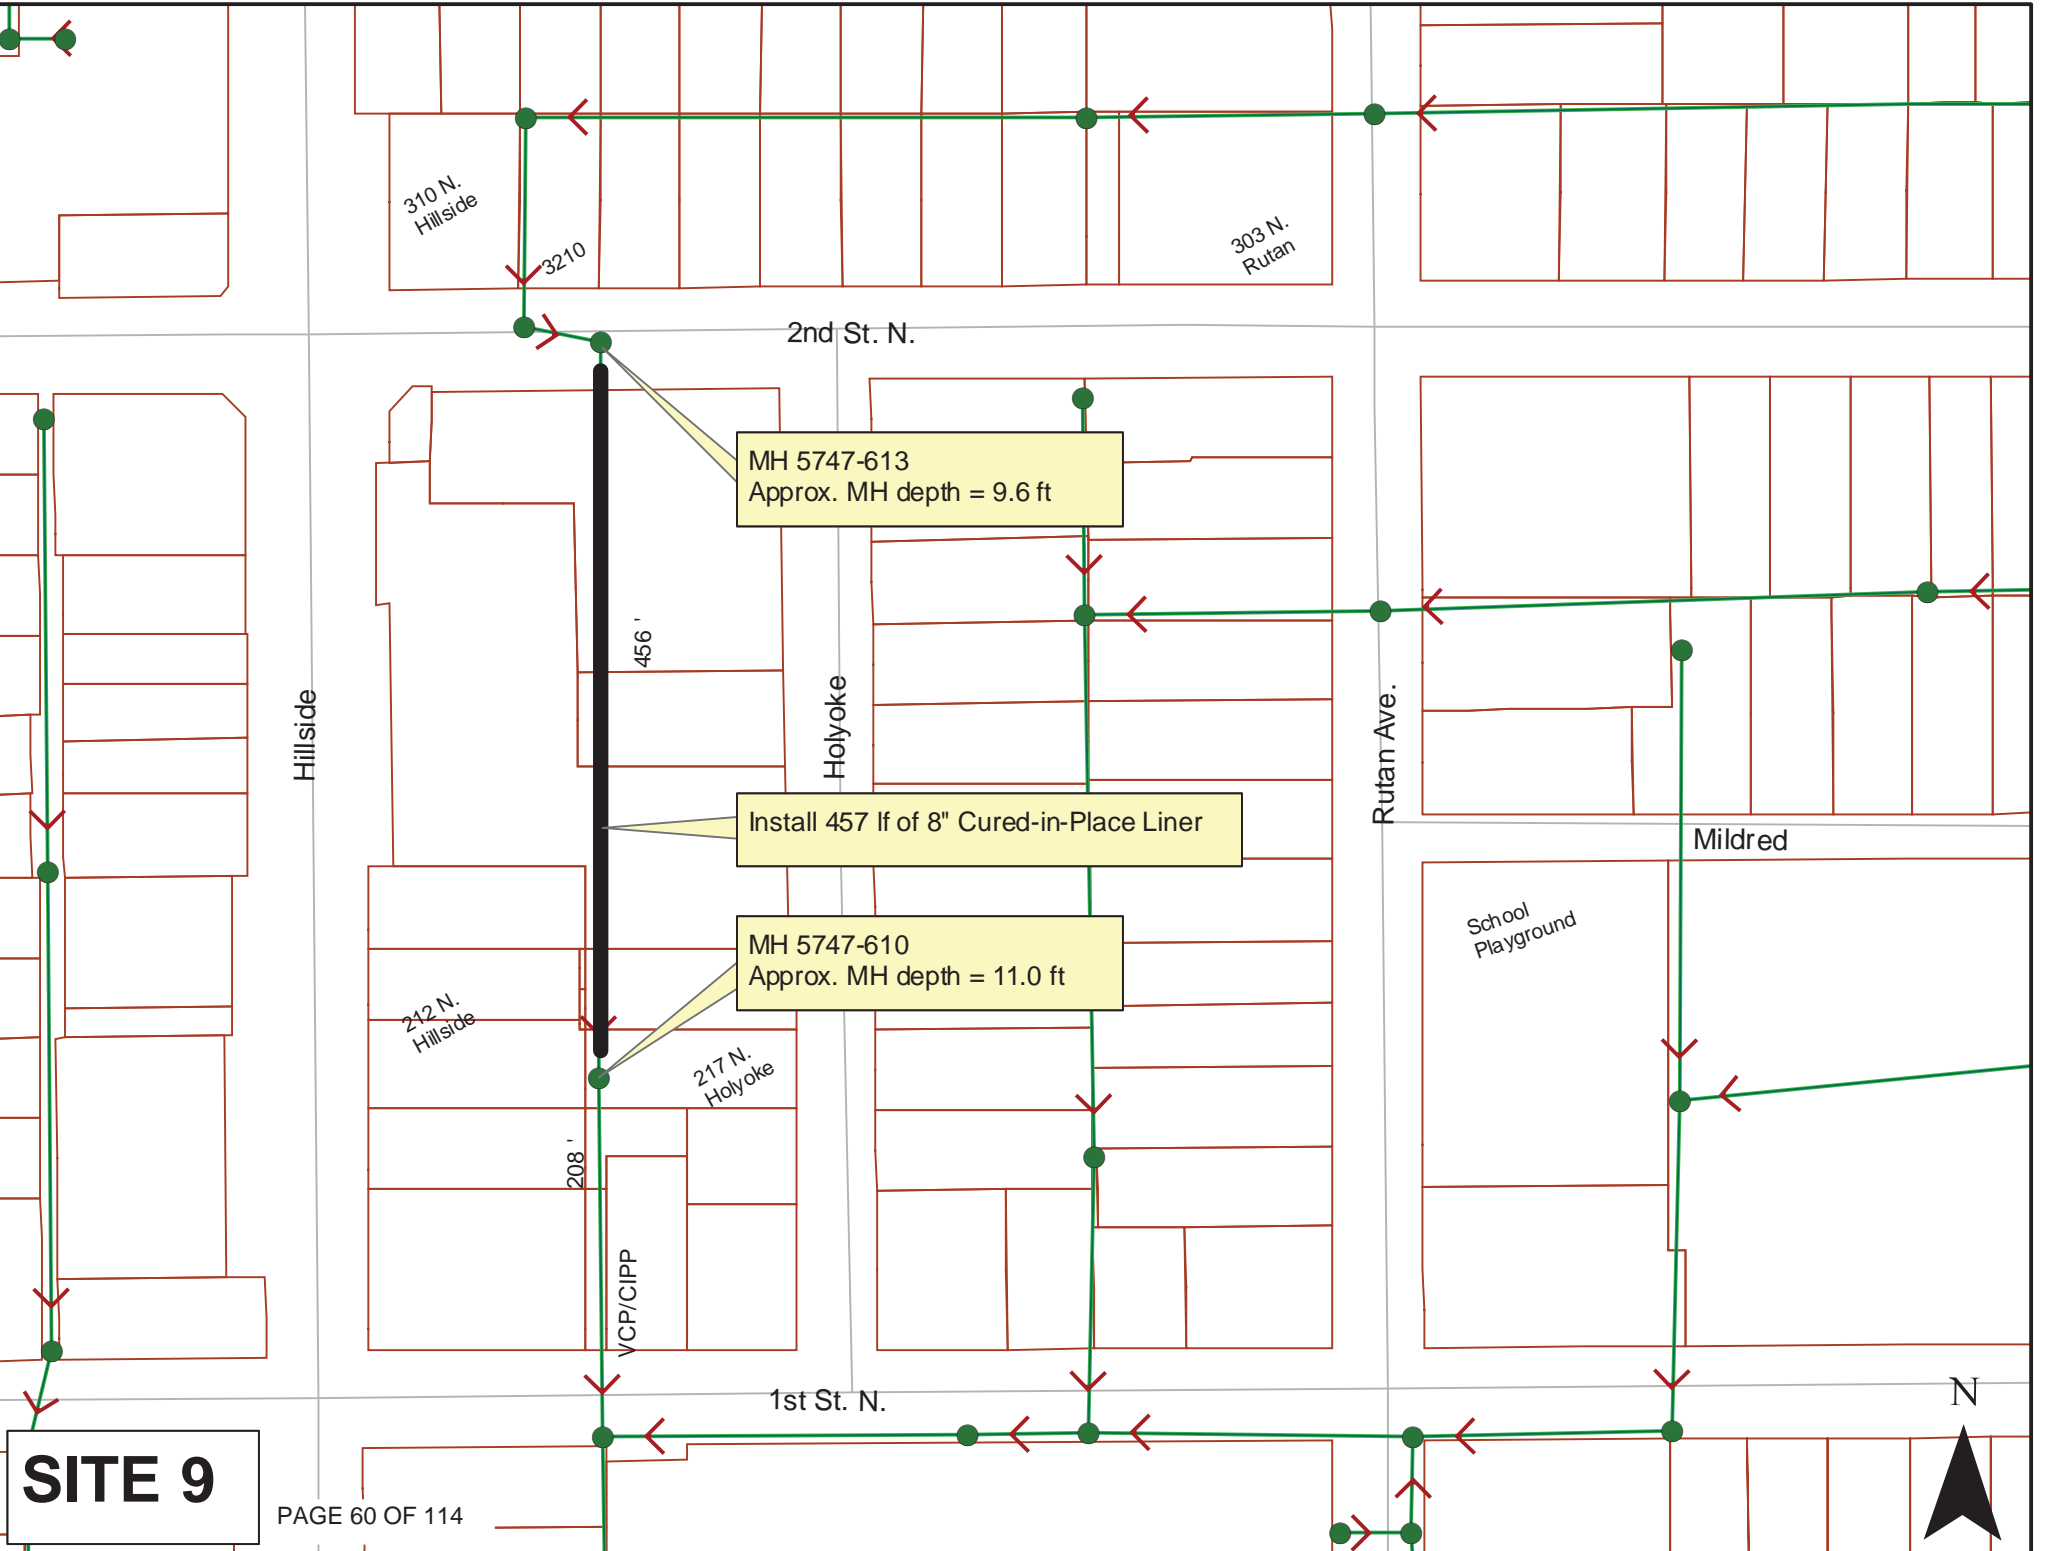
MH 5747-613
Approx. MH depth = 9.6 ft

MH 5747-610
Approx. MH depth = 11.0 ft

Install 457 lf of 8" Cured-in-Place Liner
