Install 324 lf of 8" Cured-in-Place Liner
from MH 5449-367 to MH 5449-365

SITE 10

North High School

Video Inspection Master Report

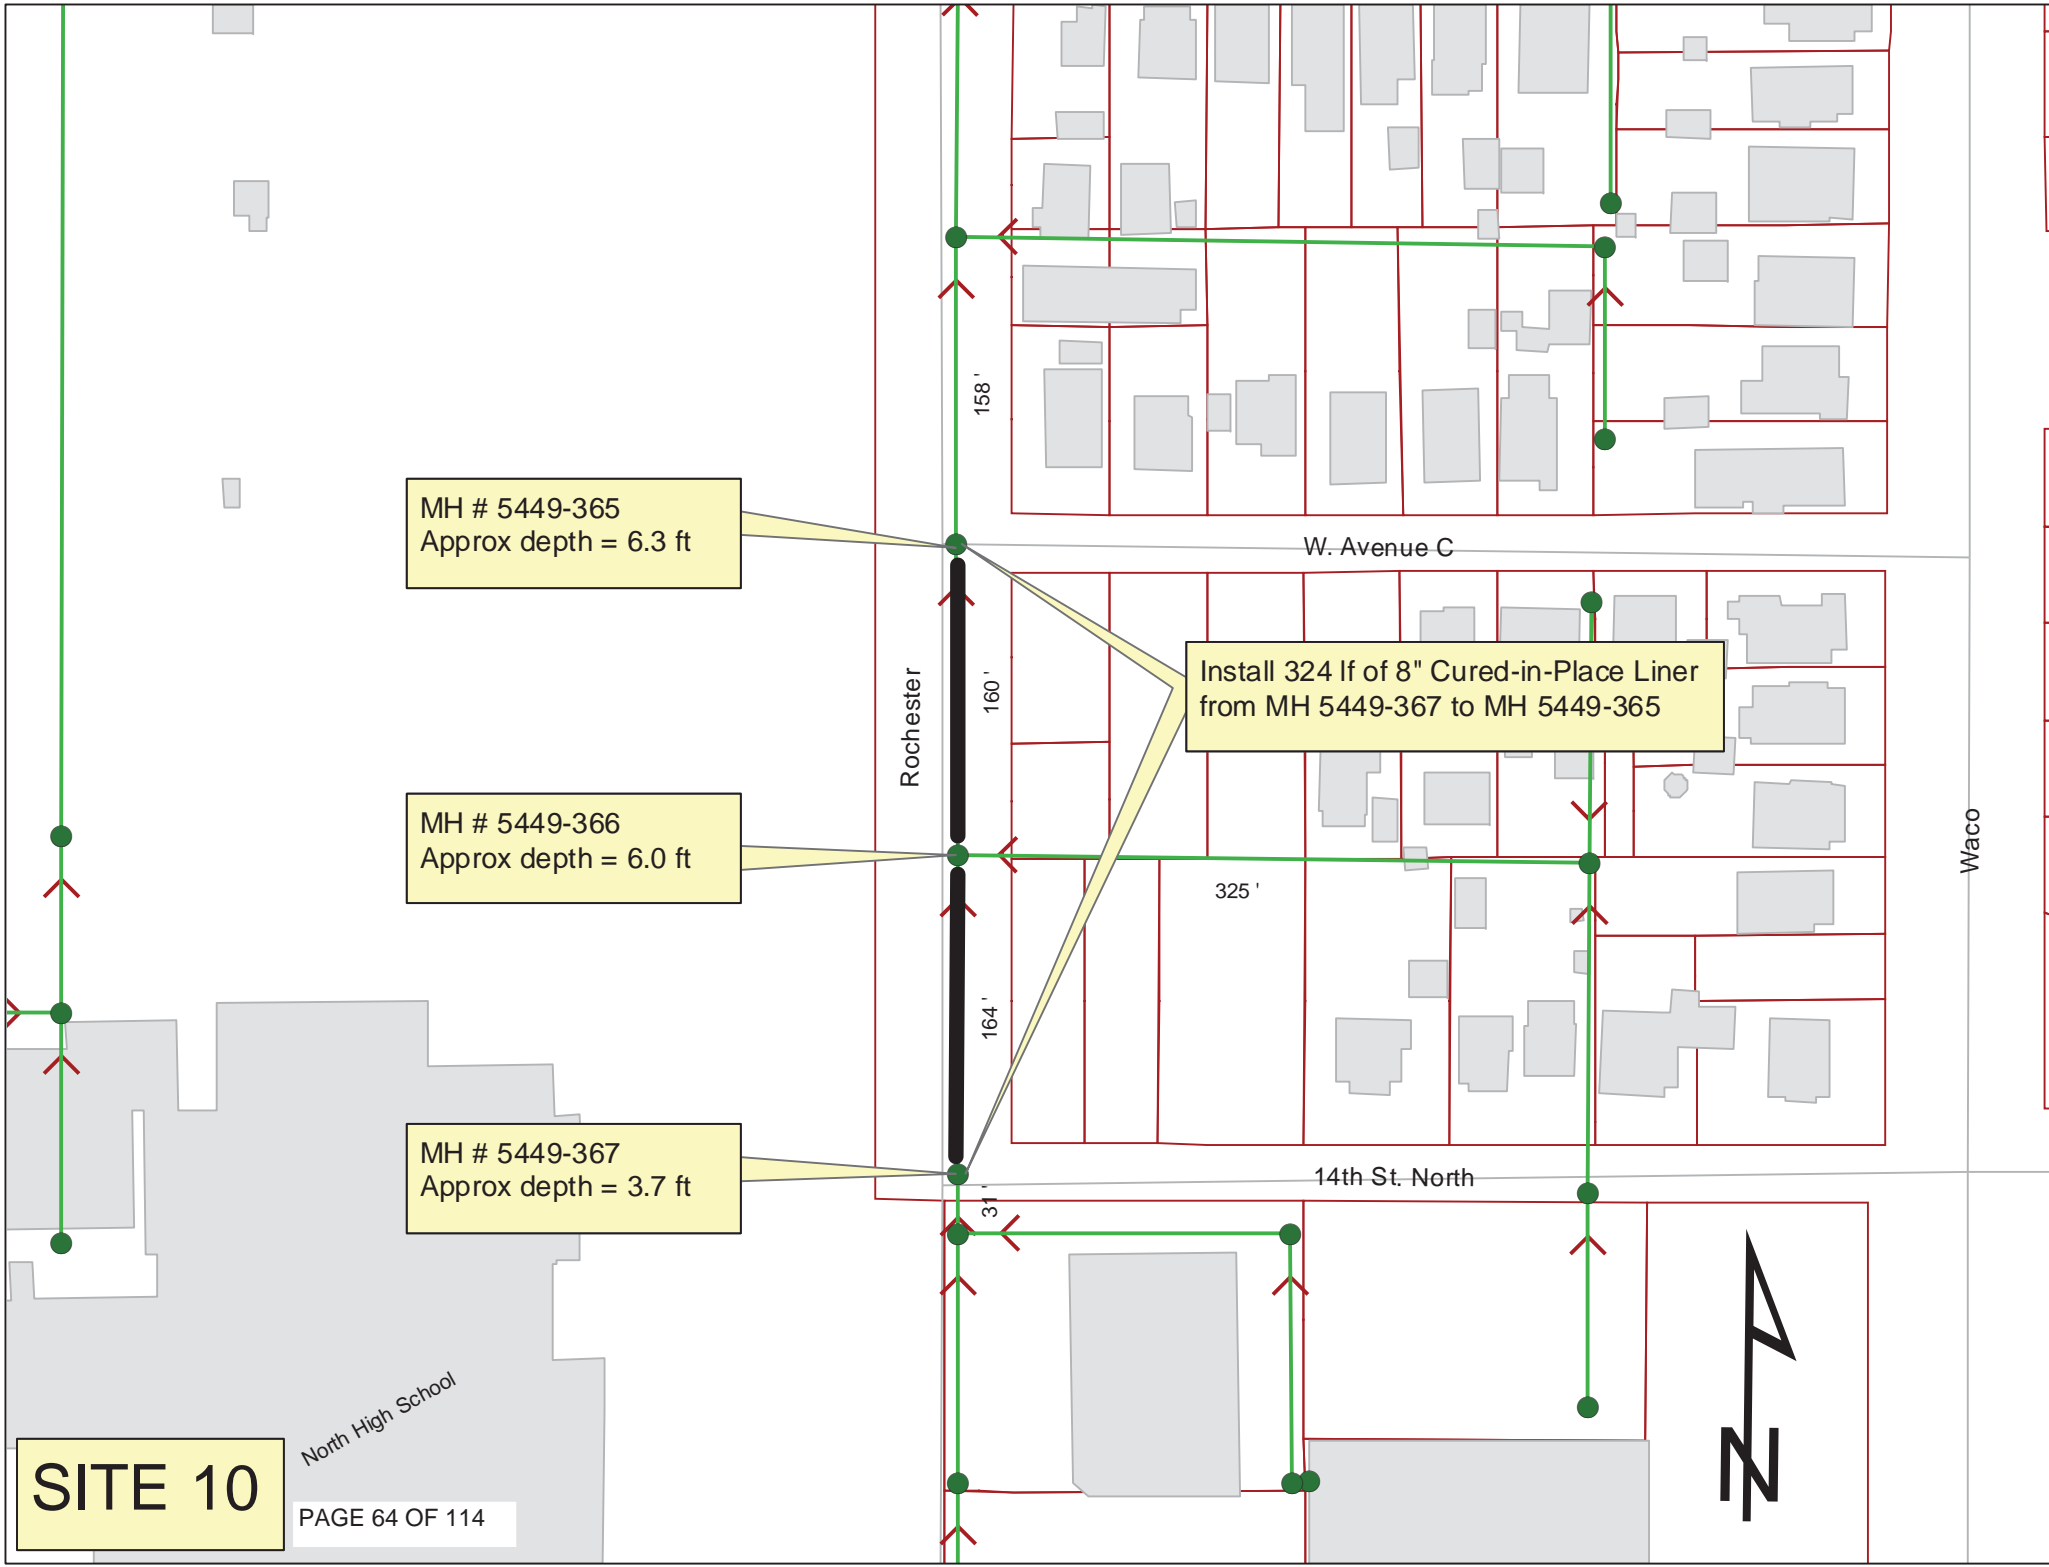
MH # 5449-365
Approx depth = 6.3 ft

MH # 5449-366
Approx depth = 6.0 ft

MH # 5449-367
Approx depth = 3.7 ft
