Install 571 lf of 8" Cured-in-Place Liner from MH 5847-333 to MH 5847-328

Install 148 lf of 8" Cured-in-Place Liner from MH 5847-327 to MH 5847-326

**SITE 12**

## Video Inspection Master Report

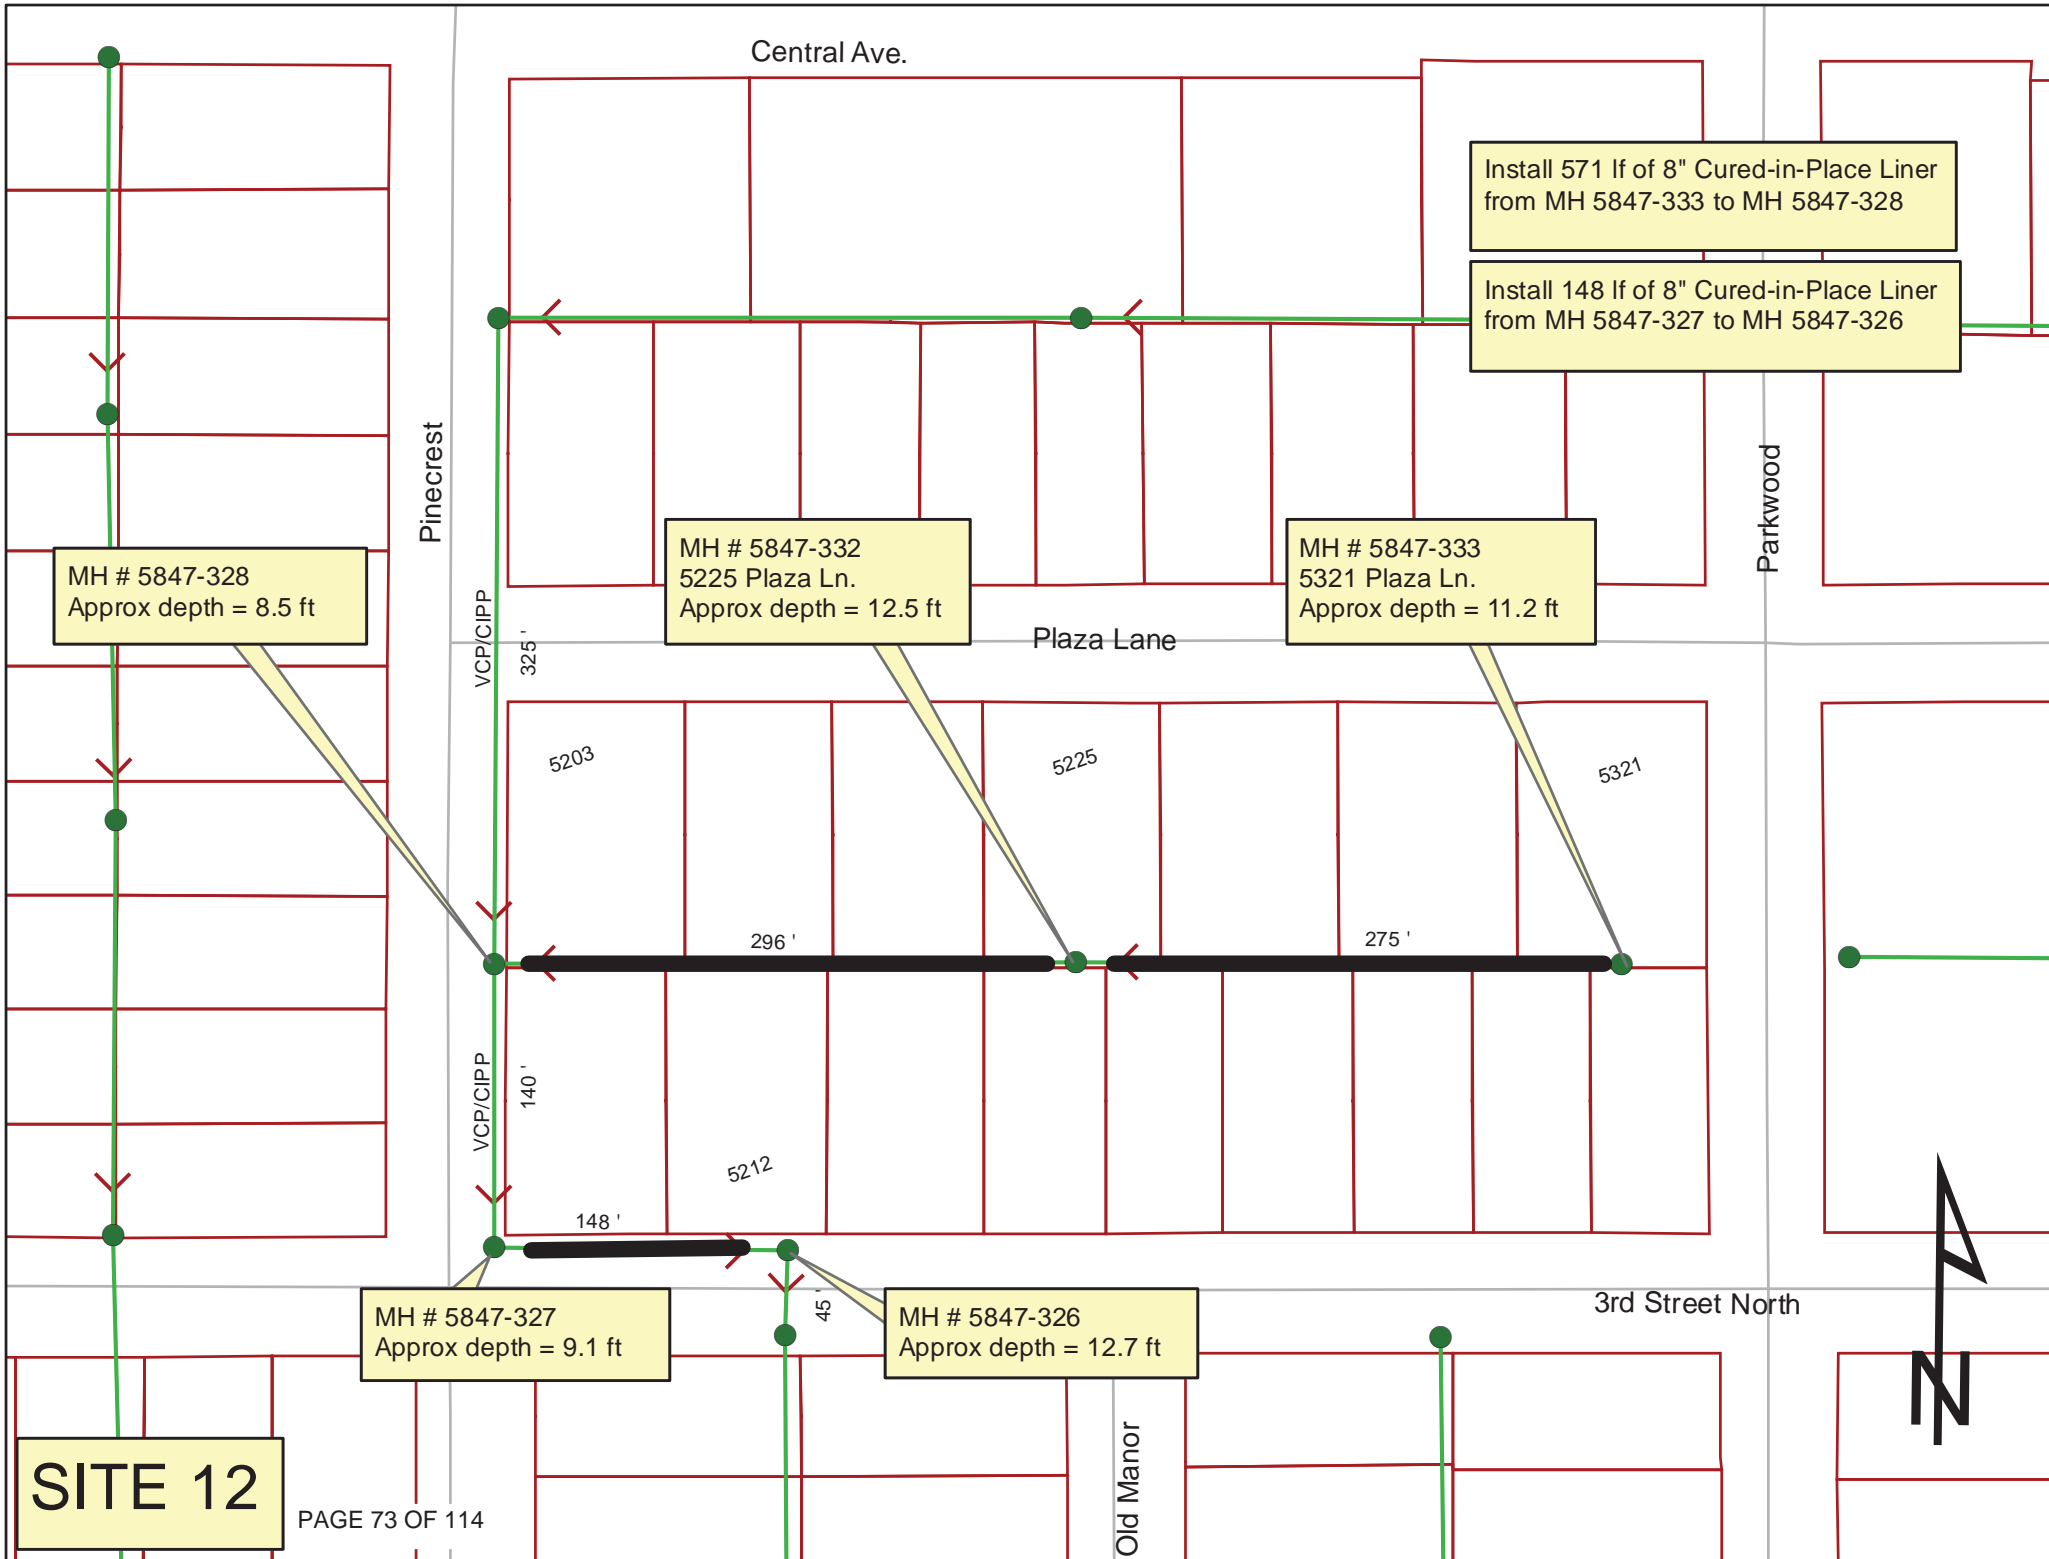
MH # 5847-328  
Approx depth = 8.5 ft

MH # 5847-332  
5225 Plaza Ln.  
Approx depth = 12.5 ft

MH # 5847-333  
5321 Plaza Ln.  
Approx depth = 11.2 ft

MH # 5847-327  
Approx depth = 9.1 ft

MH # 5847-326  
Approx depth = 12.7 ft
