**SITE 19**

North of Kellogg & East of Rock Rd.

# Video Inspection Master Report

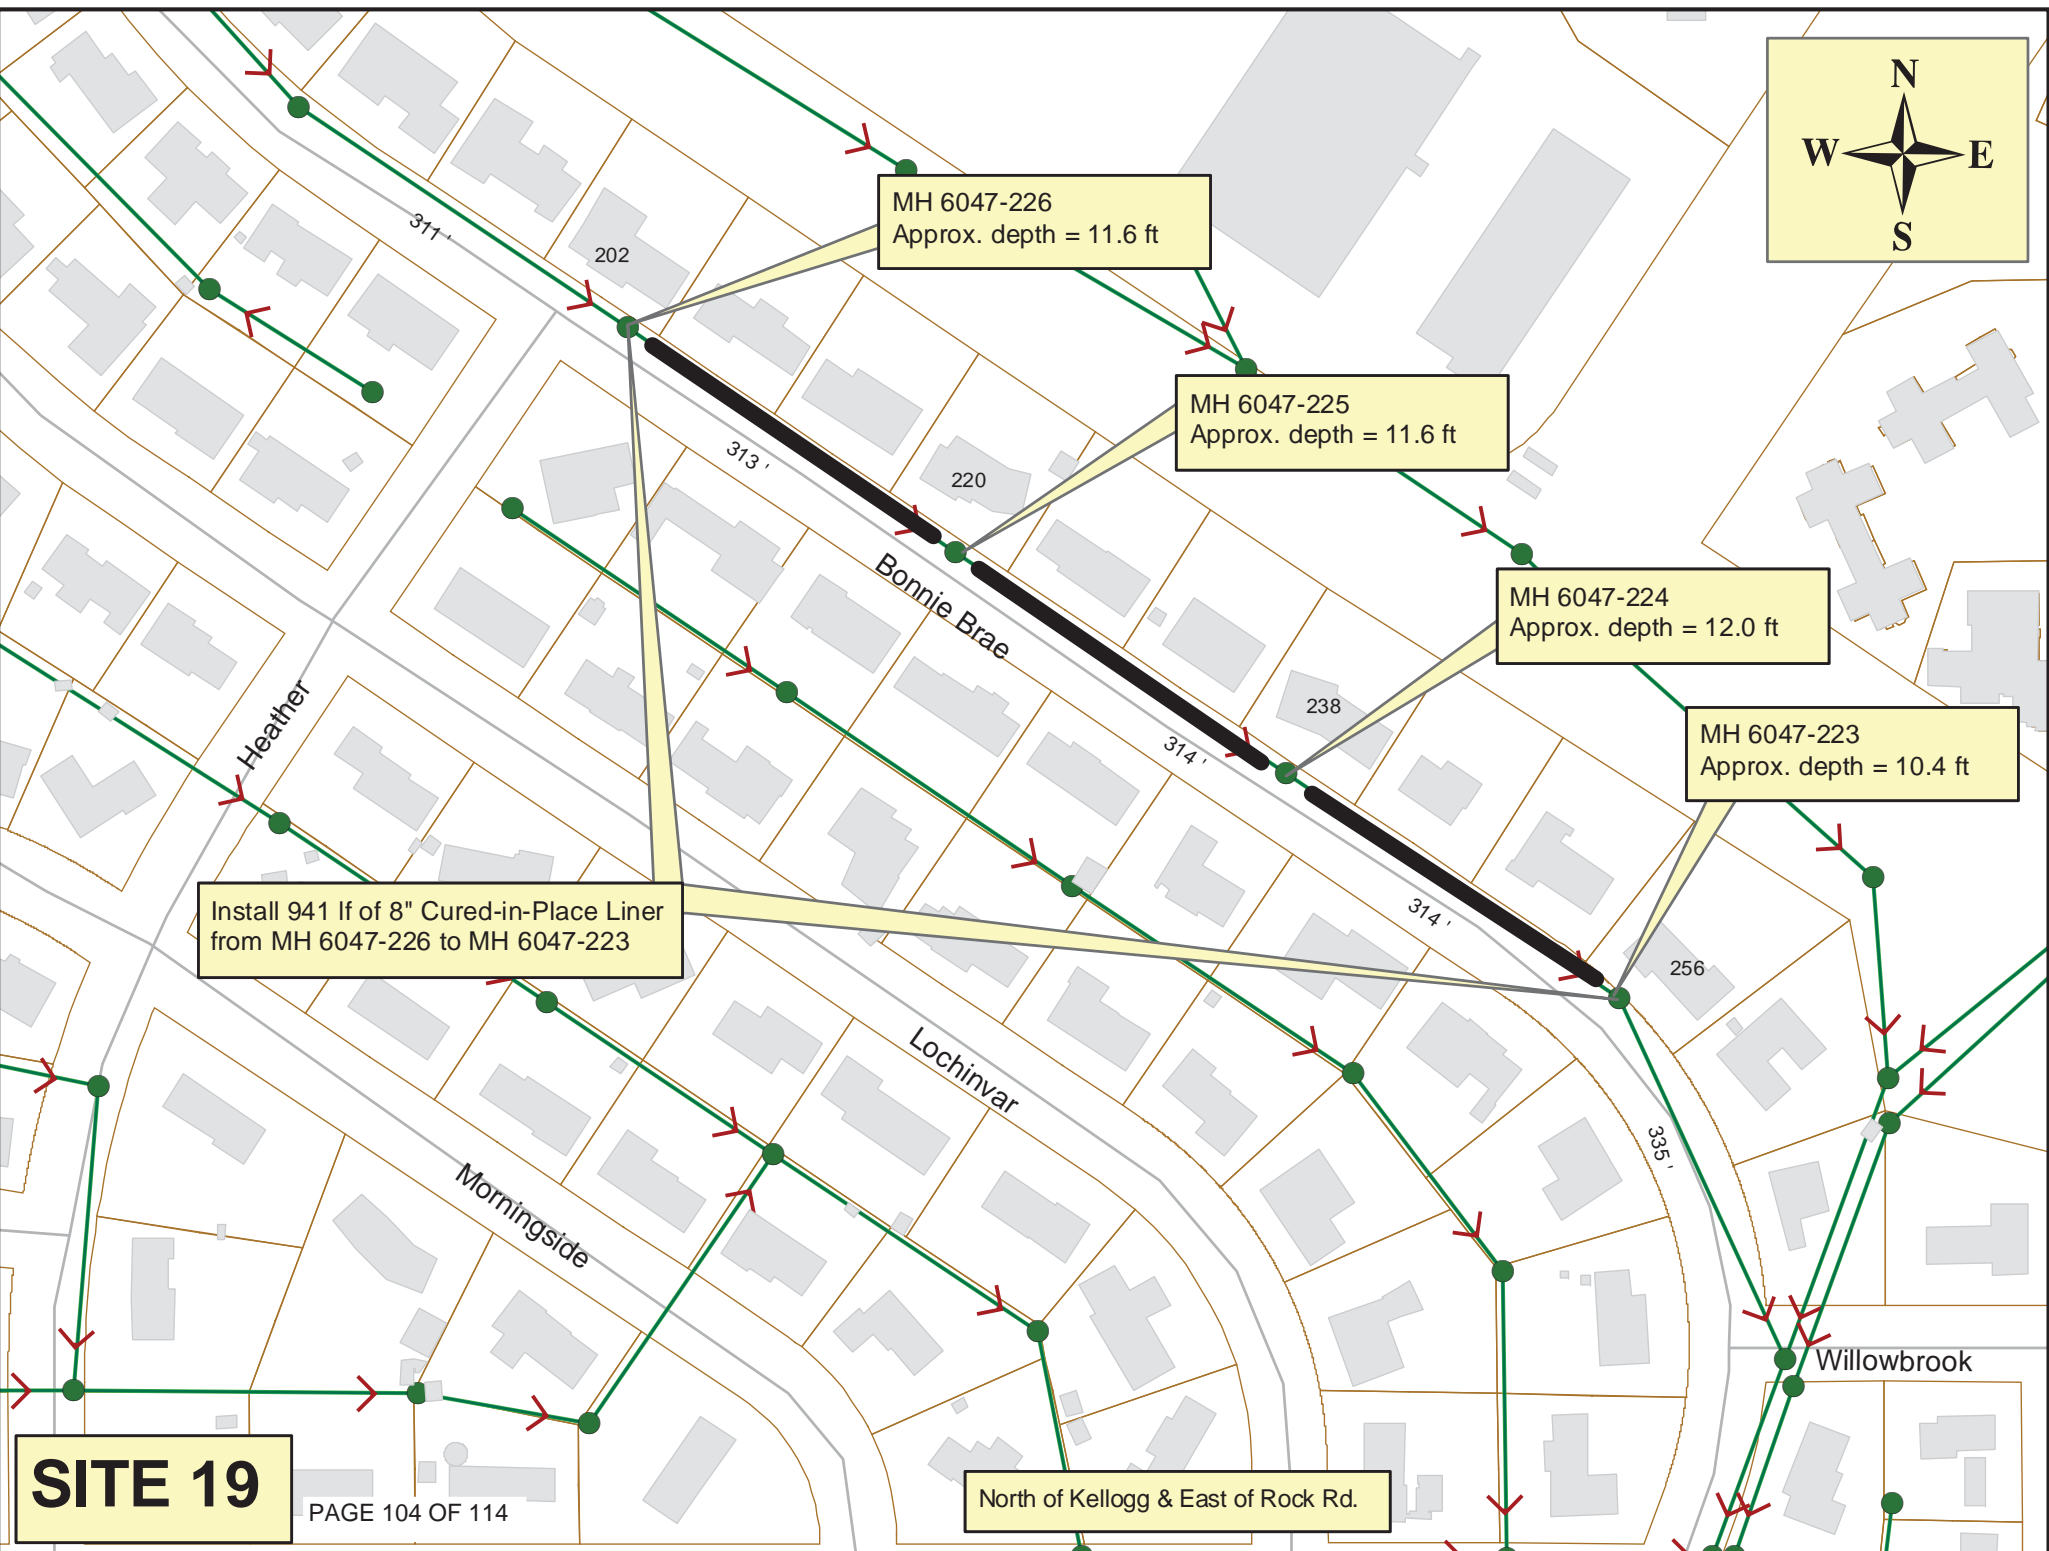
MH 6047-226  
Approx. depth = 11.6 ft

MH 6047-225  
Approx. depth = 11.6 ft

MH 6047-224  
Approx. depth = 12.0 ft

MH 6047-223  
Approx. depth = 10.4 ft

Install 941 lf of 8" Cured-in-Place Liner  
from MH 6047-226 to MH 6047-223

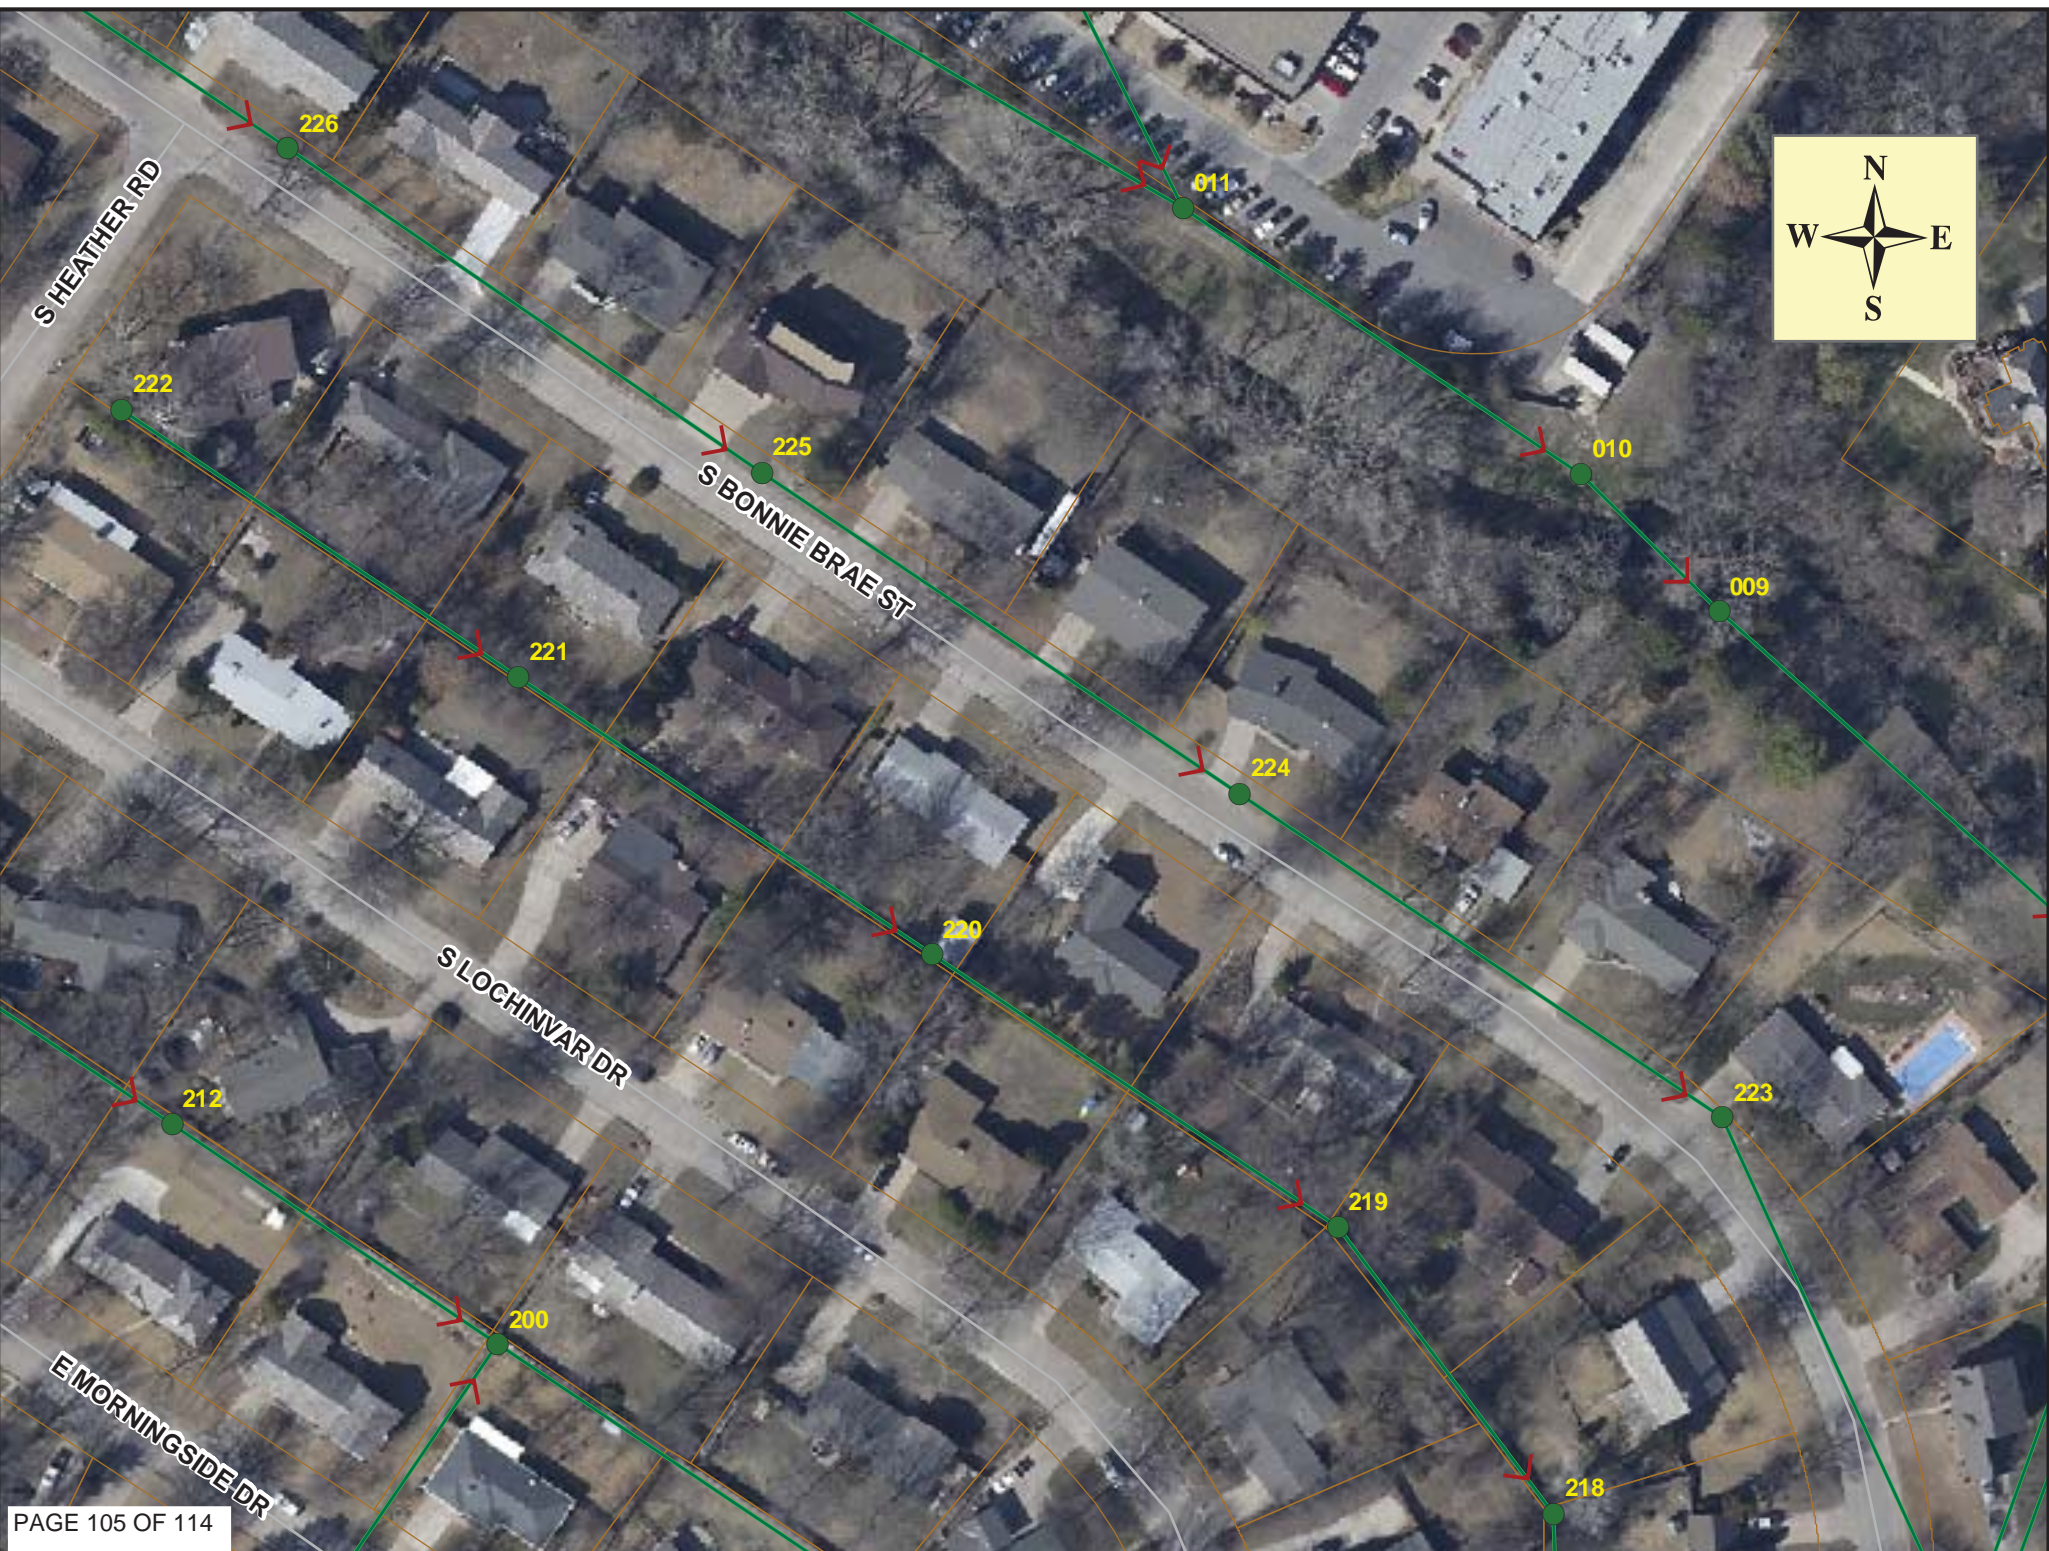
US Structure: 6047-226      202 S BONNIE BRAE ST      Date Insp.: 1/12/2012      Basin: E01G2  
 DS Structure: 6047-225      220 S BONNIE BRAE ST      Dir Televised: Upstream To Downstream

Obs. #	VTR Counter	Distance	Location	Description	Rating	Ratings				
						Obsrvd (gpm)	Est. (gpm)	Struct Clean	Remain (gpm)	
1		0.0	6047-226	US Manhole	1	0.000	0.000	0	0	0.000
2		7.5		Crack-Horizontal	3	0.004	0.004	5	0	0.004
3		10.8		Sealed Off Wye	1	0.000	0.000	0	0	0.000
4		27.1		Sag begin	3	0.000	0.000	5	0	0.000
5		32.8	(water not on lens)	Sag end	1	0.000	0.000	1	0	0.000
6		45.2		Sag begin	1	0.000	0.000	1	0	0.000
7		47.2	(water never over lens)	Sag end	1	0.000	0.000	1	0	0.000
8		49.3		Broken Pipe	3	0.010	0.010	60	0	0.010
9		54.7		Broken Pipe	3	0.010	0.010	60	0	0.010
10		57.8		Broken Pipe	3	0.010	0.010	60	0	0.010
11		58.6		Material changes to PVC	1	0.000	0.000	0	0	0.000
12		65.9		Sag	2	0.000	0.000	2	0	0.000
13		67.9	208 SOUTH BONNIE BRAE	PVC Break-In Conn	1	0.001	0.001	0	0	0.001
14		69.2		Materials changes back to VCP	1	0.000	0.000	0	0	0.000
15		81.5		Sag	3	0.000	0.000	5	0	0.000
16		84.4		Sag	1	0.000	0.000	1	0	0.000

17		84.5		Internal CIPP sleeve repair begins	1	0.000	0.000	0	0	0.000
18		87.5		Internal CIPP sleeve repair ends	1	0.000	0.000	0	0	0.000
19		113.8		Sealed Off Wye	1	0.000	0.000	0	0	0.000
20		114.2		Sag begins	1	0.000	0.000	1	0	0.000
21		120.1		Sag ends	1	0.000	0.000	1	0	0.000
22		128.0		Sag begins	1	0.000	0.000	1	0	0.000
23		132.7		Sag ends	1	0.000	0.000	1	0	0.000
24		155.4		Crack-Horizontal	3	0.004	0.004	5	0	0.004
25		157.8		Crack-Horizontal	3	0.004	0.004	5	0	0.004
26		167.2		Crack-Horizontal	3	0.004	0.004	5	0	0.004
27		172.0		Offset Joint	3	0.000	0.000	5	0	0.000
28		197.2		Sag begins	3	0.010	0.010	60	0	0.010
29		205.0		Crack-Horizontal	3	0.004	0.004	5	0	0.004
30		205.6		Sag ends	1	0.000	0.000	1	0	0.000
31		210.3		Broken Pipe	3	0.010	0.010	60	0	0.010
32		216.5		Broken Pipe	3	0.010	0.010	60	0	0.010
33		222.4		Crack-Horizontal	3	0.004	0.004	5	0	0.004
34		227.1	214 SOUTH BONNIE BRAE	PVC Break-In Conn	1	0.001	0.001	0	0	0.001

35		245.1		Sag begins	1	0.000	0.000	1	0	0.000
36		250.6		Sag ends	1	0.000	0.000	1	0	0.000
37		313.1	6047-225	DS Manhole	1					(Sags not bad enough to open cut)
