**MAP 1**

# Television Inspection Master Report

**MAP 2**

**MAP 3**

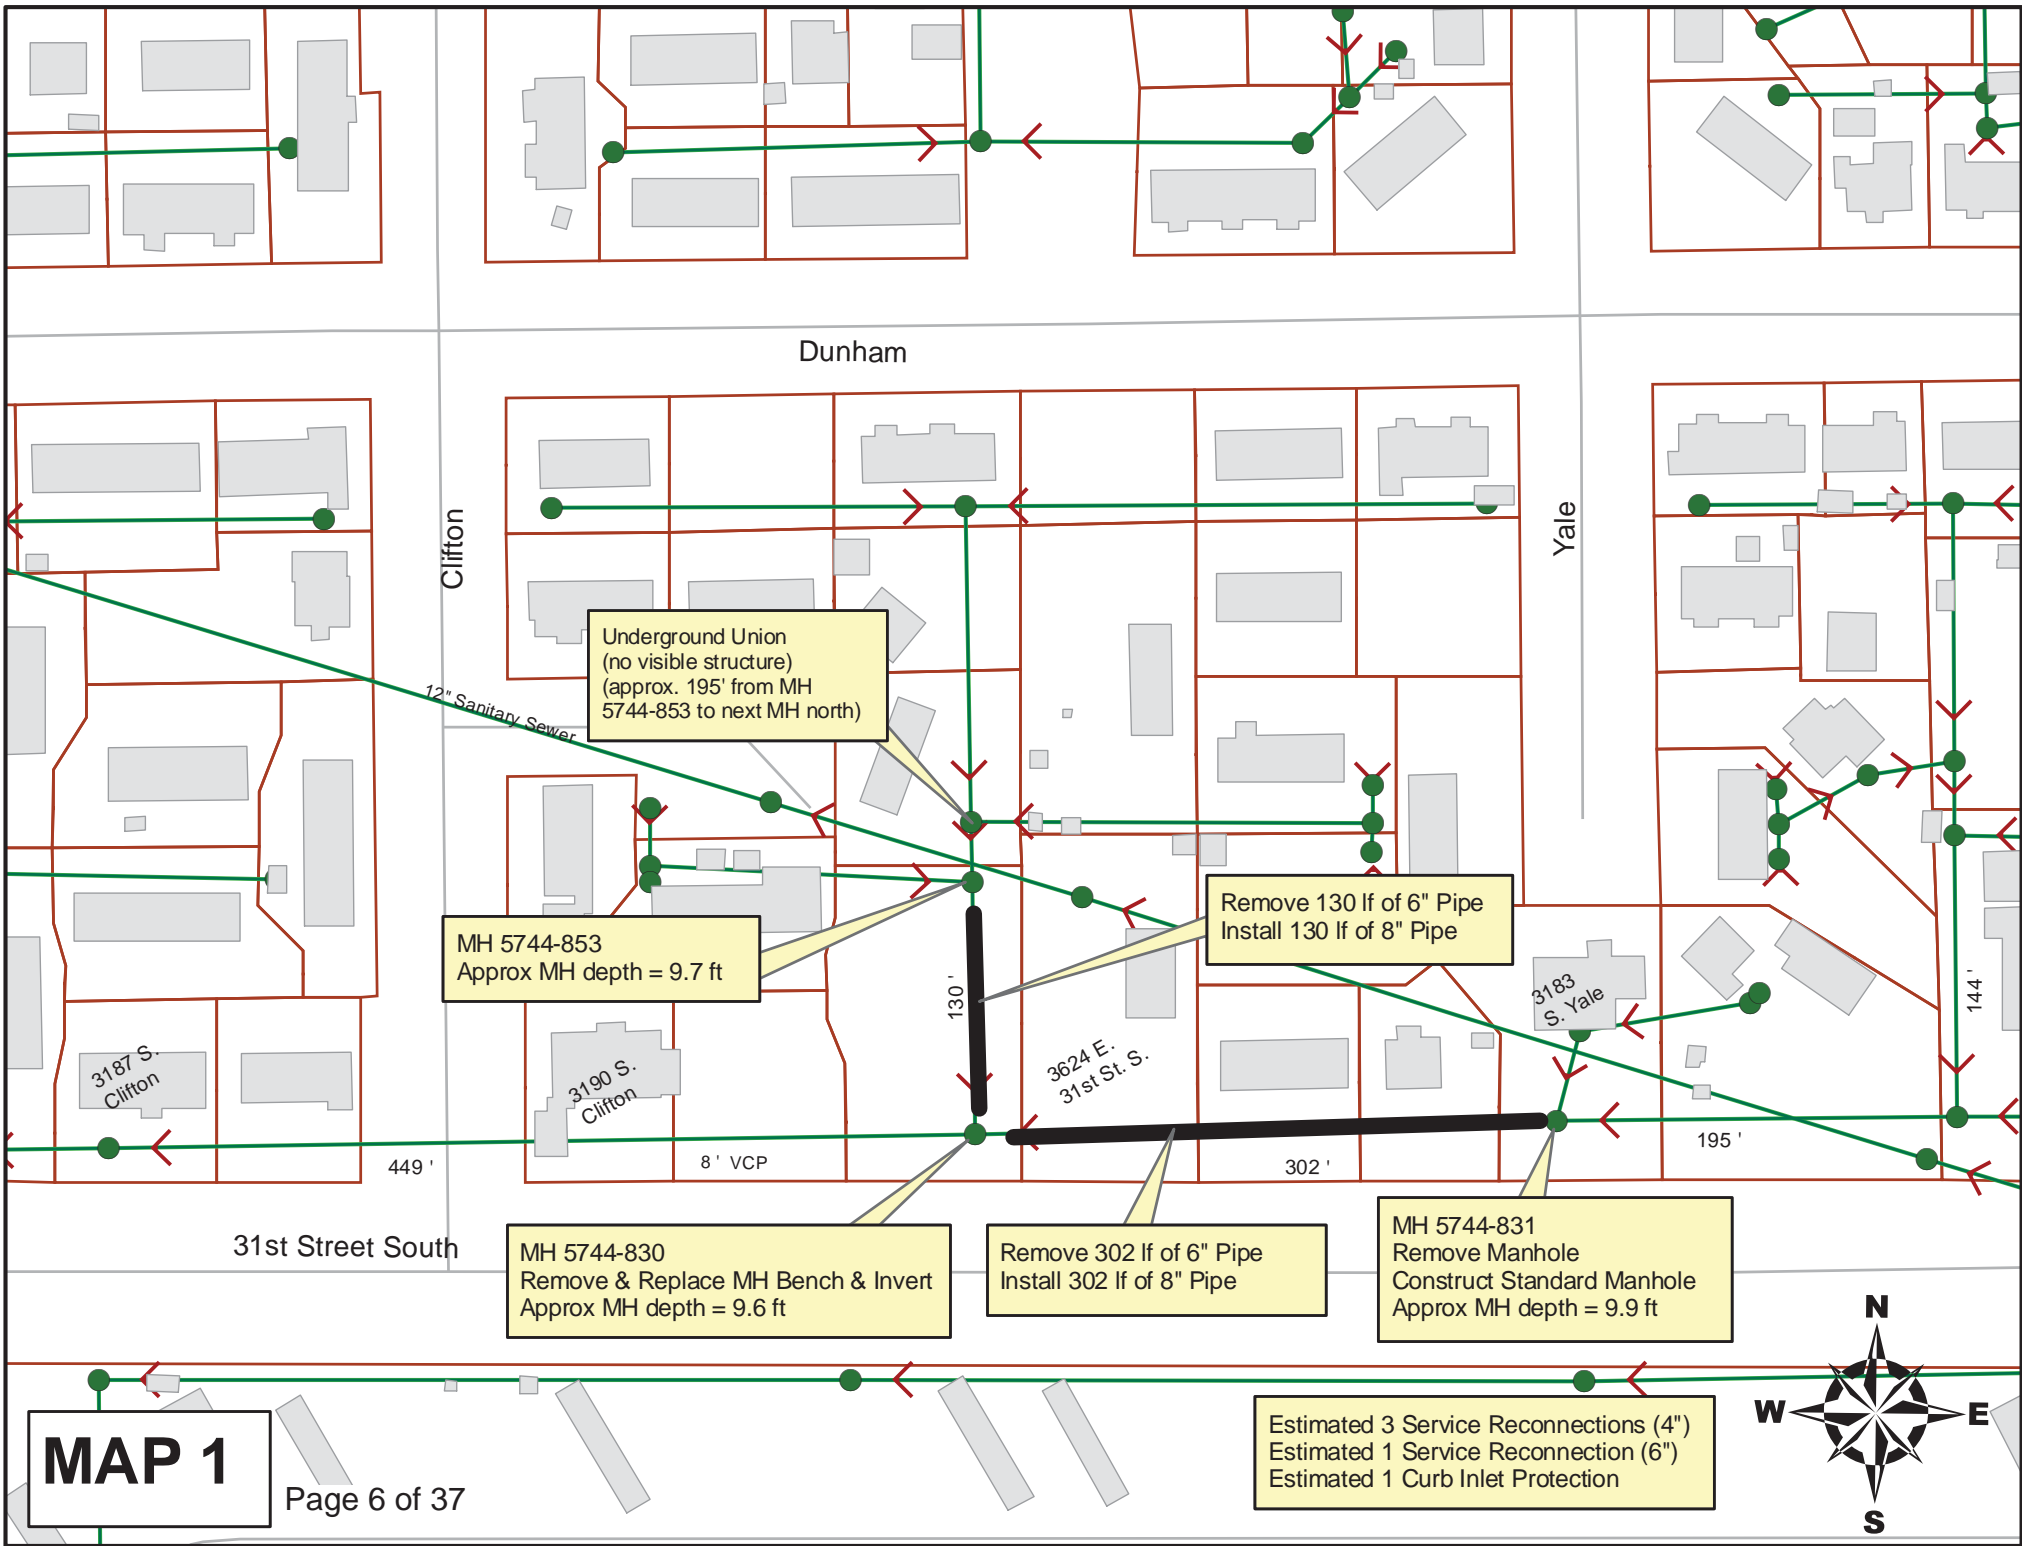
LINE IN POOR CONDITION DUE TO GREASE AND CRACKS

Obs. #	VTR	Counter	Distance	Location	Description	Rating	Ratings						
							Obsrvd (gpm)	Est. (gpm)	Struct Clean	Remain (gpm)			
1			0.0	DS Manhole 5744-830	TV AGAINST THE FLOW								
4			1.0	Pipe broken at manhole wall	Broken Pipe	3	0.010	60	0	0.010			
5			7.9	Start	Sag	3	0.000	5	0	0.000			
6			20.6		Grease	4	0.000	0	10	0.000			
7			22.8	End	Sag	1	0.000	1	0	0.000			
8			26.5	Crown	Crack-Radial	3	0.004	5	0	0.004			
9			28.2	Lower Right	Grease	4	0.000	0	10	0.000			
10			33.1	Upper Right	Grease	4	0.000	0	10	0.000			
11			33.8	Crown	Crack-Radial	4	0.008	10	0	0.008			
12			62.6	Invert	Crack-Radial	3	0.004	5	0	0.004			
13			63.7	West	Break-In Conn	1	0.001	0	0	0.001			
				Faces 3182 SOUTH CLIFTON	4" Break In Connection (needs verified to see if this is active or not)								
14			68.7	Upper Right	Broken Pipe	3	0.010	60	0	0.010			
15			80.4	East	Break-In Conn	1	0.001	0	0	0.001			
				Faces 3624 EAST 31ST ST SOUTH	4" Break In Connection

Comments: THIS LINE IS IN POOR CONDITION DUE TO ROOTS ALSO THERE IS NO CLEANOUT LID FOR THE PRIVATE CLEANOUT AT 40 FT

Obs. #	VTR	Counter	Distance	Location	Description	Rating	Obsrvd (gpm)	Est. (gpm)	Struct	Clean	Remain (gpm)
1			0.0	US Manhole	5744-831	1					
2			2.0	Upper Left	Crack-Radial	3	0.004	0.004	5	0	0.004
3			6.0	Joint	Roots	3	0.008	0.008	5	8	0.008
4			48.8	Upper Right	Broken Pipe	3	0.010	0.010	60	0	0.010
5			71.0		PR Starts - Mat. Chngs to PVC	3	0.000	0.000	0	0	0.000
6			76.2	North	Break-In Conn	1	0.001	0.001	0	0	0.001
			3646	EAST 31ST ST SOUTH	4" Predco Saddle						
7			81.1		PR Ends - Mat. Chngs to VCP	1	0.000	0.000	0	0	0.000
8			92.2	Joint	Roots	3	0.008	0.008	5	8	0.008
9			125.7	North	Break-In Conn	4	0.008	0.008	60	0	0.008
			3634	EAST 31ST ST SOUTH	4" Break In Connection						
10			162.6	North	Break-In Conn	1	0.001	0.001	0	0	0.001
			3632	EAST 31ST ST SOUTH	4" Break In Connection						
11			171.2	Upper Right	Crack-Radial	3	0.004	0.004	5	0	0.004
12			192.4	Upper Right	Broken Pipe	3	0.010	0.010	60	0	0.010
13			199.5	Crown	Crack-Horizontal	3	0.004	0.004	5	0	0.004

Remove 130 lf of 6" Pipe  
Install 130 lf of 8" Pipe

MH 5744-830  
Remove & Replace MH Bench & Invert  
Approx MH depth = 9.6 ft

Remove 302 lf of 6" Pipe  
Install 302 lf of 8" Pipe

MH 5744-831  
Remove Manhole  
Construct Standard Manhole  
Approx MH depth = 9.9 ft

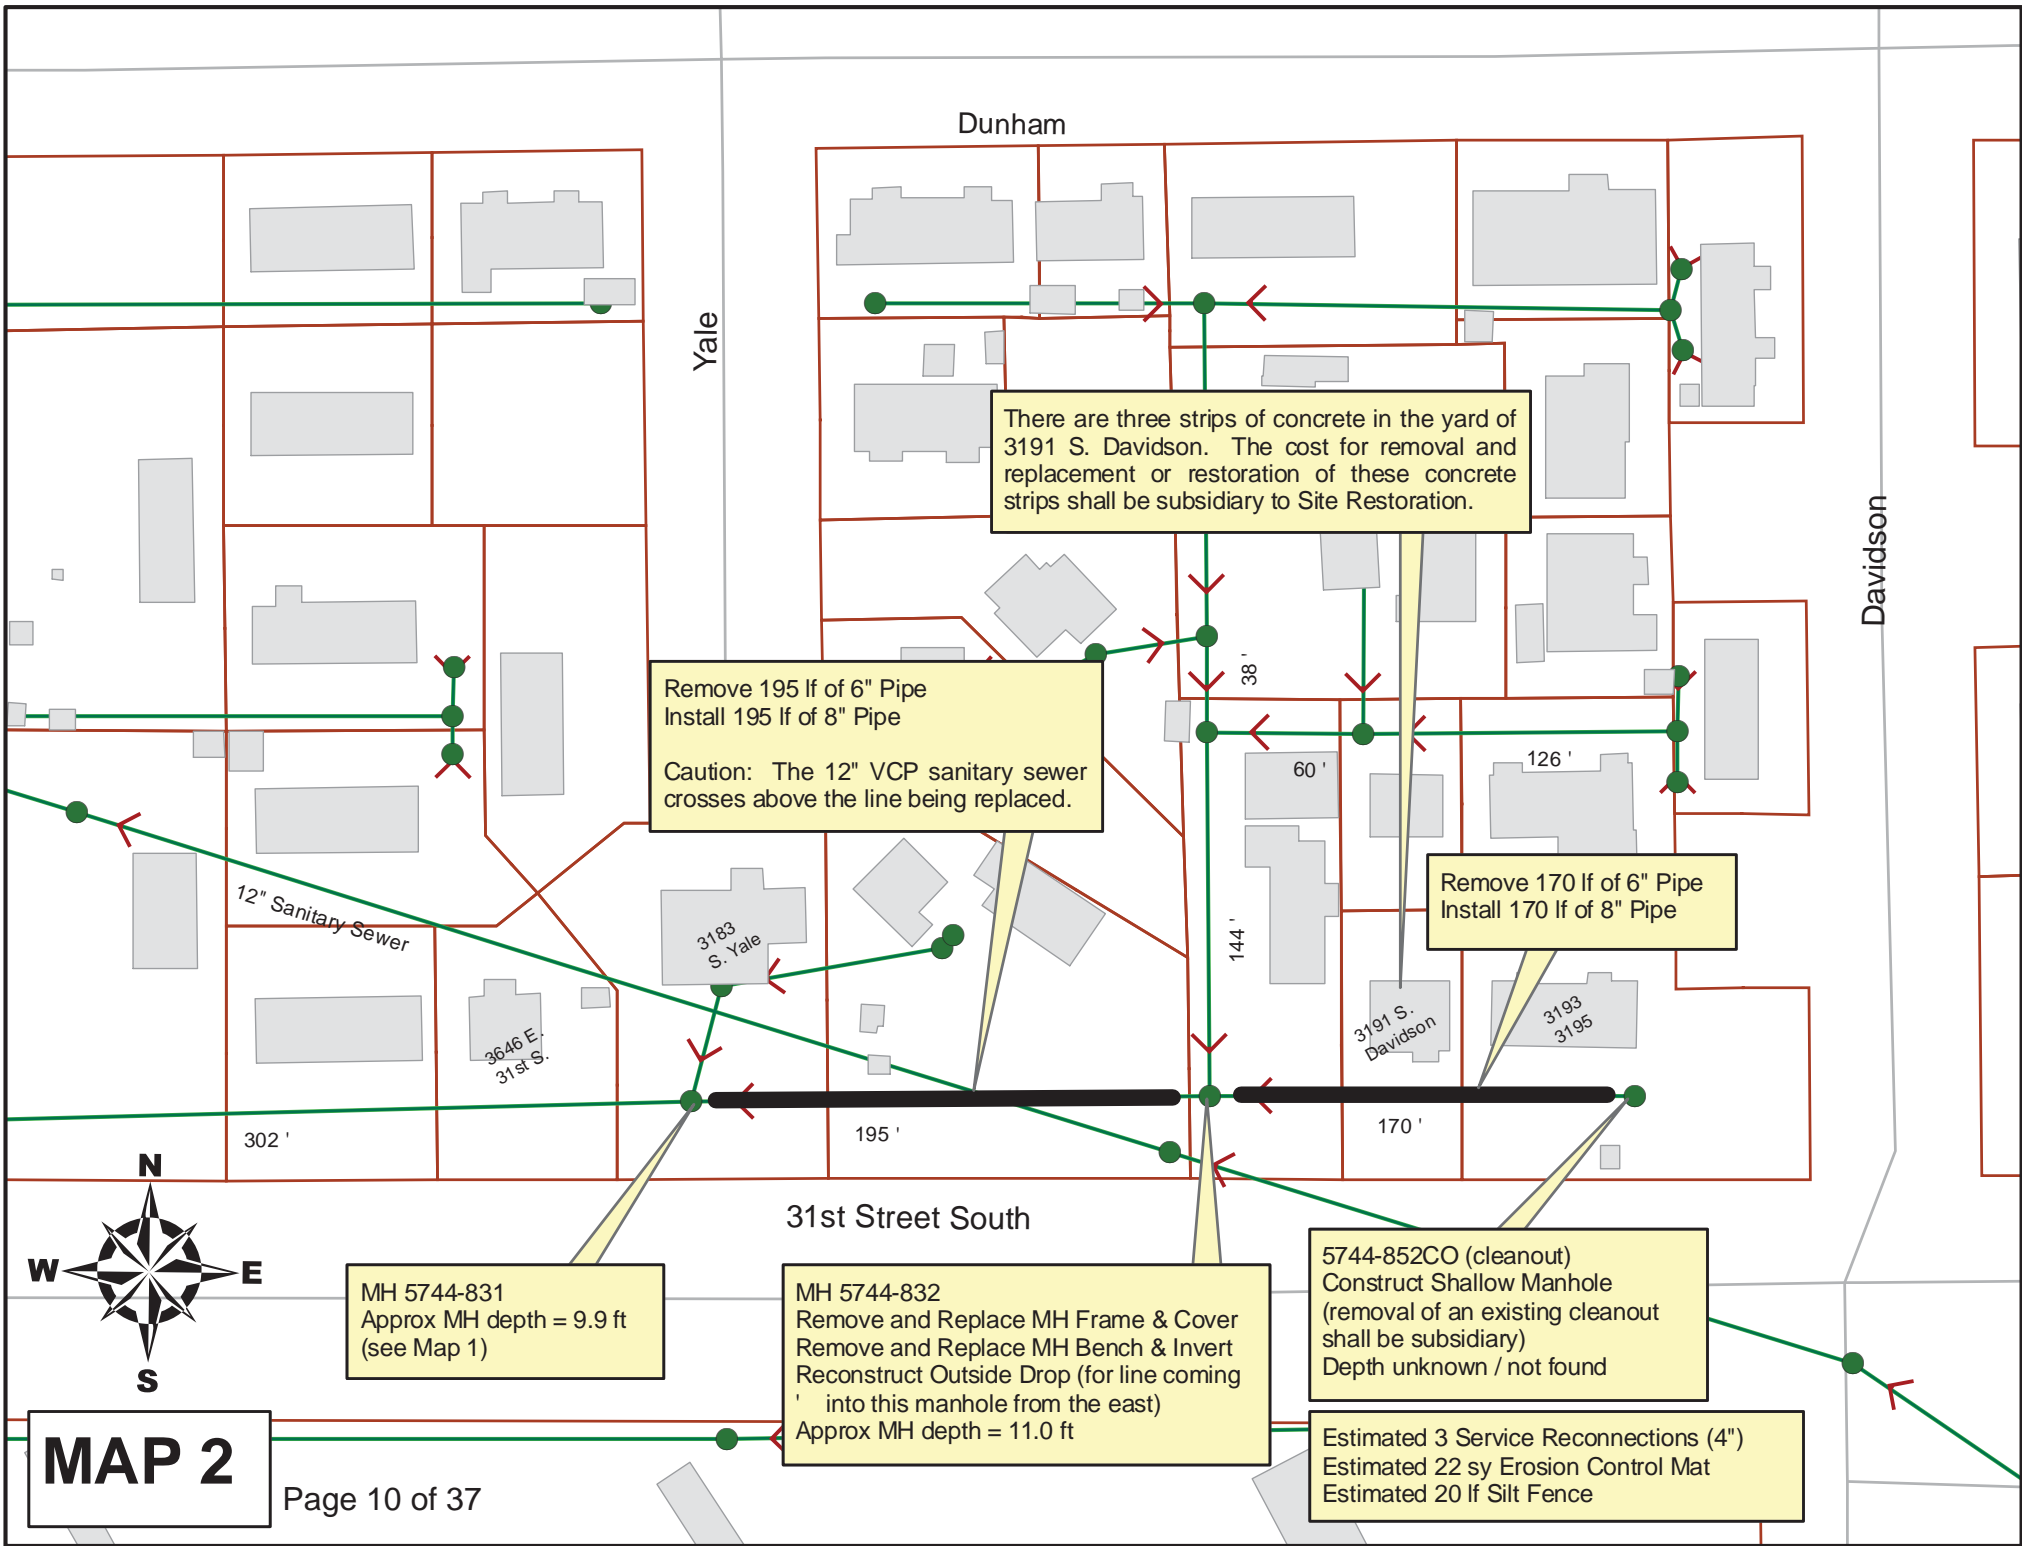
Top of pipe is squashed downward, not enough room for camera to get through. Flowline was OK.

Comments: USMH 5744-832 NEEDS RAISED LINE IN VERY POOR CONDITION BEGINING AT 88 FT TO 93 FT LINE HAS COLLAPSED PIPE AND WE STOPPED INSPECTION WE WILL REVERSE SET-UP TO FINISH INPECTION

Obs. #	VTR	Counter	Distance	Location	Description	Rating	Obsrvd (gpm)	Est. (gpm)	Struct Clean	Clean	Remain (gpm)
1			0.0	US Manhole	5744-832 (in gravel driveway)	1					
2			88.7	Crown	Broken Pipe	4	0.030	78	0	0	0.030
3			91.3	Crown	Collapsed Pipe	5	0.100	400	0	0	0.100
						Comment: DIRT EXPOSED					
4			92.3		Stopped Inspection	5	0.000	0	0	0	0.000
						Comment: DUE TO COLLAPSED PIPE

Comments: REVERSED SET-UP AND HAD TO STOP INSPECTION AT 3 FT DUE TO BAD OFFSET RECOMMEND POINT REPAIR FOR OFFSET UNABLE TO COMPLETE THIS INSPECTION DUE TO COLLAPSED PIPE AT 92 FT WEST OF USHM 5744-832 AND BAD OFFSET AT 3 FT EAST OF DSMH 5744-831

Obs. #	VTR	Counter	Distance	Location	Description	Rating	Obsrvd (gpm)	Est. (gpm)	Struct Clean	Clean	Remain (gpm)
1			0.0	DS Manhole	5744-831	1					
						Comment: AGAINST THE FLOW					
2			3.0	Joint	Severe Offset Joint	5	0.060	100	0	0	0.060
3			3.0		Stopped Inspection	5	0.000	0	0	0	0.000

Remove 195 lf of 6" Pipe  
Install 195 lf of 8" Pipe

Remove 170 lf of 6" Pipe  
Install 170 lf of 8" Pipe

MH 5744-832  
Remove and Replace MH Frame & Cover  
Remove and Replace MH Bench & Invert  
Reconstruct Outside Drop (for line coming ' into this manhole from the east)  
Approx MH depth = 11.0 ft

5744-852CO (cleanout)  
Construct Shallow Manhole  
(removal of an existing cleanout shall be subsidiary)  
Depth unknown / not found

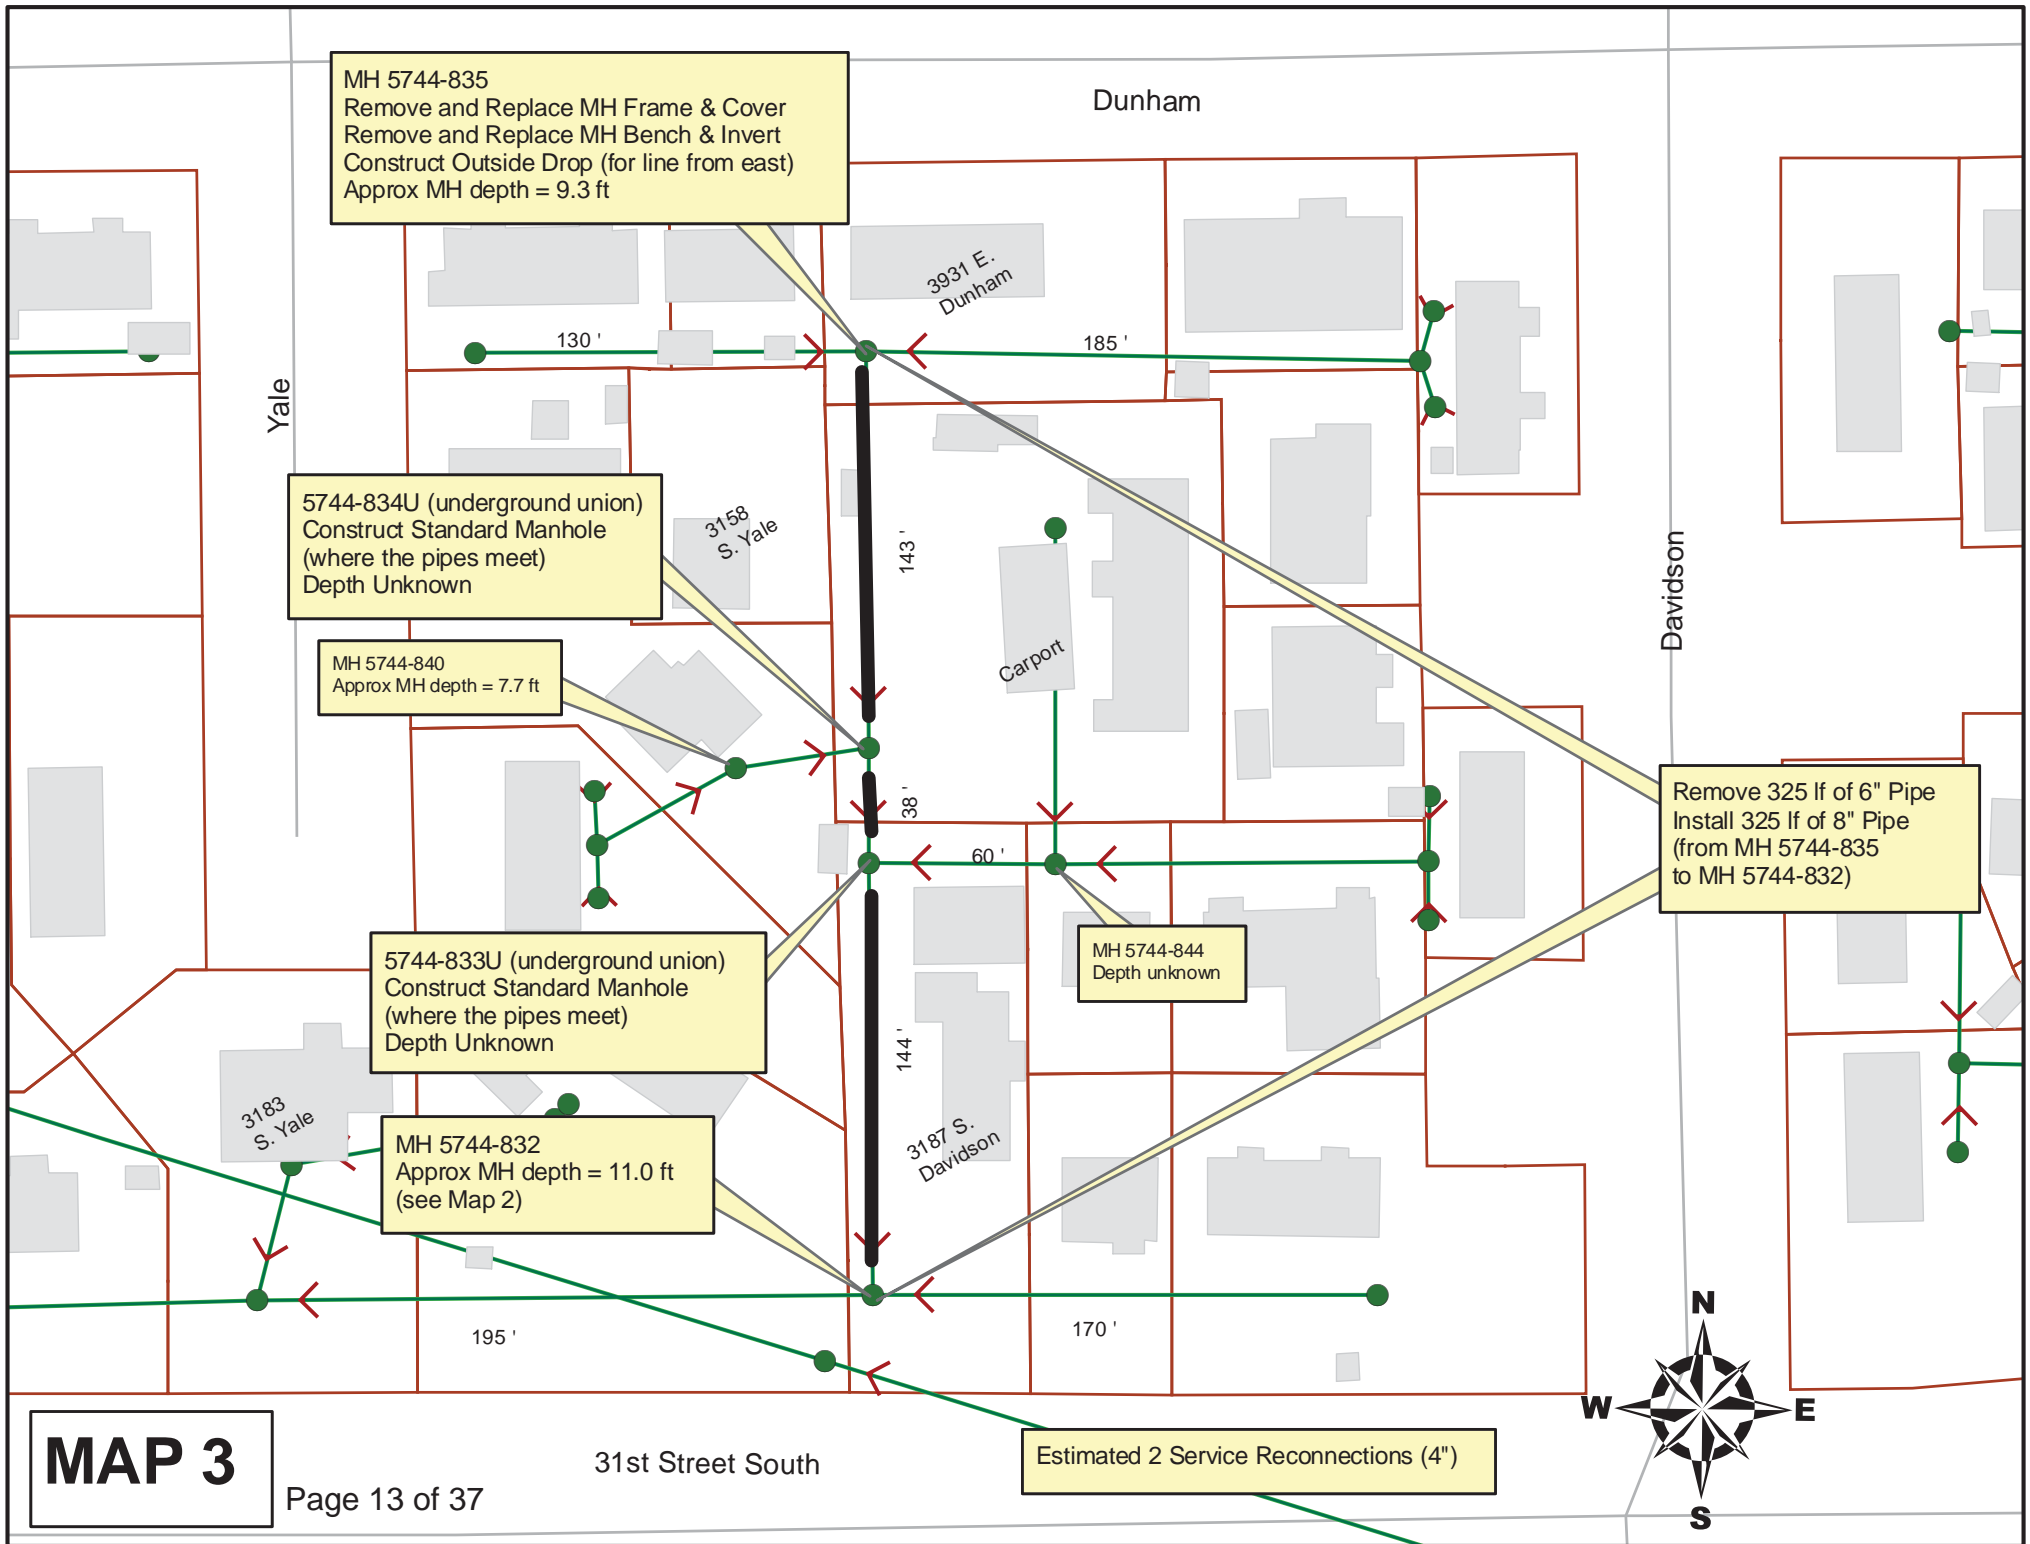
The union area is PVC from a previous point repair. The pipe from the east does not come straight in. It dips downward to get to the level of the north/south pipe.

2		2.3		Material Changes to VCP	0			
3		19.4		Crack-Radial	3			
4		39.3		Debris	3			
5		54.9		E Wye Service	3			
3187 SOUTH DAVIDSON / ball of roots – cannot tell if this is active								
6		80.9		Crack-Horizontal	3			
7		84.6		E Wye Service	3			
3187 SOUTH 31ST SOUTH / possibly active – needs checked								
8		100.3		Broken Pipe	1			
9		143.6		DS Manhole 5744-832	1			
3187 E 31ST SOUTH

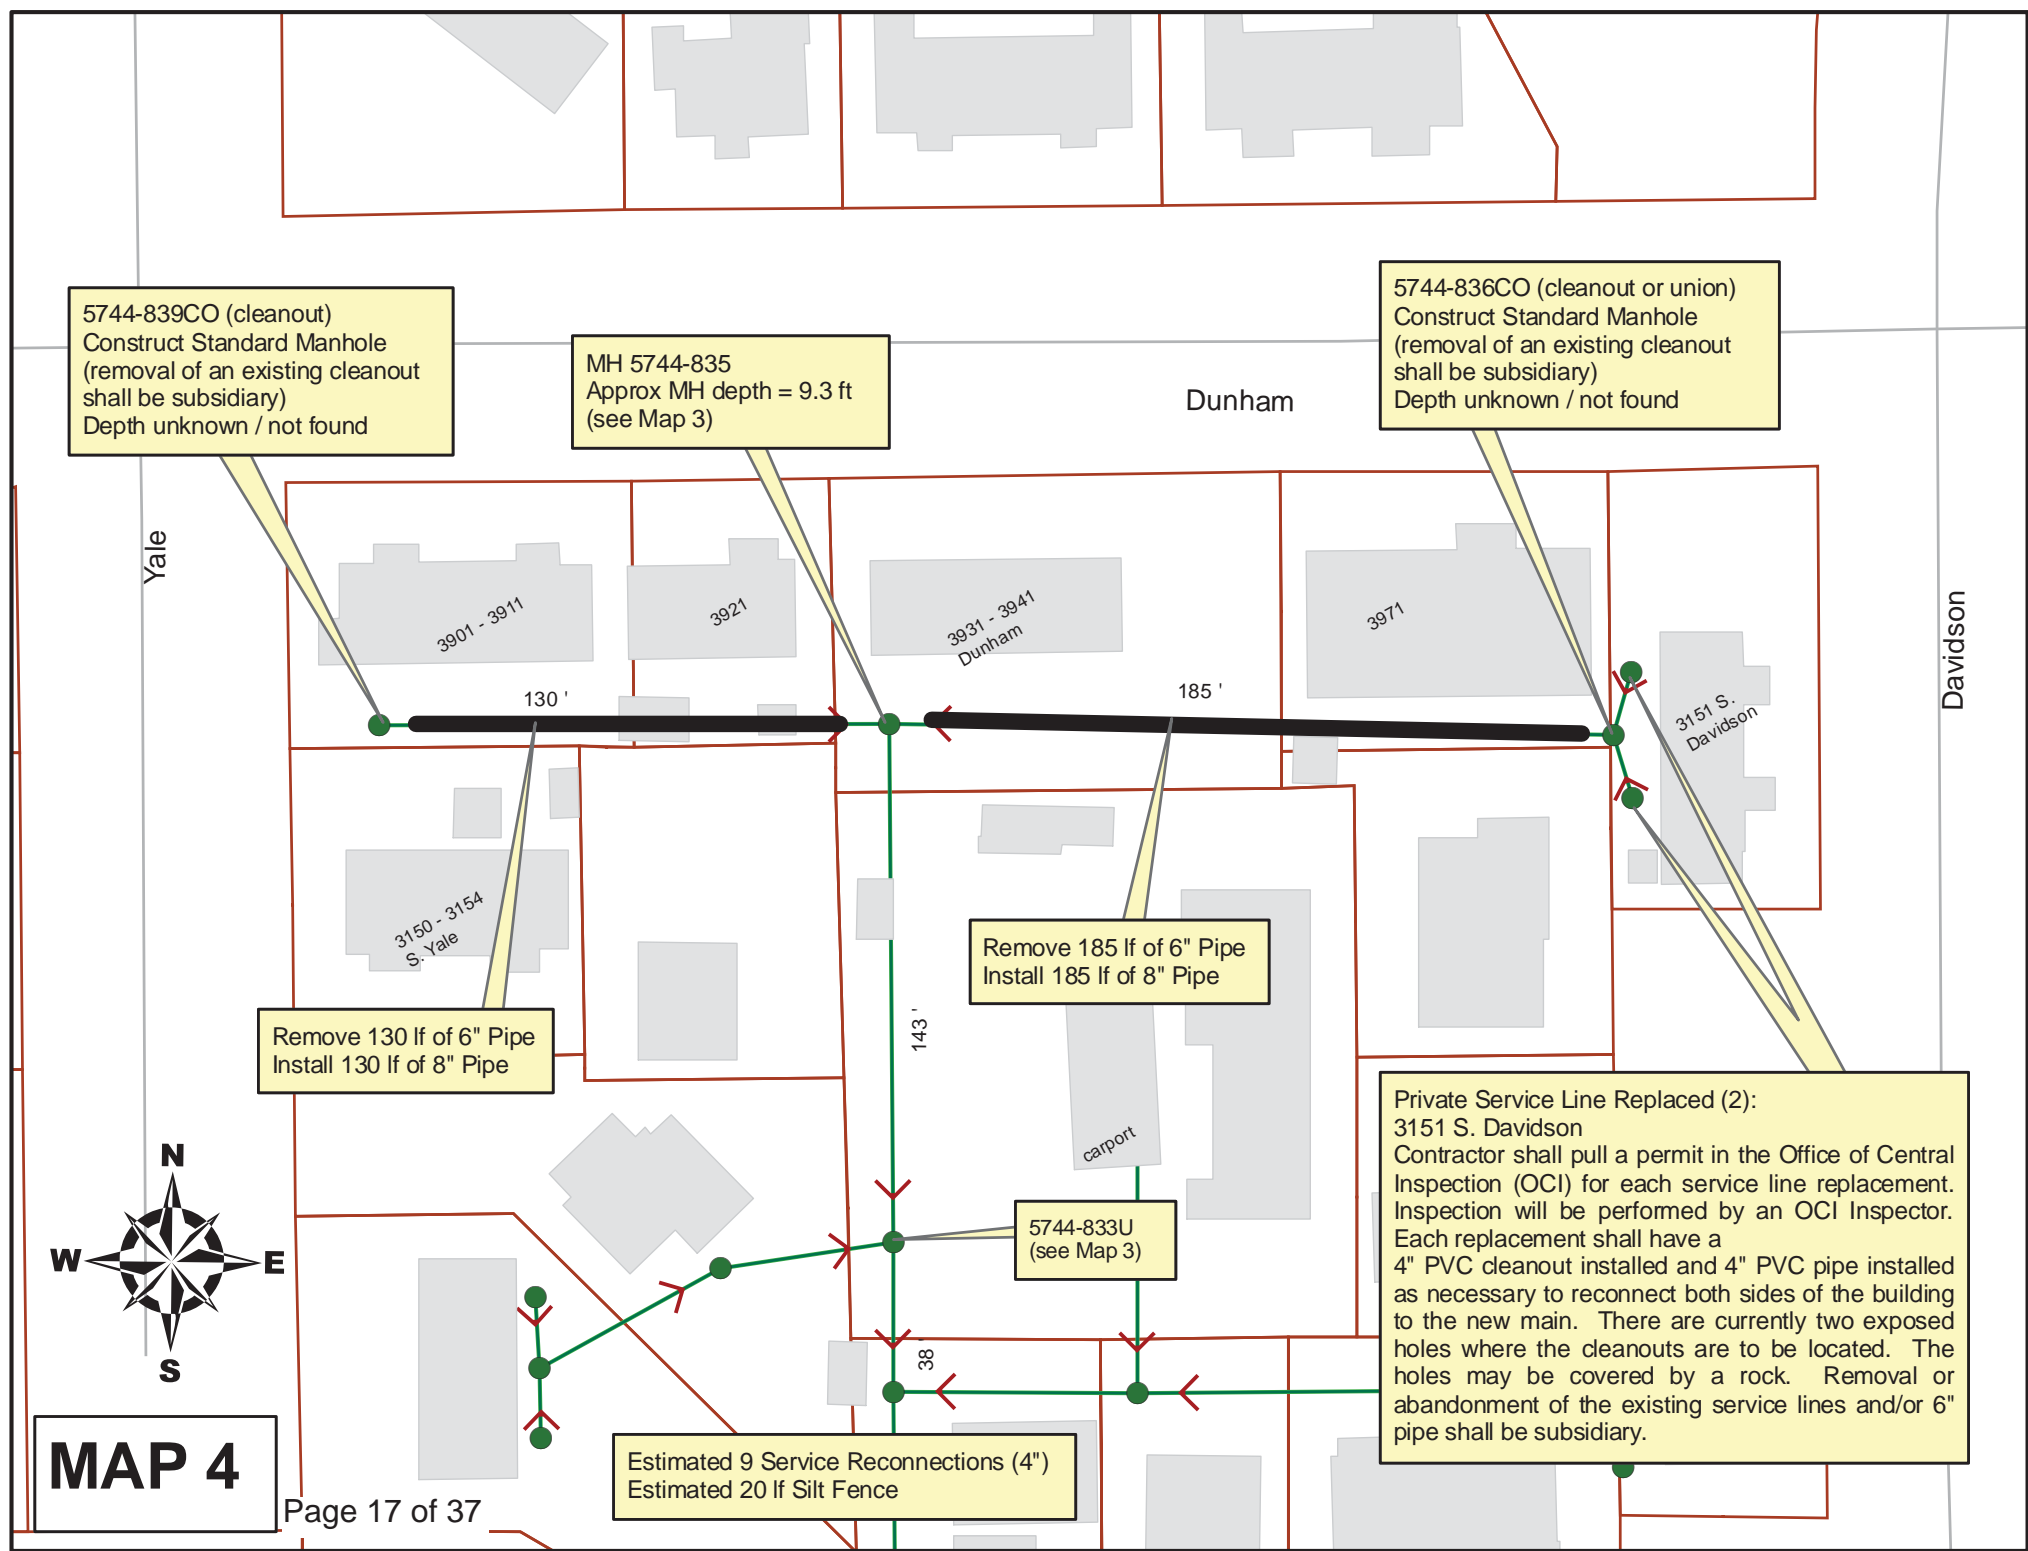
# MAP 4

Obs. #	VTR Counter	Distance	Location	Description	Rating	Ratings				
						Obsrvd (gpm)	Est. (gpm)	Struct Clean	Remain (gpm)	
1		0.0		5744-835 DS Manhole	1	TV AGAINST THE FLOW				
2		3.0	Joint	Offset	3		0.010	20	0	0.010
3		7.4		Crack-Horizontal	4		0.008	10	0	0.008
4		7.9		Broken Pipe	4		0.030	78	0	0.030
5		11.4		Roots	4		0.010	10	25	0.010
6		13.1		Broken Pipe	4		0.030	78	0	0.030
7		15.2		Broken Pipe	4		0.030	78	0	0.030
8		17.3		Broken Pipe	4		0.030	78	0	0.030
9		20.9		Broken Pipe	3		0.010	60	0	0.010
10		28.7		Roots	3		0.008	5	8	0.008
11		30.8		Roots	4		0.010	10	25	0.010
12		35.0	3921 EAST DUNHAM	Wye Service	3		0.000	2	0	0.000
13		35.2		Roots	4		0.010	10	25	0.010
14		38.4		Roots	3		0.008	5	8	0.008
15		70.0		Roots	3		0.008	5	8	0.008
16		72.8		Roots	3		0.008	5	8	0.008
17		87.0	3911 EAST DUNHAM	Wye Service	2		0.000	0	0	0.000
18		87.6		Broken Pipe	3		0.010	60	0	0.010
19		89.7	3154 SOUTH YALE	Break-In Conn	3		0.004	2	0	0.004

20		92.3		Roots	4		0.010	10	25	0.010
21		95.0		Roots	3		0.008	5	8	0.008
22		97.0	3150 SOUTH YALE	Wye Service	3		0.000	2	0	0.000
23		99.6		Roots	4		0.010	10	25	0.010
24		101.9		Roots	3		0.008	5	8	0.008
25		103.9		Roots	4		0.010	10	25	0.010
26		106.8		Roots	3		0.008	5	8	0.008
27		109.8		Roots	3		0.008	5	8	0.008
28		112.2		Roots	3		0.008	5	8	0.008
29		119.7		Roots	3		0.008	5	8	0.008
30		124.0	3901 SOUTH YALE	Wye Service	3		0.000	2	0	0.000
31		125.1	3901 EAST DUNHAM	US cleanout	4		0.000	0	0	0.000
32		125.1	TELEVISION STOPPED	Other / cavity	5		0.000	0	0	0.000

Obs. #	VTR Counter	Distance	Location	Description	Rating	Obsrvd	Est.	Ratings		
						(gpm)	(gpm)	Struct	Clean	Remain
						(gpm)	(gpm)			(gpm)
1		0.0	DS Manhole / TV AGAINST THE FLOW /	3182 SOUTH CLIFTON						
2		8.1	North	Wye Service	5	0.000	400	0	0.000	
						3931 EAST DUNHAM 4" Clay Wye Connection Comment: ROOTS				
3		9.1	Crown	Broken Pipe	3	0.010	60	0	0.010	
4		16.0	Crown	Crack-Horizontal	3	0.004	5	0	0.004	
5		18.4	Crown	Broken Pipe	3	0.010	60	0	0.010	
6		20.7	Crown	Broken Pipe	3	0.010	60	0	0.010	
7		23.4	Crown	Broken Pipe	3	0.010	60	0	0.010	
8		26.0	Crown	Broken Pipe	3	0.010	60	0	0.010	
9		30.7	Crown	Broken Pipe	3	0.010	60	0	0.010	
10		33.6	Crown	Broken Pipe	3	0.010	60	0	0.010	
11		37.4	Crown	Broken Pipe	3	0.010	60	0	0.010	
12		38.7	Crown	Broken Pipe	3	0.010	60	0	0.010	
13		41.5	Crown	Broken Pipe	3	0.010	60	0	0.010	
14		43.8	Crown	Broken Pipe	3	0.010	60	0	0.010	
15		48.1	North	Wye Service	5	0.000	400	0	0.000

3841 EAST DUNHAM 4" Clay Wye Connection Comment: ROOTS				
16		48.4	Upper Right	Broken Pipe	3	0.010	60	0	0.010	
17		58.9	Crown	Broken Pipe	3	0.010	60	0	0.010	
18		60.9	Crown	Broken Pipe	3	0.010	60	0	0.010	
19		63.4	Crown	Broken Pipe	3	0.010	60	0	0.010	
20		65.7	Crown	Broken Pipe	3	0.010	60	0	0.010	
21		75.8	Upper Right	Broken Pipe	3	0.010	60	0	0.010	
22		87.2	Start	Sag	3	0.000	5	0	0.000	
23		95.9	End	Sag	1	0.000	1	0	0.000	
24		155.4	North	Break-In Conn	1	0.001	0	0	0.001	
						3971 EAST DAVIDSON 4" Break In Connection				
25		155.4	South	Break-In Conn	4	0.008	60	0	0.008	
						3157 SOUTH DAVIDSON 4" Break In Connection Comment: OFFSET				
26		160.3	Crown	Crack-Horizontal	3	0.004	5	0	0.004	
27		165.4	Crown	Crack-Horizontal	3	0.004	5	0	0.004	
28		179.8	Invert	Other	1	0.000	0	0	0.000	
						3157 SOUTH DAVIDSON Comment: LINE FROM SOUTH				
29		184.0	Crown	Other	1	0.000	0	0	0.000	
						3151 SOUTH DAVIDSON Comment: LINE FROM NORTH

5744-839CO (cleanout)  
Construct Standard Manhole  
(removal of an existing cleanout shall be subsidiary)  
Depth unknown / not found

5744-836CO (cleanout or union)  
Construct Standard Manhole  
(removal of an existing cleanout shall be subsidiary)  
Depth unknown / not found

Remove 130 lf of 6" Pipe  
Install 130 lf of 8" Pipe

Remove 185 lf of 6" Pipe  
Install 185 lf of 8" Pipe

Private Service Line Replaced (2):  
3151 S. Davidson  
Contractor shall pull a permit in the Office of Central Inspection (OCI) for each service line replacement. Inspection will be performed by an OCI Inspector. Each replacement shall have a 4" PVC cleanout installed and 4" PVC pipe installed as necessary to reconnect both sides of the building to the new main. There are currently two exposed holes where the cleanouts are to be located. The holes may be covered by a rock. Removal or abandonment of the existing service lines and/or 6" pipe shall be subsidiary.

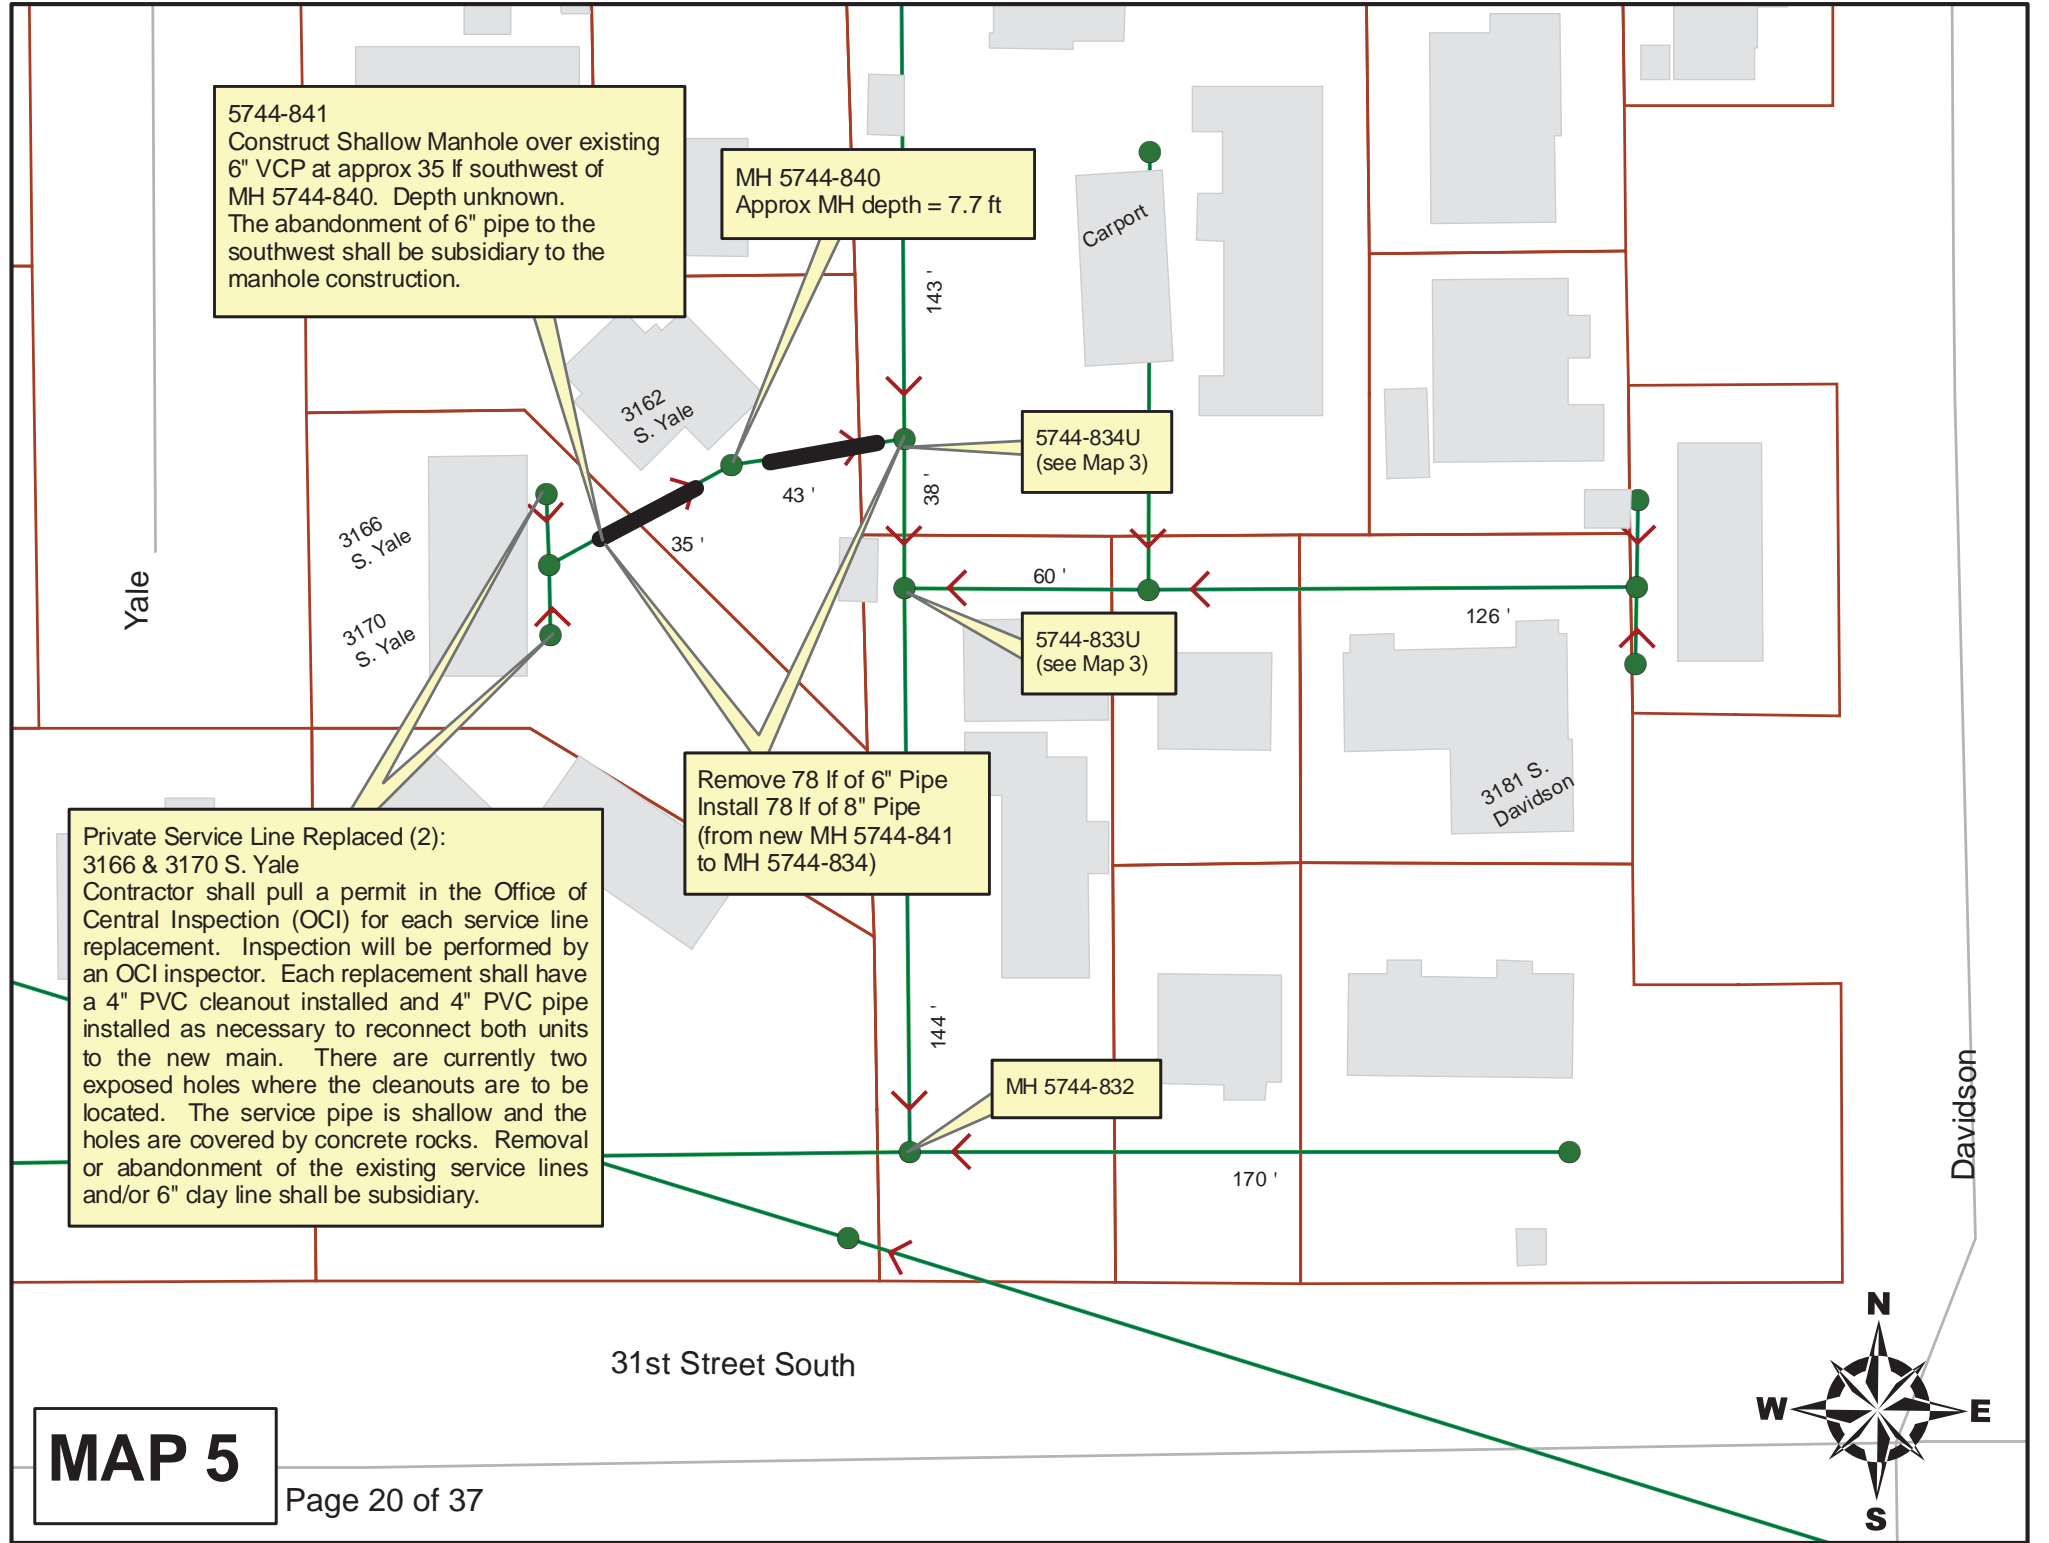
# MAP 5

Obs. #	VTR Counter	Distance	Location	Description	Rating	Ratings				
						Obsrvd (gpm)	Est. (gpm)	Struct Clean	Remain (gpm)	
1		0.0	DS Manhole 5744-840	N/A	2		TV against the flow			
0.00 Manhole tap for 3162 S. Yale										
2		4.0	Invert		3	0.000	5	0	0.000	
3		10.0	End		2	0.000	2	0	0.000	
4		13.0	Camera Blocked / pipe missing	Offset	4	0.030	60	0	0.030	
Camera is climbing a fairly steep incline and cannot get past the offset joint. / stopped inspection

Obs. #	VTR	Counter	Distance	Location	Description	Rating	Ratings				
							Obsrvd (gpm)	Est. (gpm)	Struct	Clean	Remain (gpm)
1			0.0	US Manhole 5744-840	1	0.000	0	0	0	0.000	
2			3.0		Sealed Off Wye North	1	0.000	0	0	0.000	
3			0.0	Joint	Roots	3	0.008	5	8	0.008	
4			10.1	Joint	Roots	3	0.008	5	8	0.008	
5			15.4	Joint	Roots	3	0.008	5	8	0.008	
6			20.4	Joint	Roots	3	0.008	5	8	0.008	
7			23.2	Joint	Roots	4	0.010	10	25	0.010	
8			25.5	Joint	Roots	3	0.008	5	8	0.008	
9			28.5	Joint	Roots	3	0.008	5	8	0.008	
10			33.3	Joint	Roots	3	0.008	5	8	0.008	
11			35.6	Joint	Roots	4	0.010	10	25	0.010	
12			40.8	Joint /Pipe deflects downwards	Roots	4	0.010	10	25	0.010	
Deflection is too steep for camera to go down / pipe may possibly bend again prior to meeting the north/south main.											
13			43.0	DS Underground Union		4	0.000	0	0	0.000

5744-841  
Construct Shallow Manhole over existing 6" VCP at approx 35 lf southwest of MH 5744-840. Depth unknown. The abandonment of 6" pipe to the southwest shall be subsidiary to the manhole construction.

Remove 78 lf of 6" Pipe  
Install 78 lf of 8" Pipe  
(from new MH 5744-841 to MH 5744-834)

Private Service Line Replaced (2):  
3166 & 3170 S. Yale  
Contractor shall pull a permit in the Office of Central Inspection (OCI) for each service line replacement. Inspection will be performed by an OCI inspector. Each replacement shall have a 4" PVC cleanout installed and 4" PVC pipe installed as necessary to reconnect both units to the new main. There are currently two exposed holes where the cleanouts are to be located. The service pipe is shallow and the holes are covered by concrete rocks. Removal or abandonment of the existing service lines and/or 6" clay line shall be subsidiary.

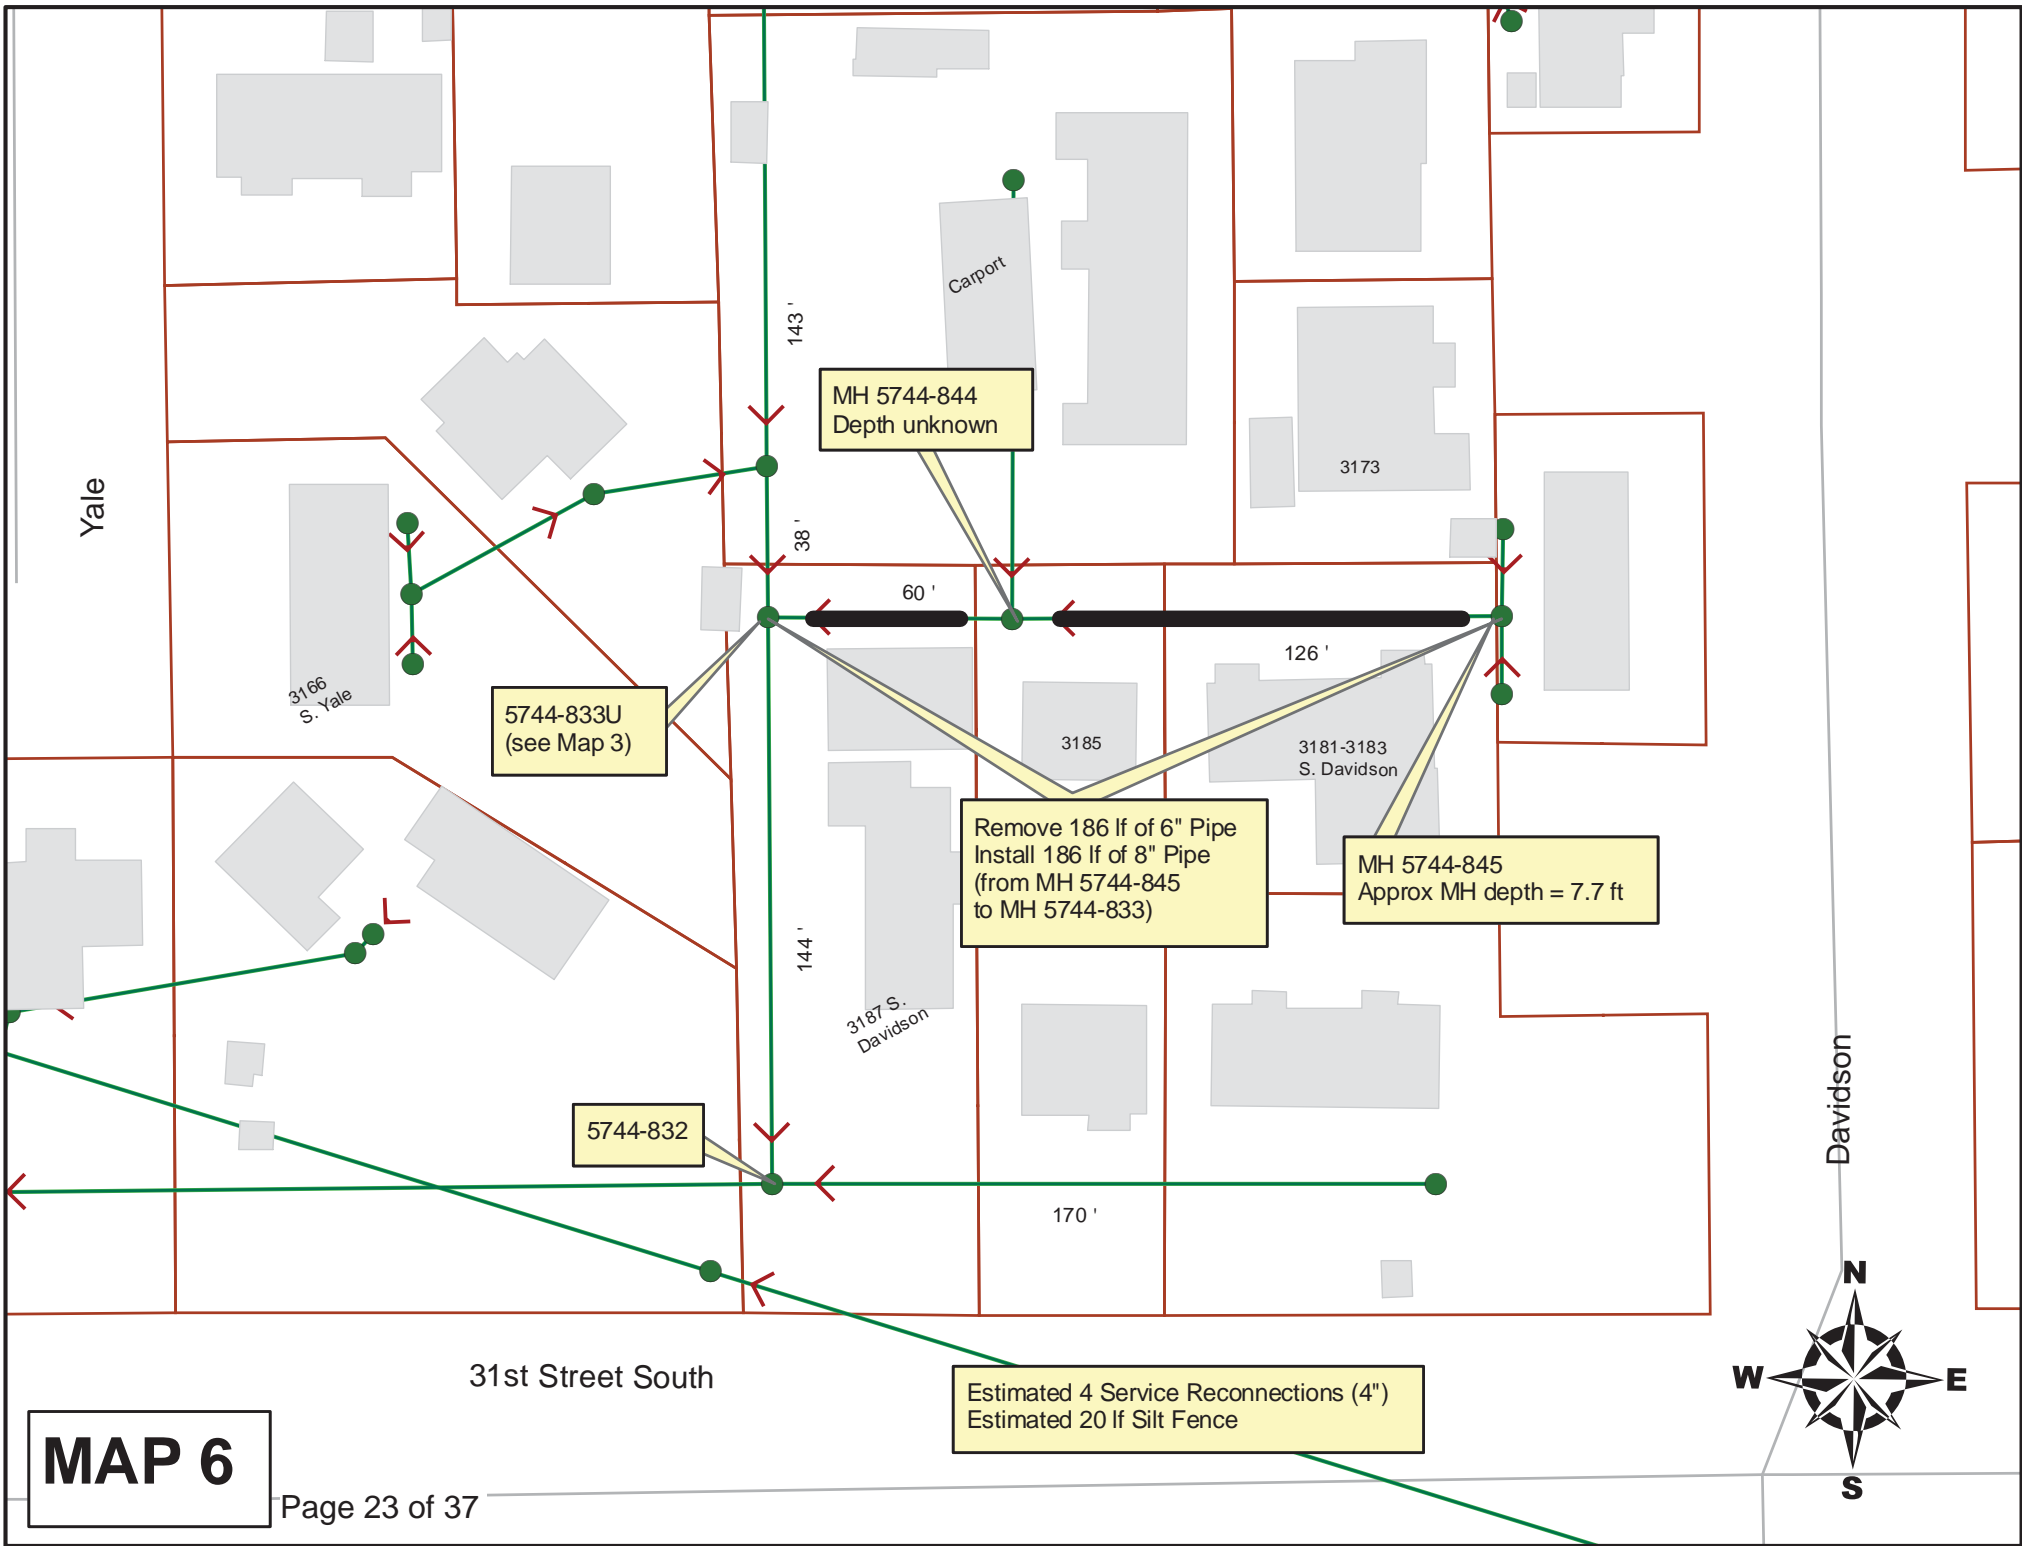
**MAP 6**

Obs. #	VTR Counter	Distance	Location	Description	Rating	Ratings			
						Obsrvd (gpm)	Est. (gpm)	Struct Clean	Remain (gpm)
1		0.0	DS Manhole 5744-844	AGAINST THE FLOW	1	0.000	0	0	0.000
2		0.0	Joint	Roots	4	0.010	10	25	0.010
3		18.5	South	Break-In Conn	1	0.001	0	0	0.001
			3185 SOUTH DAVIDSON	4" Break In Connection					
4		23.2	Lower Right	Broken Pipe	3	0.010	60	0	0.010
5		32.2	Crown	Broken Pipe	4	0.030	78	0	0.030
6		39.2	Crown	Crack-Radial	4	0.008	10	0	0.008
7		60.3	Crown	Broken Pipe	4	0.030	78	0	0.030
8		65.3	South	Wye Service	4	0.000	60	0	0.000
			3183 SOUTH DAVIDSON / roots & offset	4" Clay Wye Connection					
9		67.9	Crown	Broken Pipe	3	0.010	60	0	0.010
10		71.6	Upper Right	Broken Pipe	3	0.010	60	0	0.010
11		73.1	Crown	Broken Pipe	4	0.030	78	0	0.030
12		82.5	Crown	Broken Pipe	3	0.010	60	0	0.010
13		93.6	Upper Left	Prior point repair made here	2	0.000	0	0	0.000
14		96.1	North	Wye Service	1	0.000	0	0	0.000

3173 SOUTH DAVIDSON	4" Clay Wye Connection (connected to PVC service pipe)					
15		96.1	South	Break-In Conn	4	0.008	60	0	0.008
			3181 SOUTH DAVIDSON / broken pipe	4" Break In Connection					
16		96.2	Upper Left	Broken Pipe	4	0.030	78	0	0.030
17		97.9	Upper Left	Broken Pipe	3	0.010	60	0	0.010
18		103.2	Upper Left	Crack-Horizontal	3	0.004	5	0	0.004
19		104.9	Joint	Roots	3	0.008	5	8	0.008
20		116.0	Lower Left	Broken Pipe	4	0.030	78	0	0.030
21		116.0	Joint	Roots	3	0.008	5	8	0.008
22		120.9	Joint	Roots	3	0.008	5	8	0.008
23		123.1	Joint	Roots	3	0.008	5	8	0.008
24		124.2	Upper Right	Broken Pipe	3	0.010	60	0	0.010
25		126.3	US Manhole 5744-845		1

Obs. #	VTR Counter	Distance	Location	Description	Rating	Ratings			
						Obsrvd (gpm)	Est. (gpm)	Struct Clean	Remain (gpm)
1		0.0	US Manhole 5744-844		1	0.000	0	0	0.000
2		6.9	Joint	Roots	4	0.010	10	25	0.010
3		11.8	Crown	Broken Pipe	3	0.010	60	0	0.010
4		16.4	Crown	Broken Pipe	3	0.010	60	0	0.010
5		23.2	Joint	Roots	3	0.008	5	8	0.008
6		27.0	Joint	Roots	3	0.008	5	8	0.008
7		30.3	Joint	Roots	3	0.008	5	8	0.008
8		37.1	Joint	Roots	3	0.008	5	8	0.008
9		44.3	Joint	Roots	3	0.008	5	8	0.008
10		51.8	Crown	PR Starts - Mat. Chngs to PVC	1	0.000	0	0	0.000
11		60.0	DS Structure is an Underground Union (Tee)		1	0.000	0	0	0.000

This pipe turns 90 degrees down, then bends again to get into the N/S main.

Remove 186 lf of 6" Pipe  
Install 186 lf of 8" Pipe  
(from MH 5744-845  
to MH 5744-833)
