MAP 7

Video Inspection Master Report

MAP 8

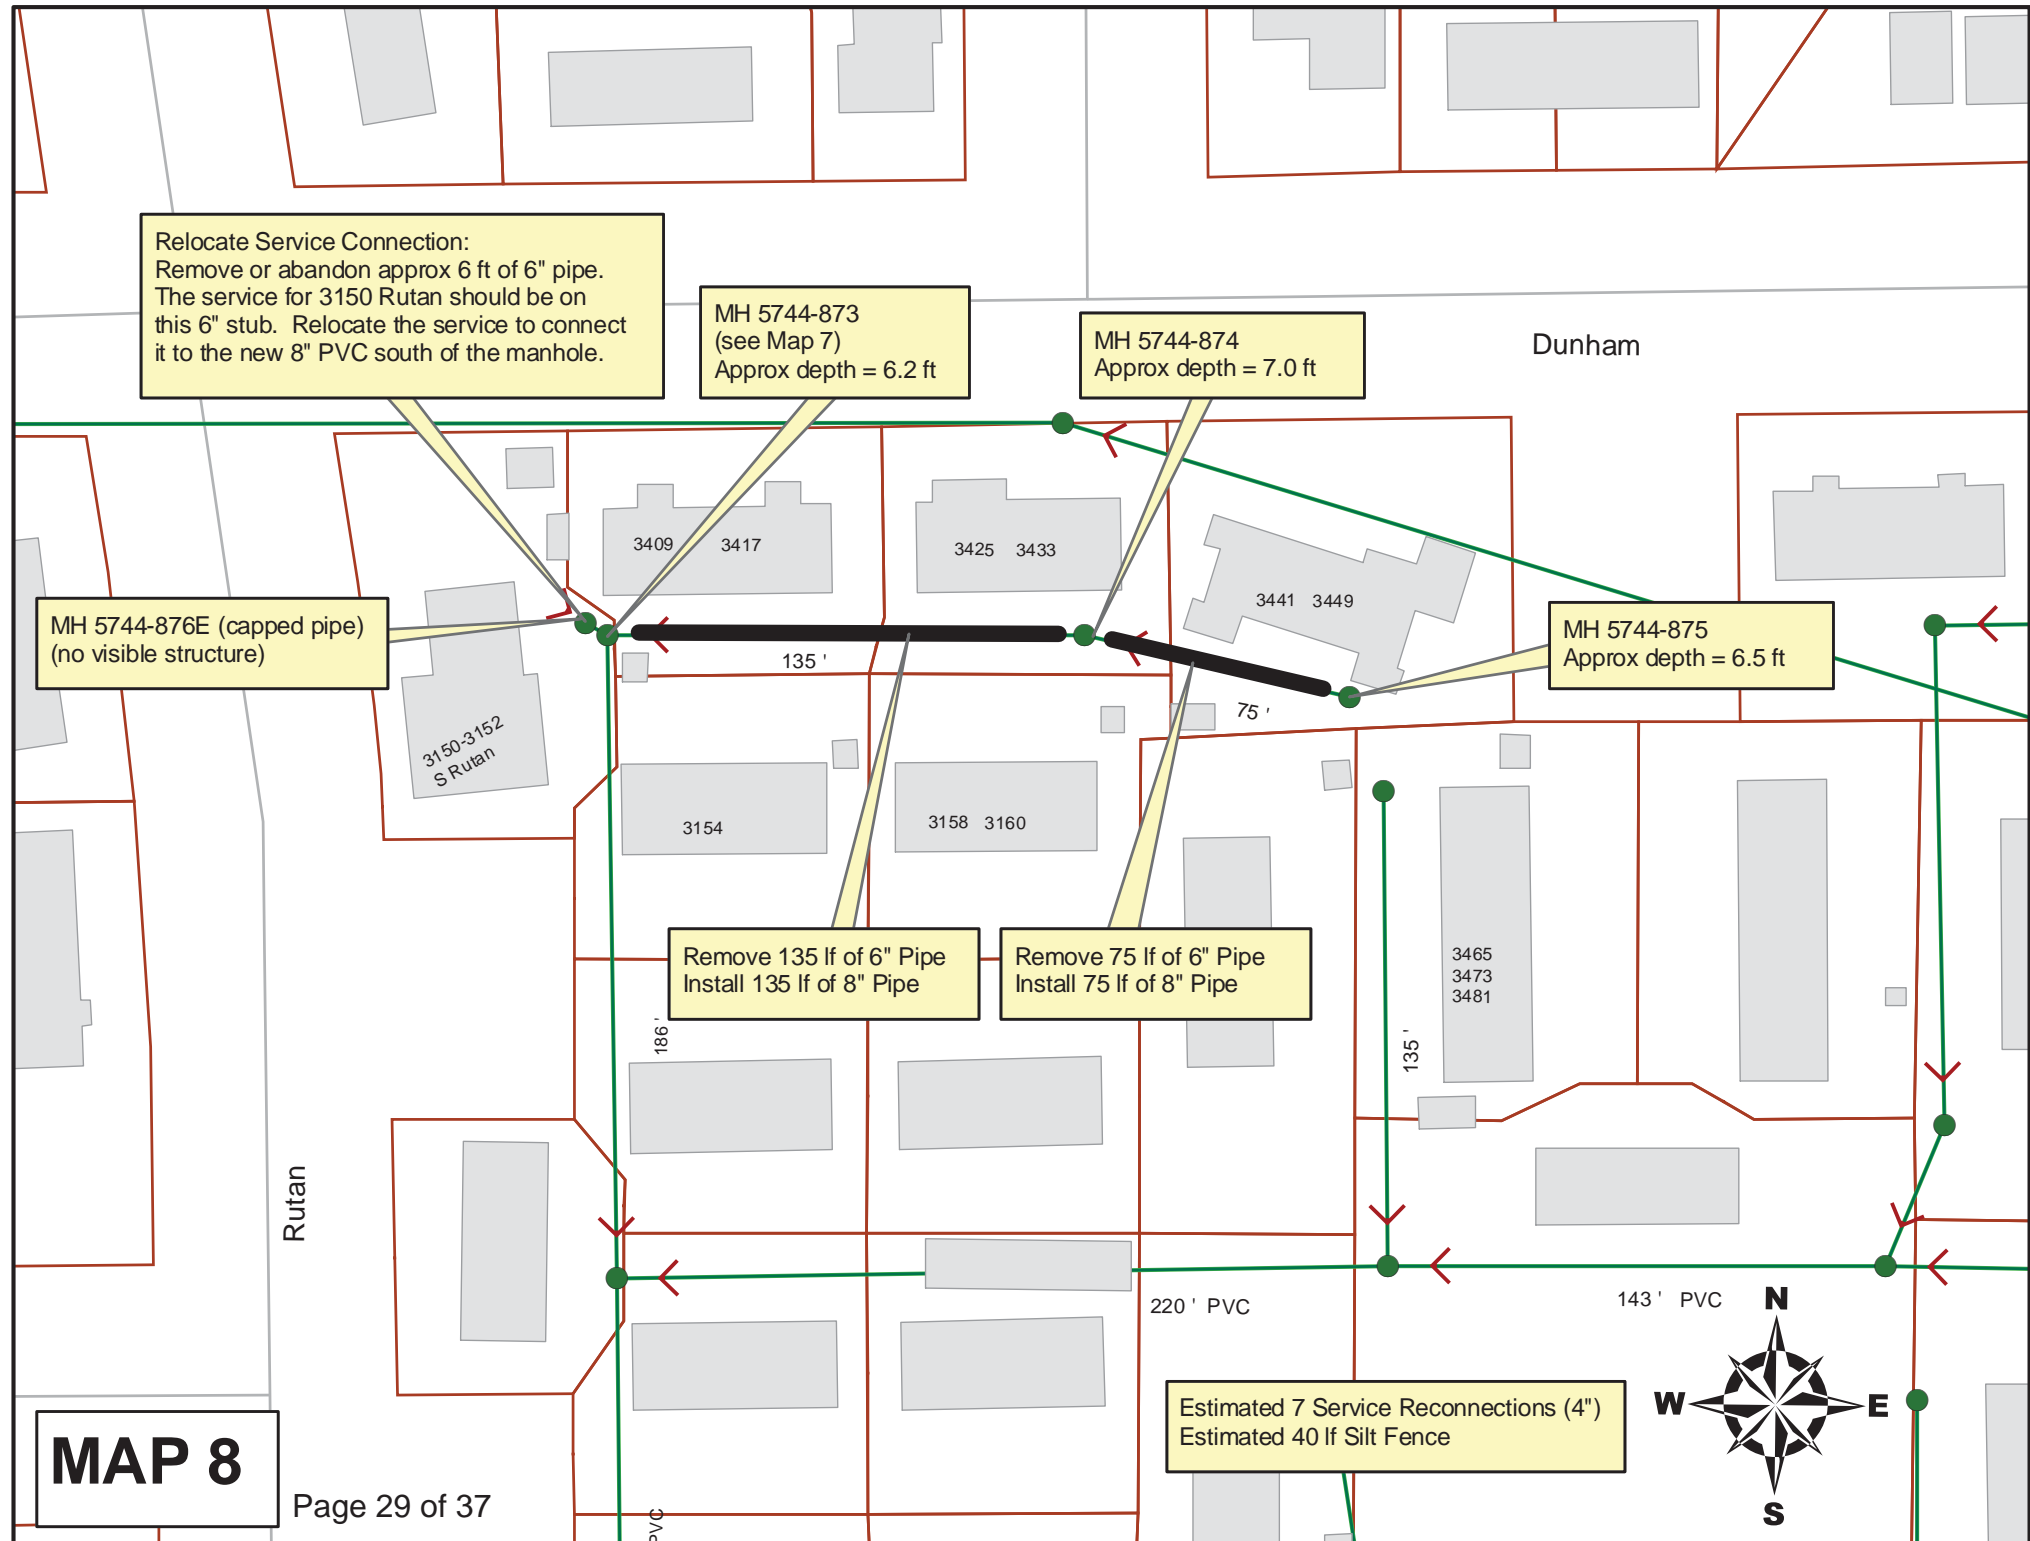
MH 5744-873
(see Map 7)
Approx depth = 6.2 ft

MH 5744-874
Approx depth = 7.0 ft

MH 5744-876E (capped pipe)
(no visible structure)

MH 5744-875
Approx depth = 6.5 ft

Relocate Service Connection:
Remove or abandon approx 6 ft of 6" pipe.
The service for 3150 Rutan should be on
this 6" stub. Relocate the service to connect
it to the new 8" PVC south of the manhole.

Remove 135 lf of 6" Pipe
Install 135 lf of 8" Pipe

Remove 75 lf of 6" Pipe
Install 75 lf of 8" Pipe

Estimated 7 Service Reconnections (4")
Estimated 40 lf Silt Fence
