SITE 2

Install 621 lf of 8" Cured-in-Place Liner

Video Inspection Master Report

Television Inspection Master Report

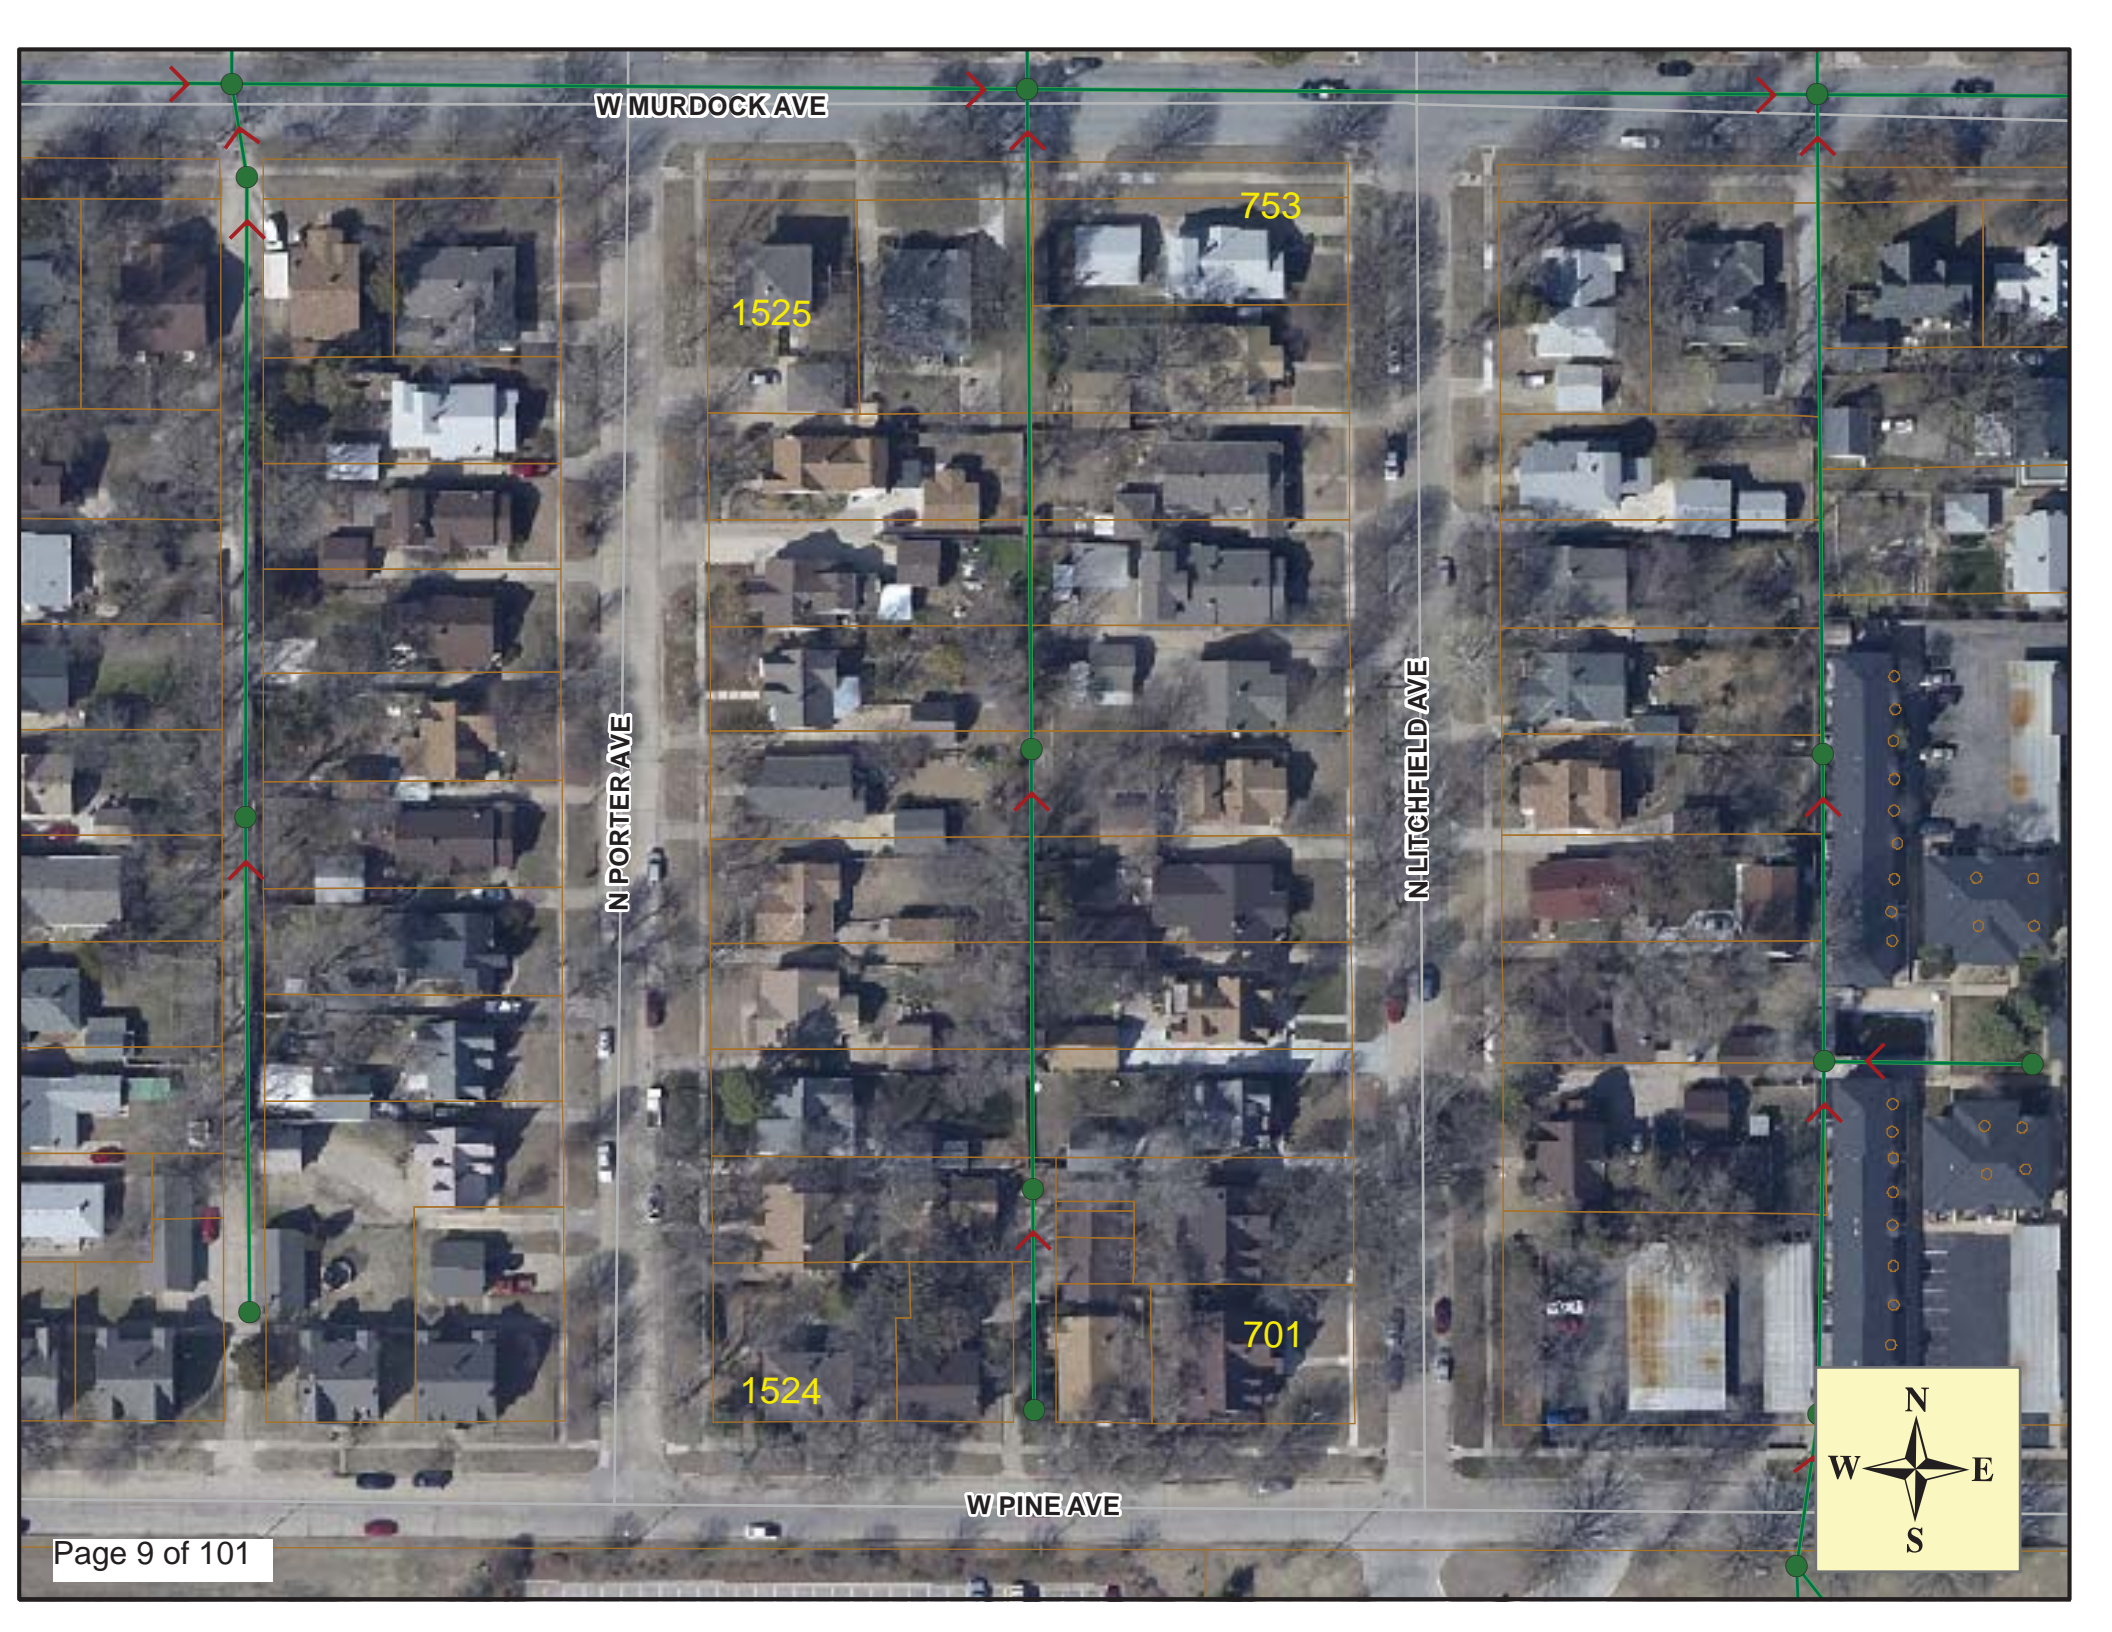
MH 5348-003
Approx MH depth = 8.4

MH 5348-197
733 N. Litchfield
Approx MH depth = 7.7 ft

MH 5348-200
Approx MH depth = 5.3 ft

MH 5348-201
Approx MH depth = 5.5 ft
