SITE 4

Video Inspection Master Report

US Structure: **5348-024** 1046 N AMIDON AVE Date Insp: 6/4/2010 Basin: **C03E**
 DS Structure: **5348-021** 1018 N AMIDON AVE Dir Televised: Upstream To Downstream

US Structure: 5348-070
DS Structure: 5348-067

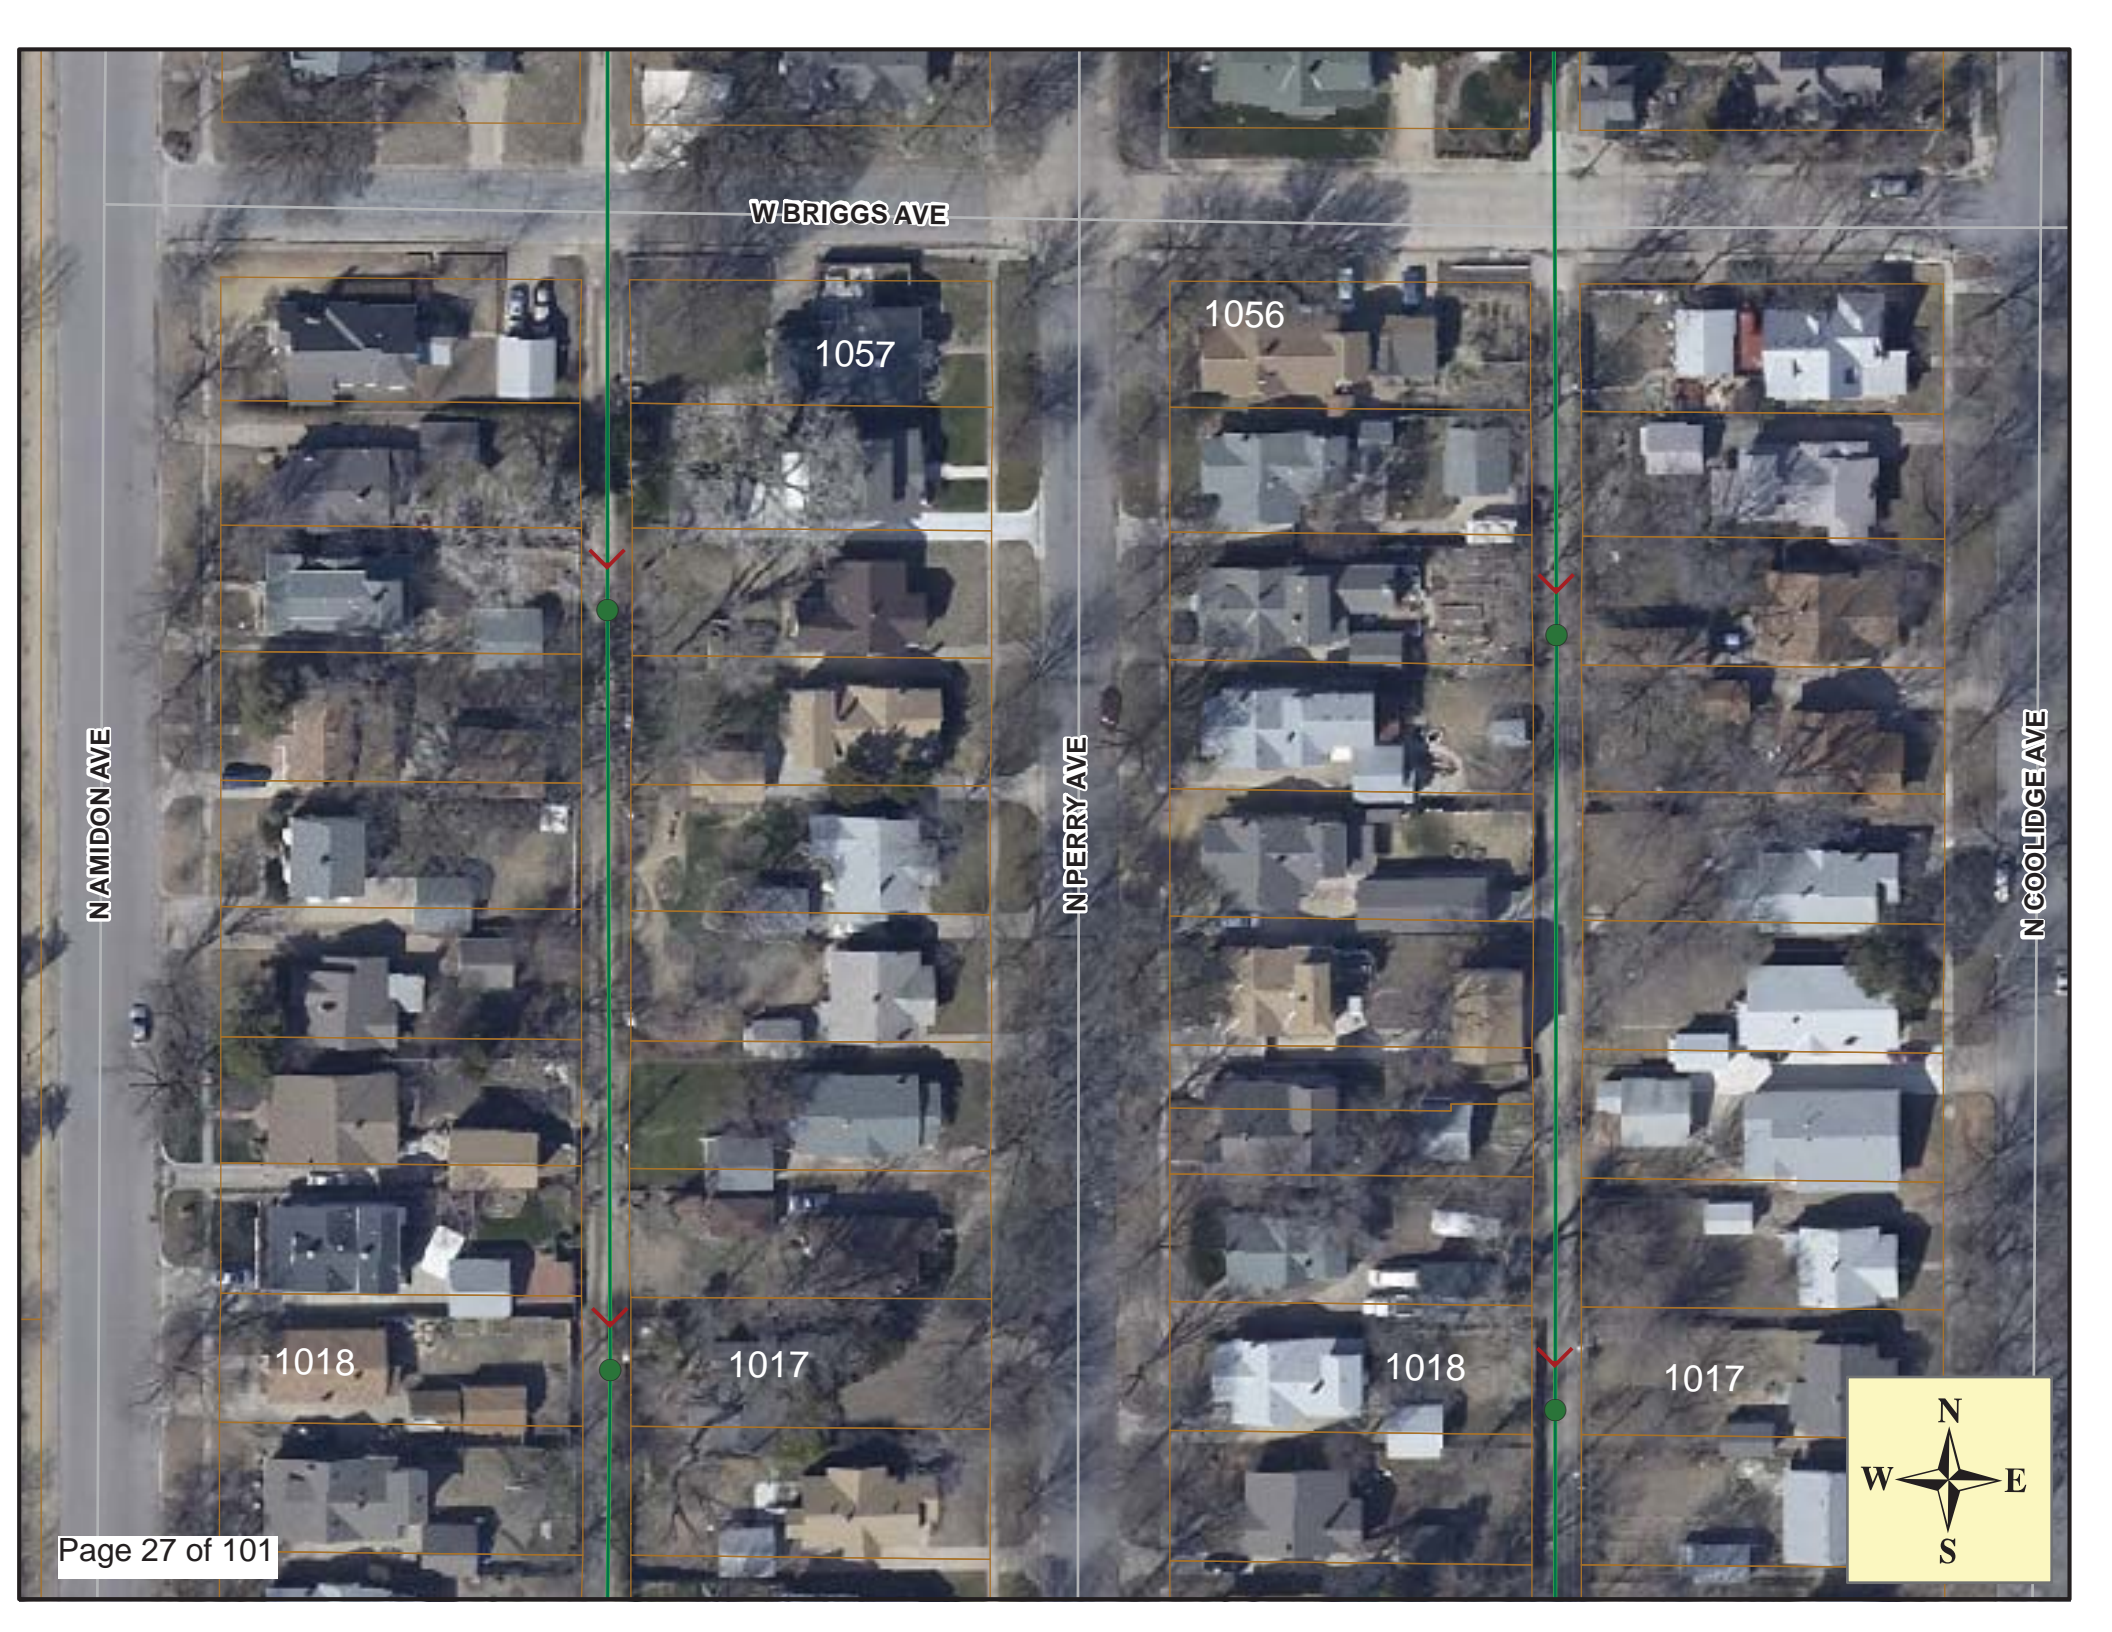
MH 5348-024
Approx. MH depth = 5.9 ft

MH 5348-070
Approx. MH depth = 5.7 ft

MH 5348-021
Approx. MH depth = 4.2 ft

MH 5348-067
Approx. MH depth = 5.9 ft

Install 293 lf of 8"
Cured-in-Place Liner

Install 298 lf of 8"
Cured-in-Place Liner
