Install 910 lf of 8"
Cured-in-Place Liner

SITE 5

Video Inspection Master Report

US Structure: 5348-015 932 N AMIDON ST Date Insp: 6/7/2010 Basin: C03E
 DS Structure: 5348-012 858 N AMIDON AVE Dir Televised: Upstream To Downstream

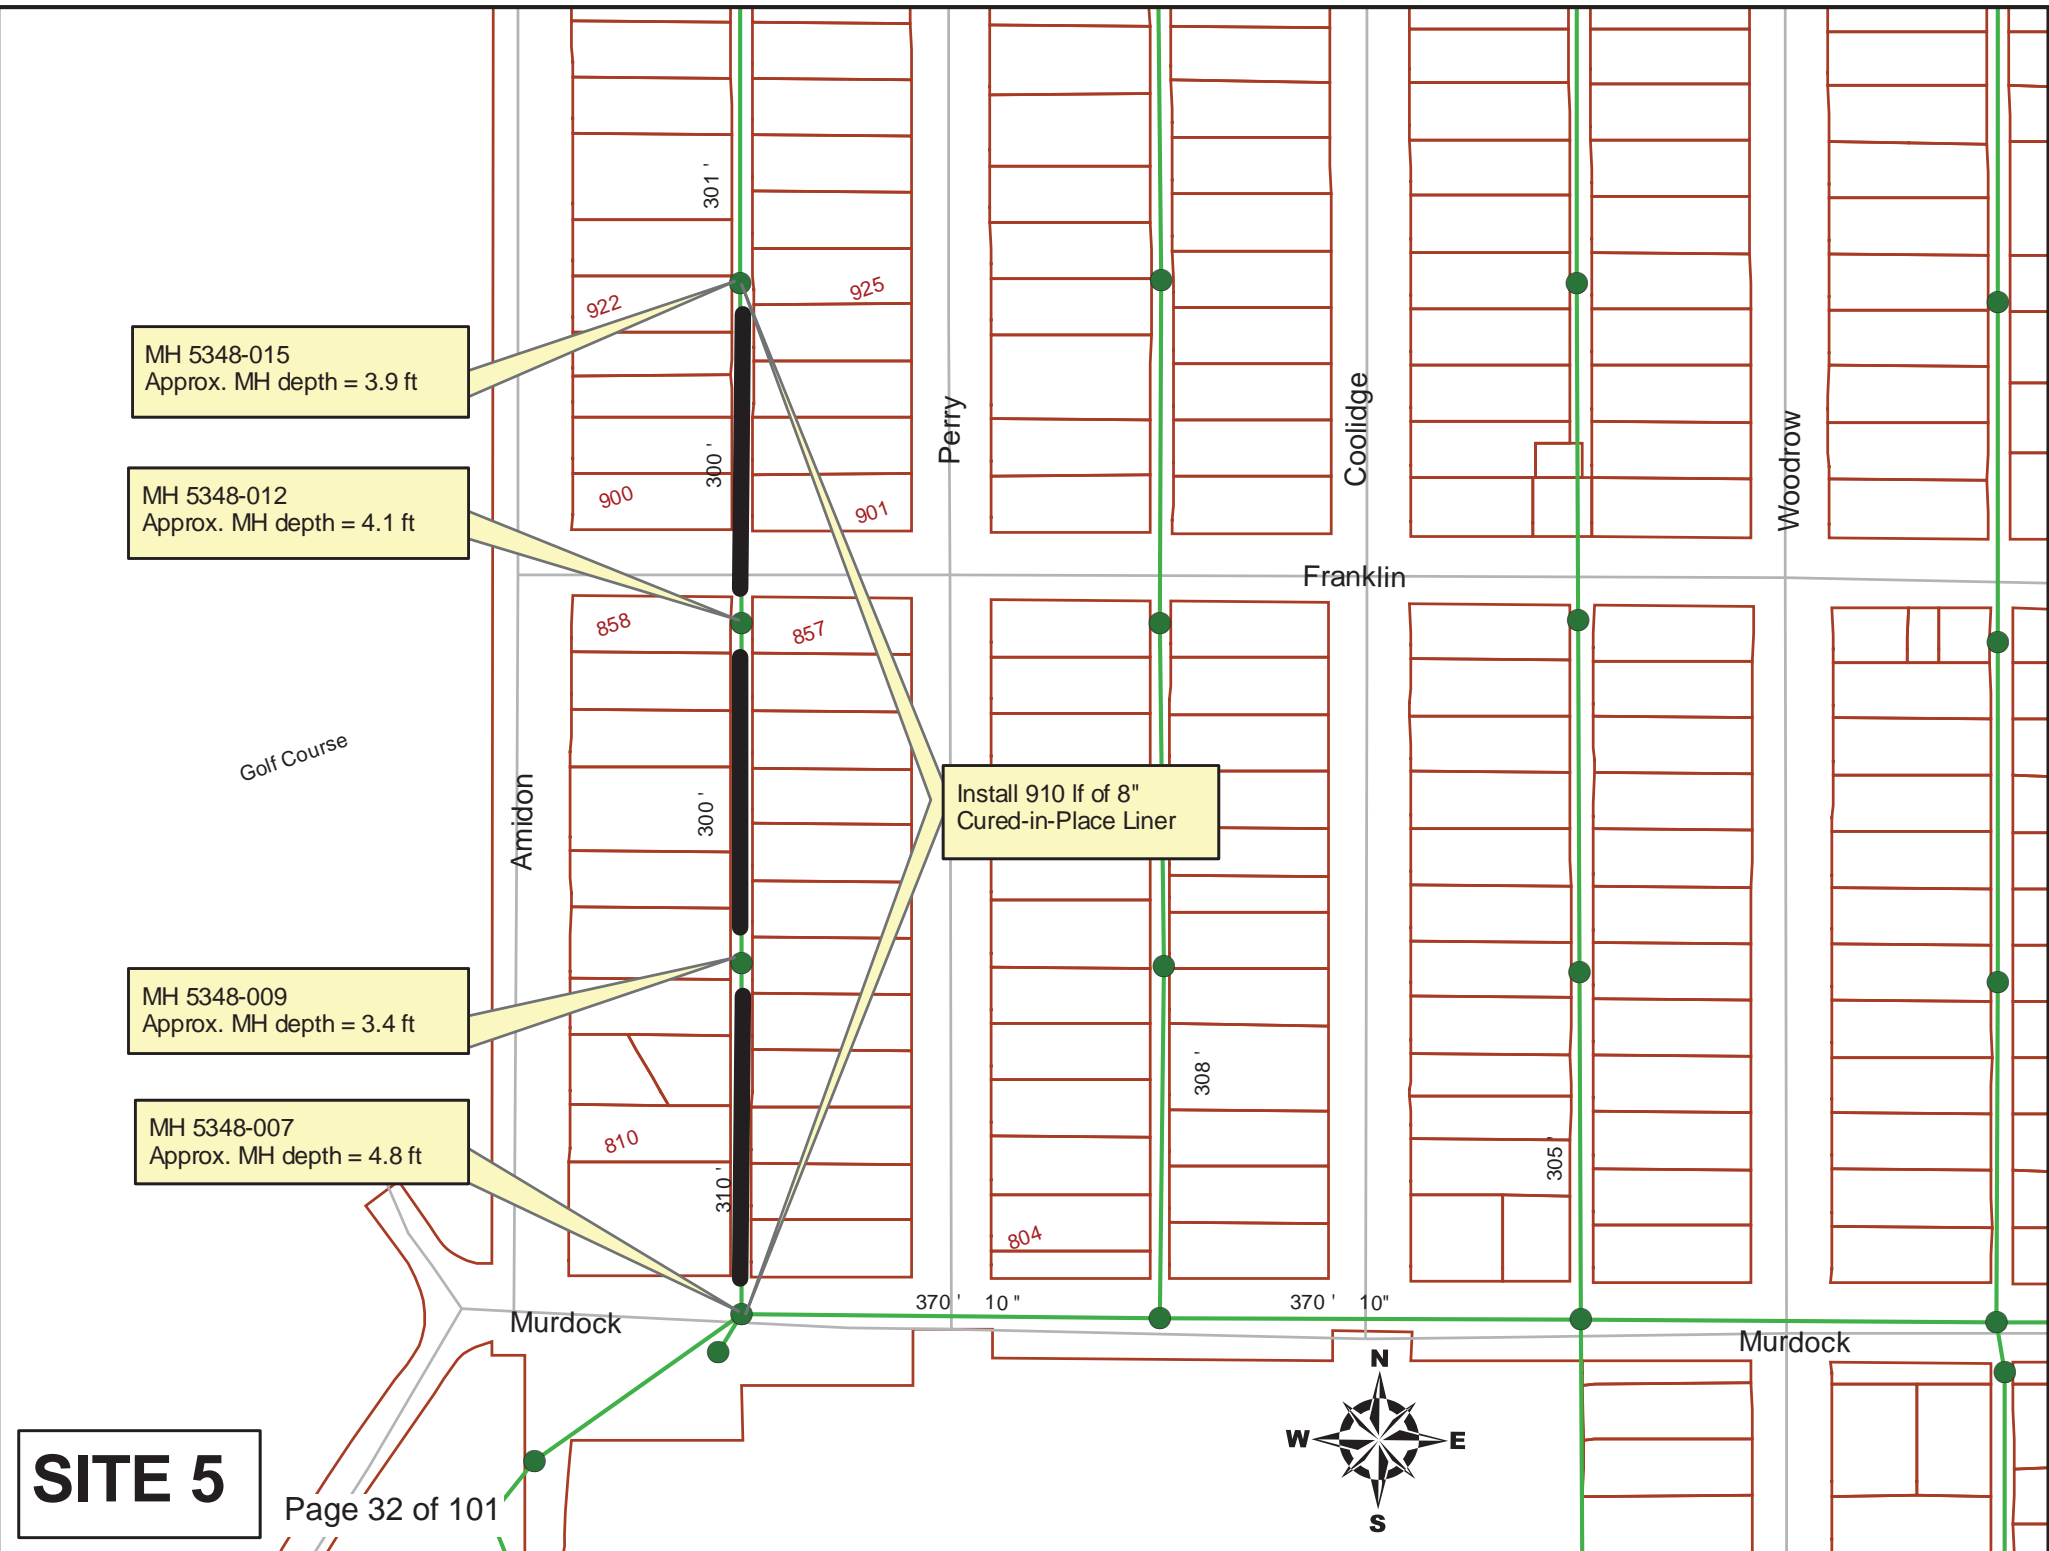
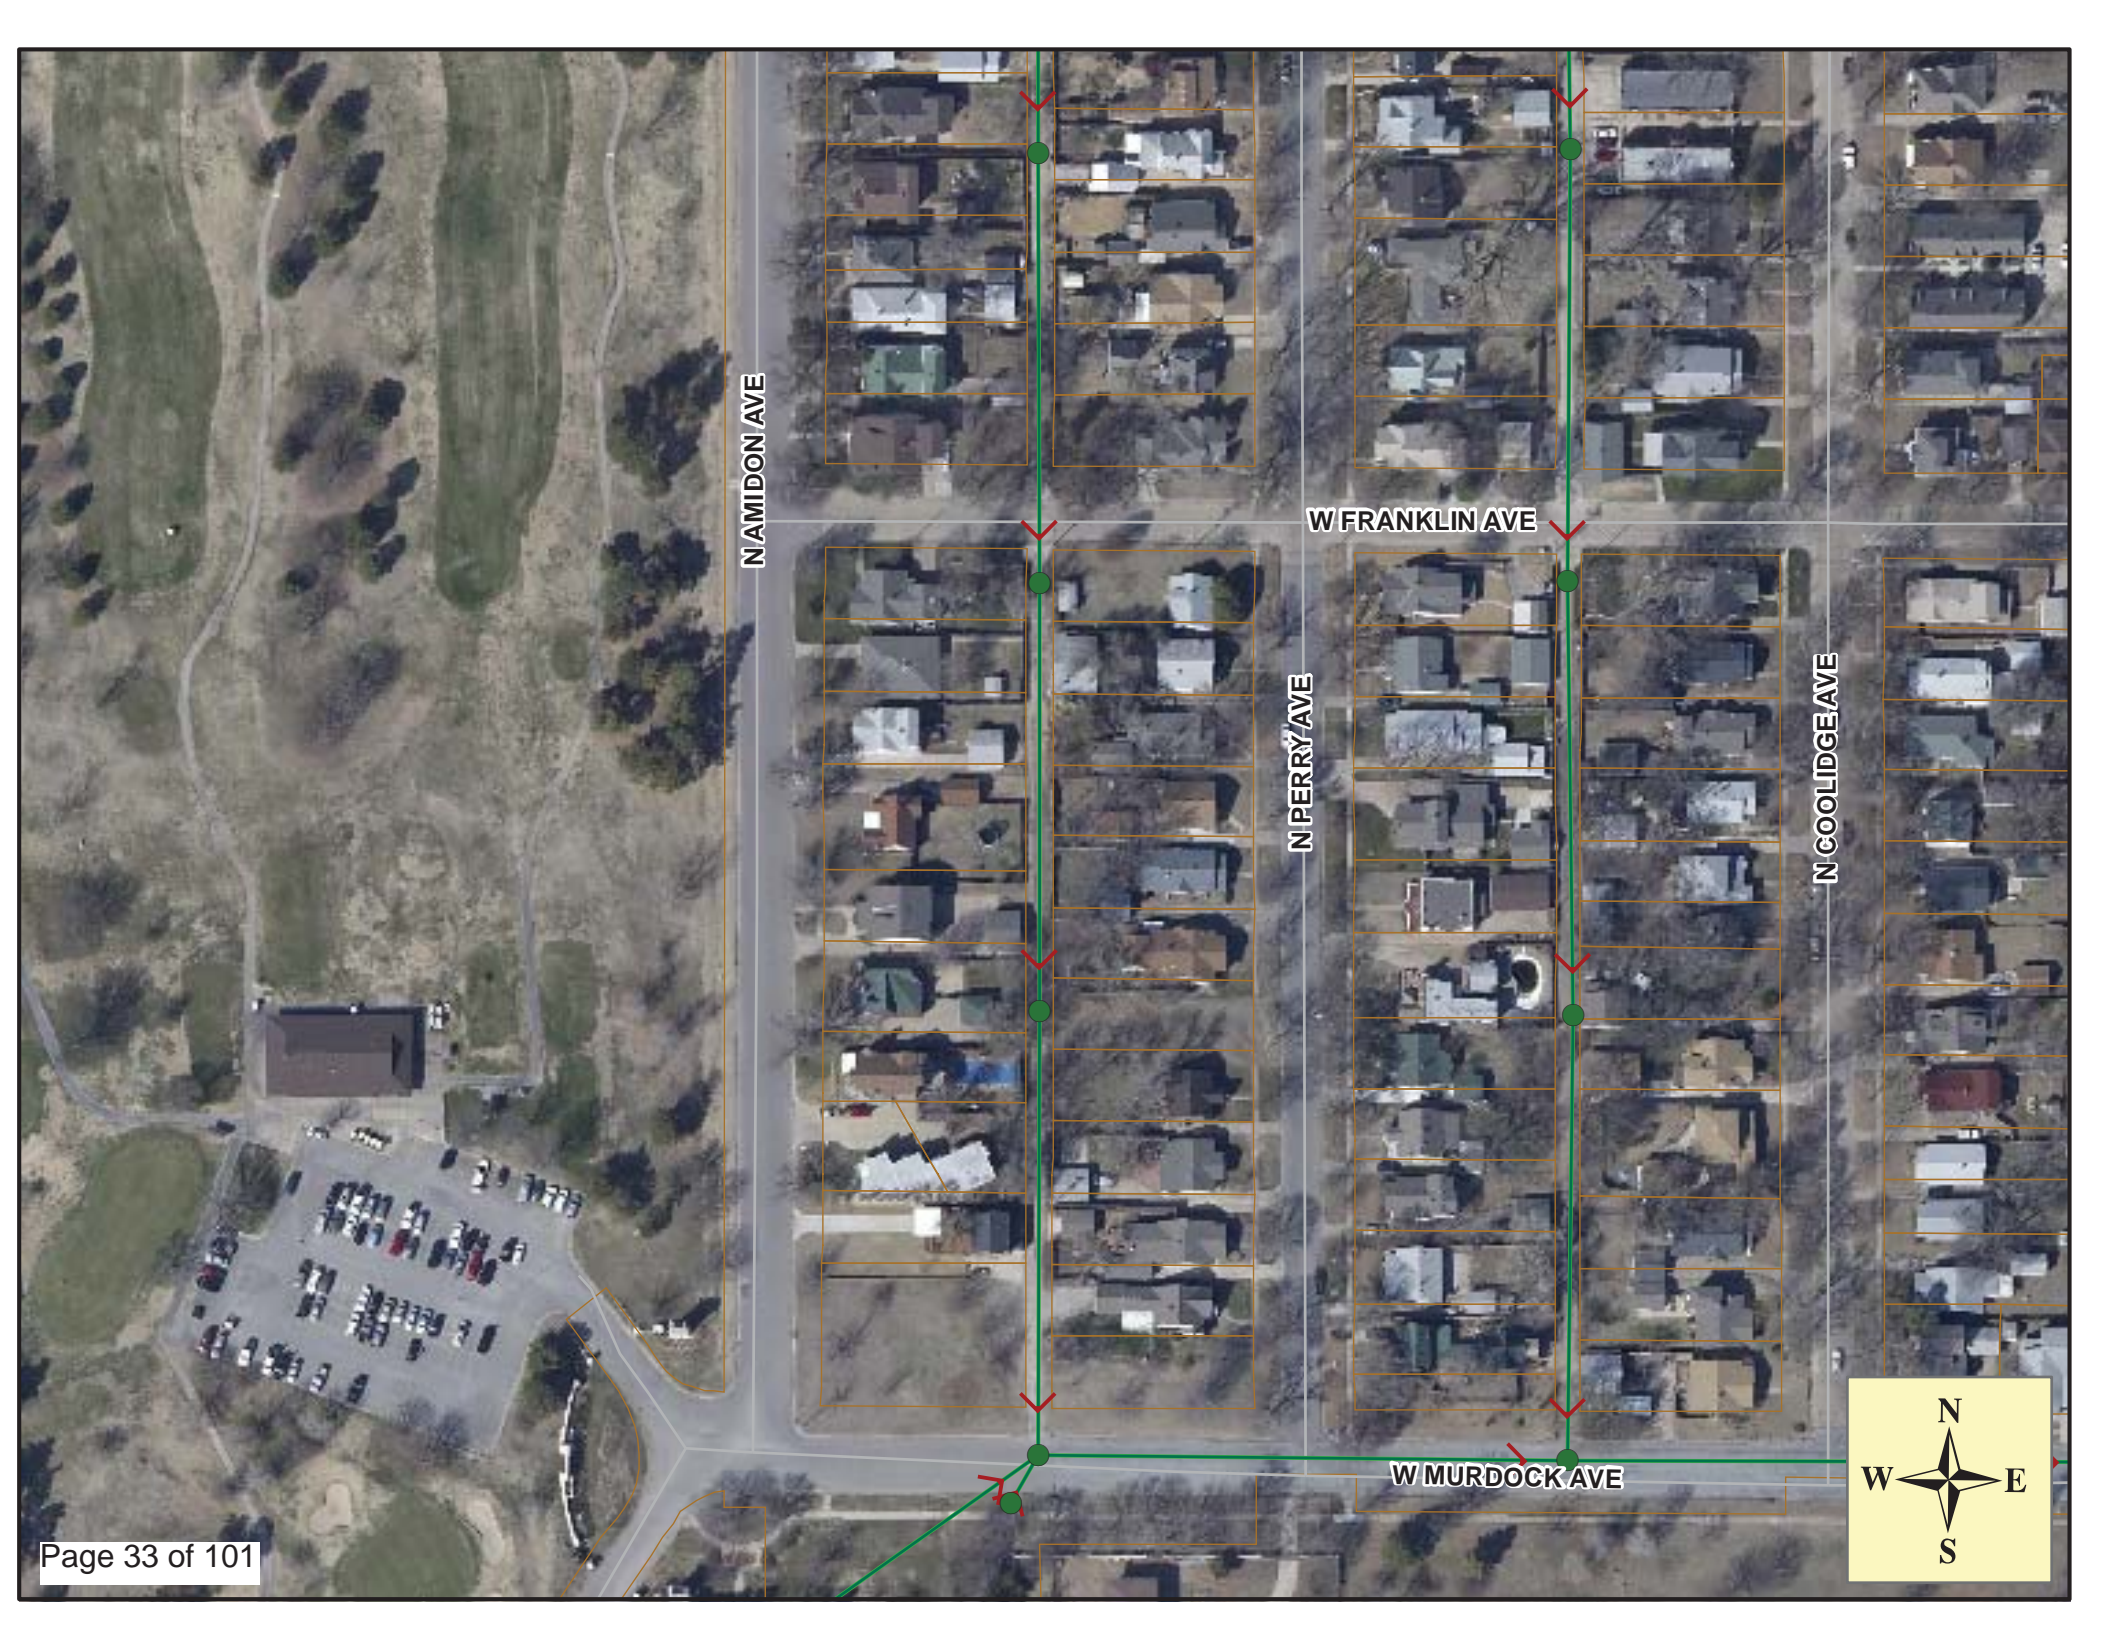
MH 5348-015
Approx. MH depth = 3.9 ft

MH 5348-012
Approx. MH depth = 4.1 ft

MH 5348-009
Approx. MH depth = 3.4 ft

MH 5348-007
Approx. MH depth = 4.8 ft
