Install 734 lf of 8"
Cured-in-Place Liner

SITE 6

Television Inspection Master Report

Project No. : B-223 Dia/Ht: 8 Material: VCP Length: 362.6 Tape ID: DVD #0585

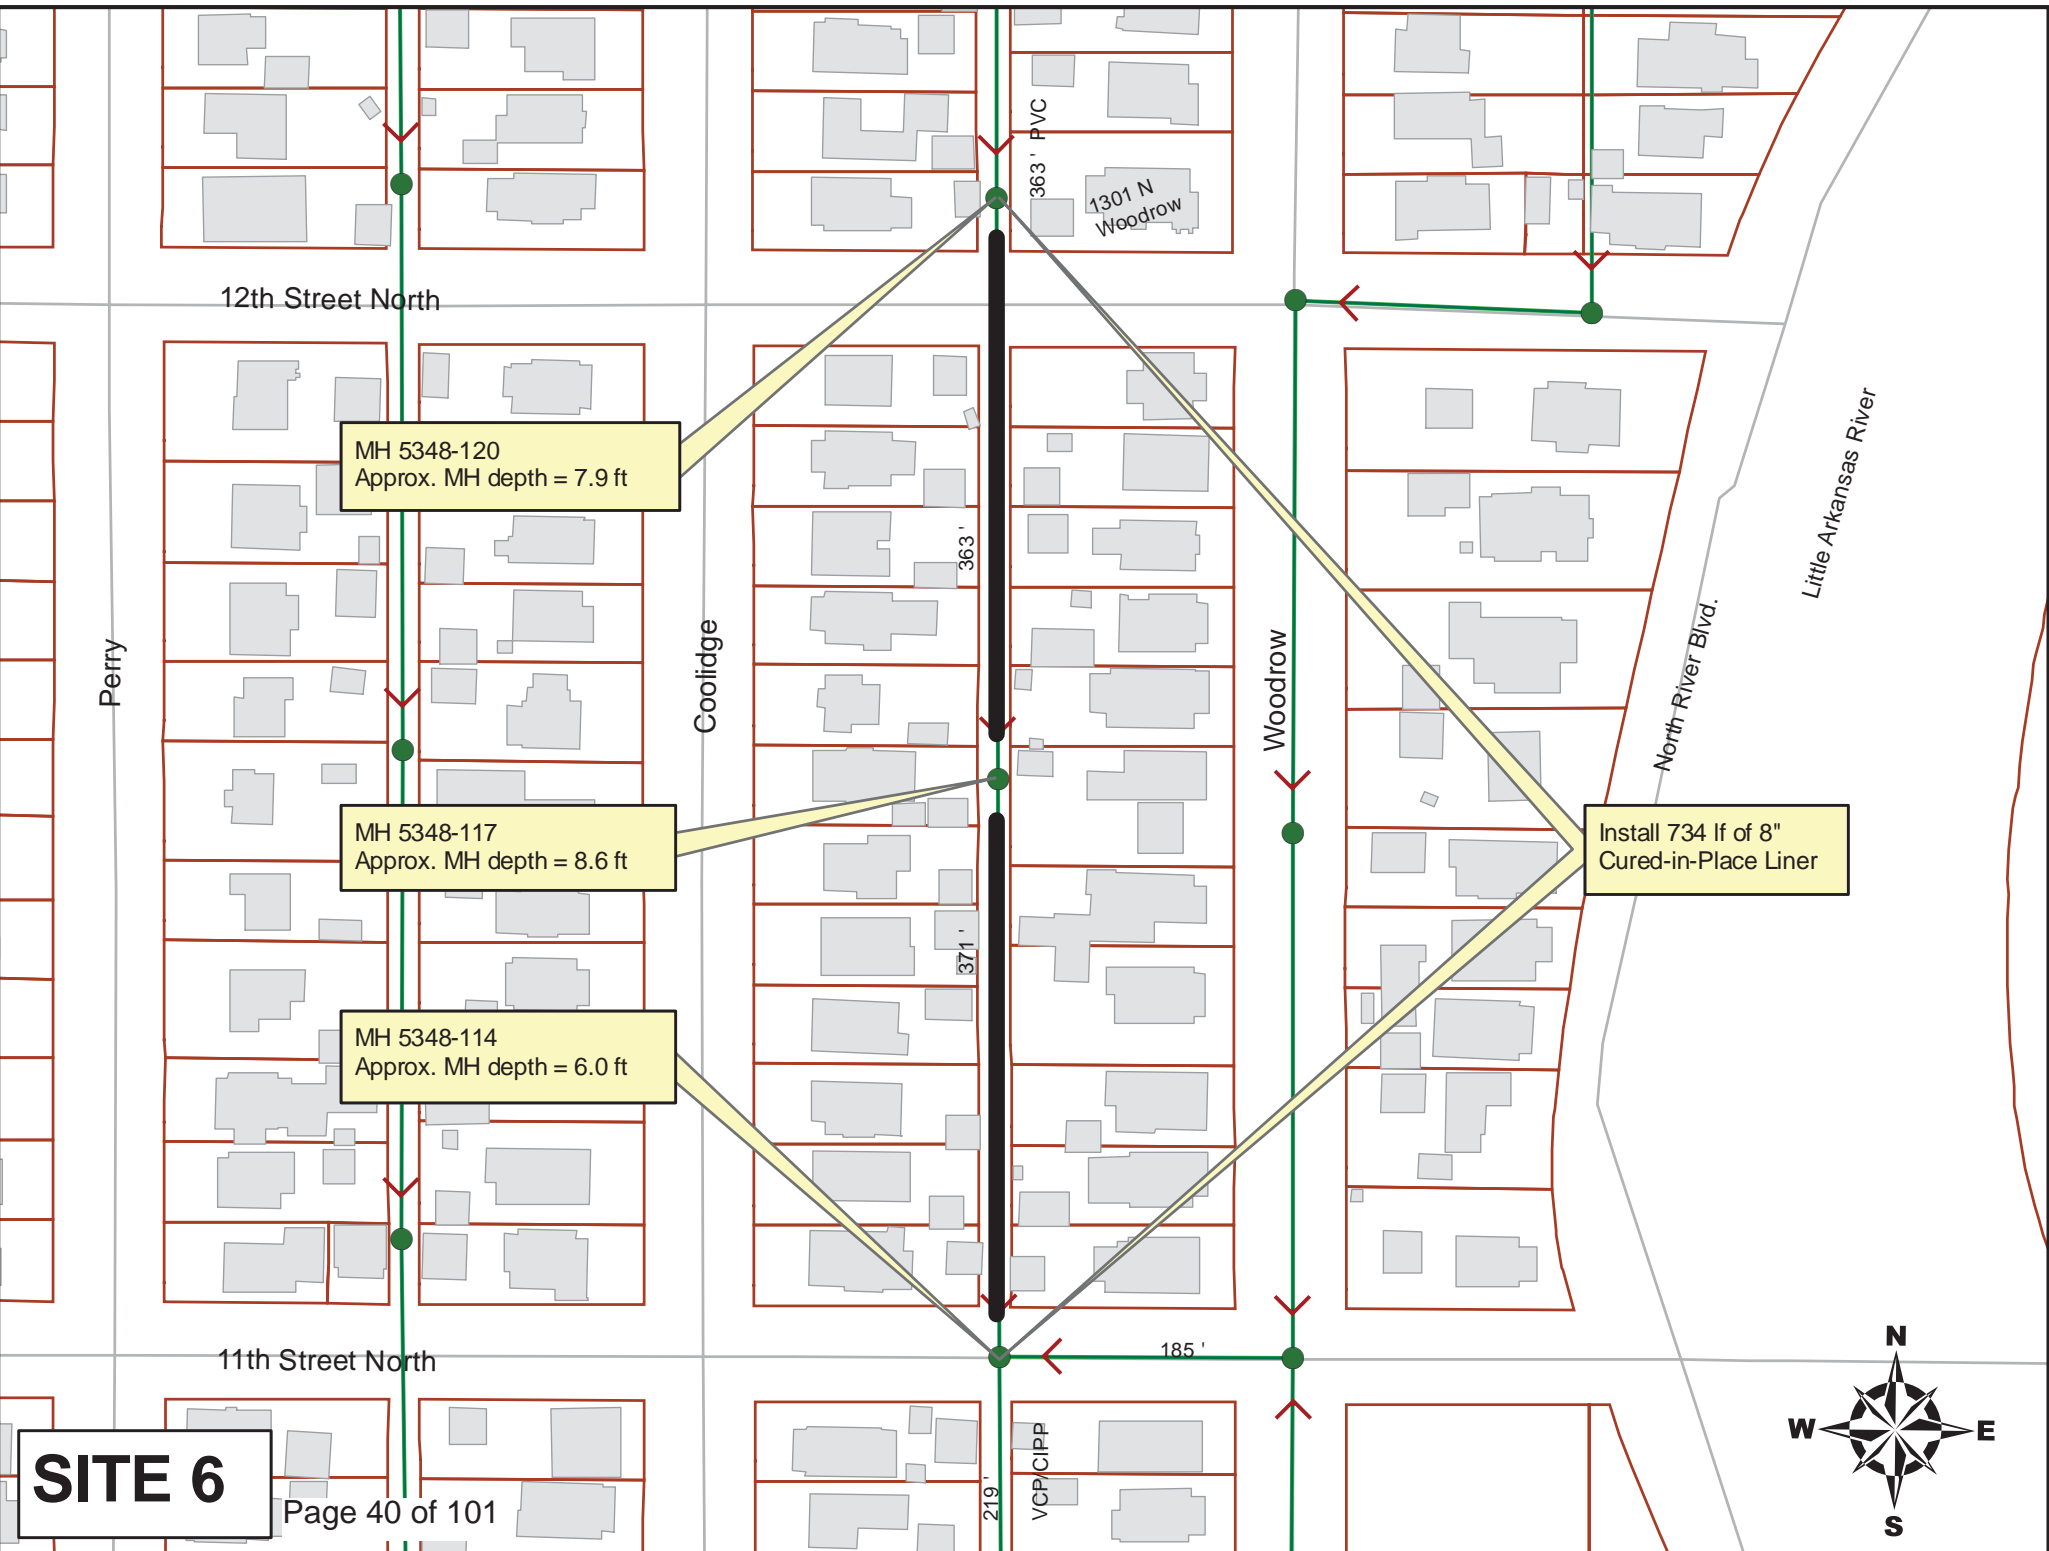
MH 5348-120
Approx. MH depth = 7.9 ft

MH 5348-117
Approx. MH depth = 8.6 ft

MH 5348-114
Approx. MH depth = 6.0 ft
