Install 595 lf of 8" Cured-in-Place Liner

SITE 9

Television Inspection Master Report

US Structure: 5348-103
DS Structure: 5348-100

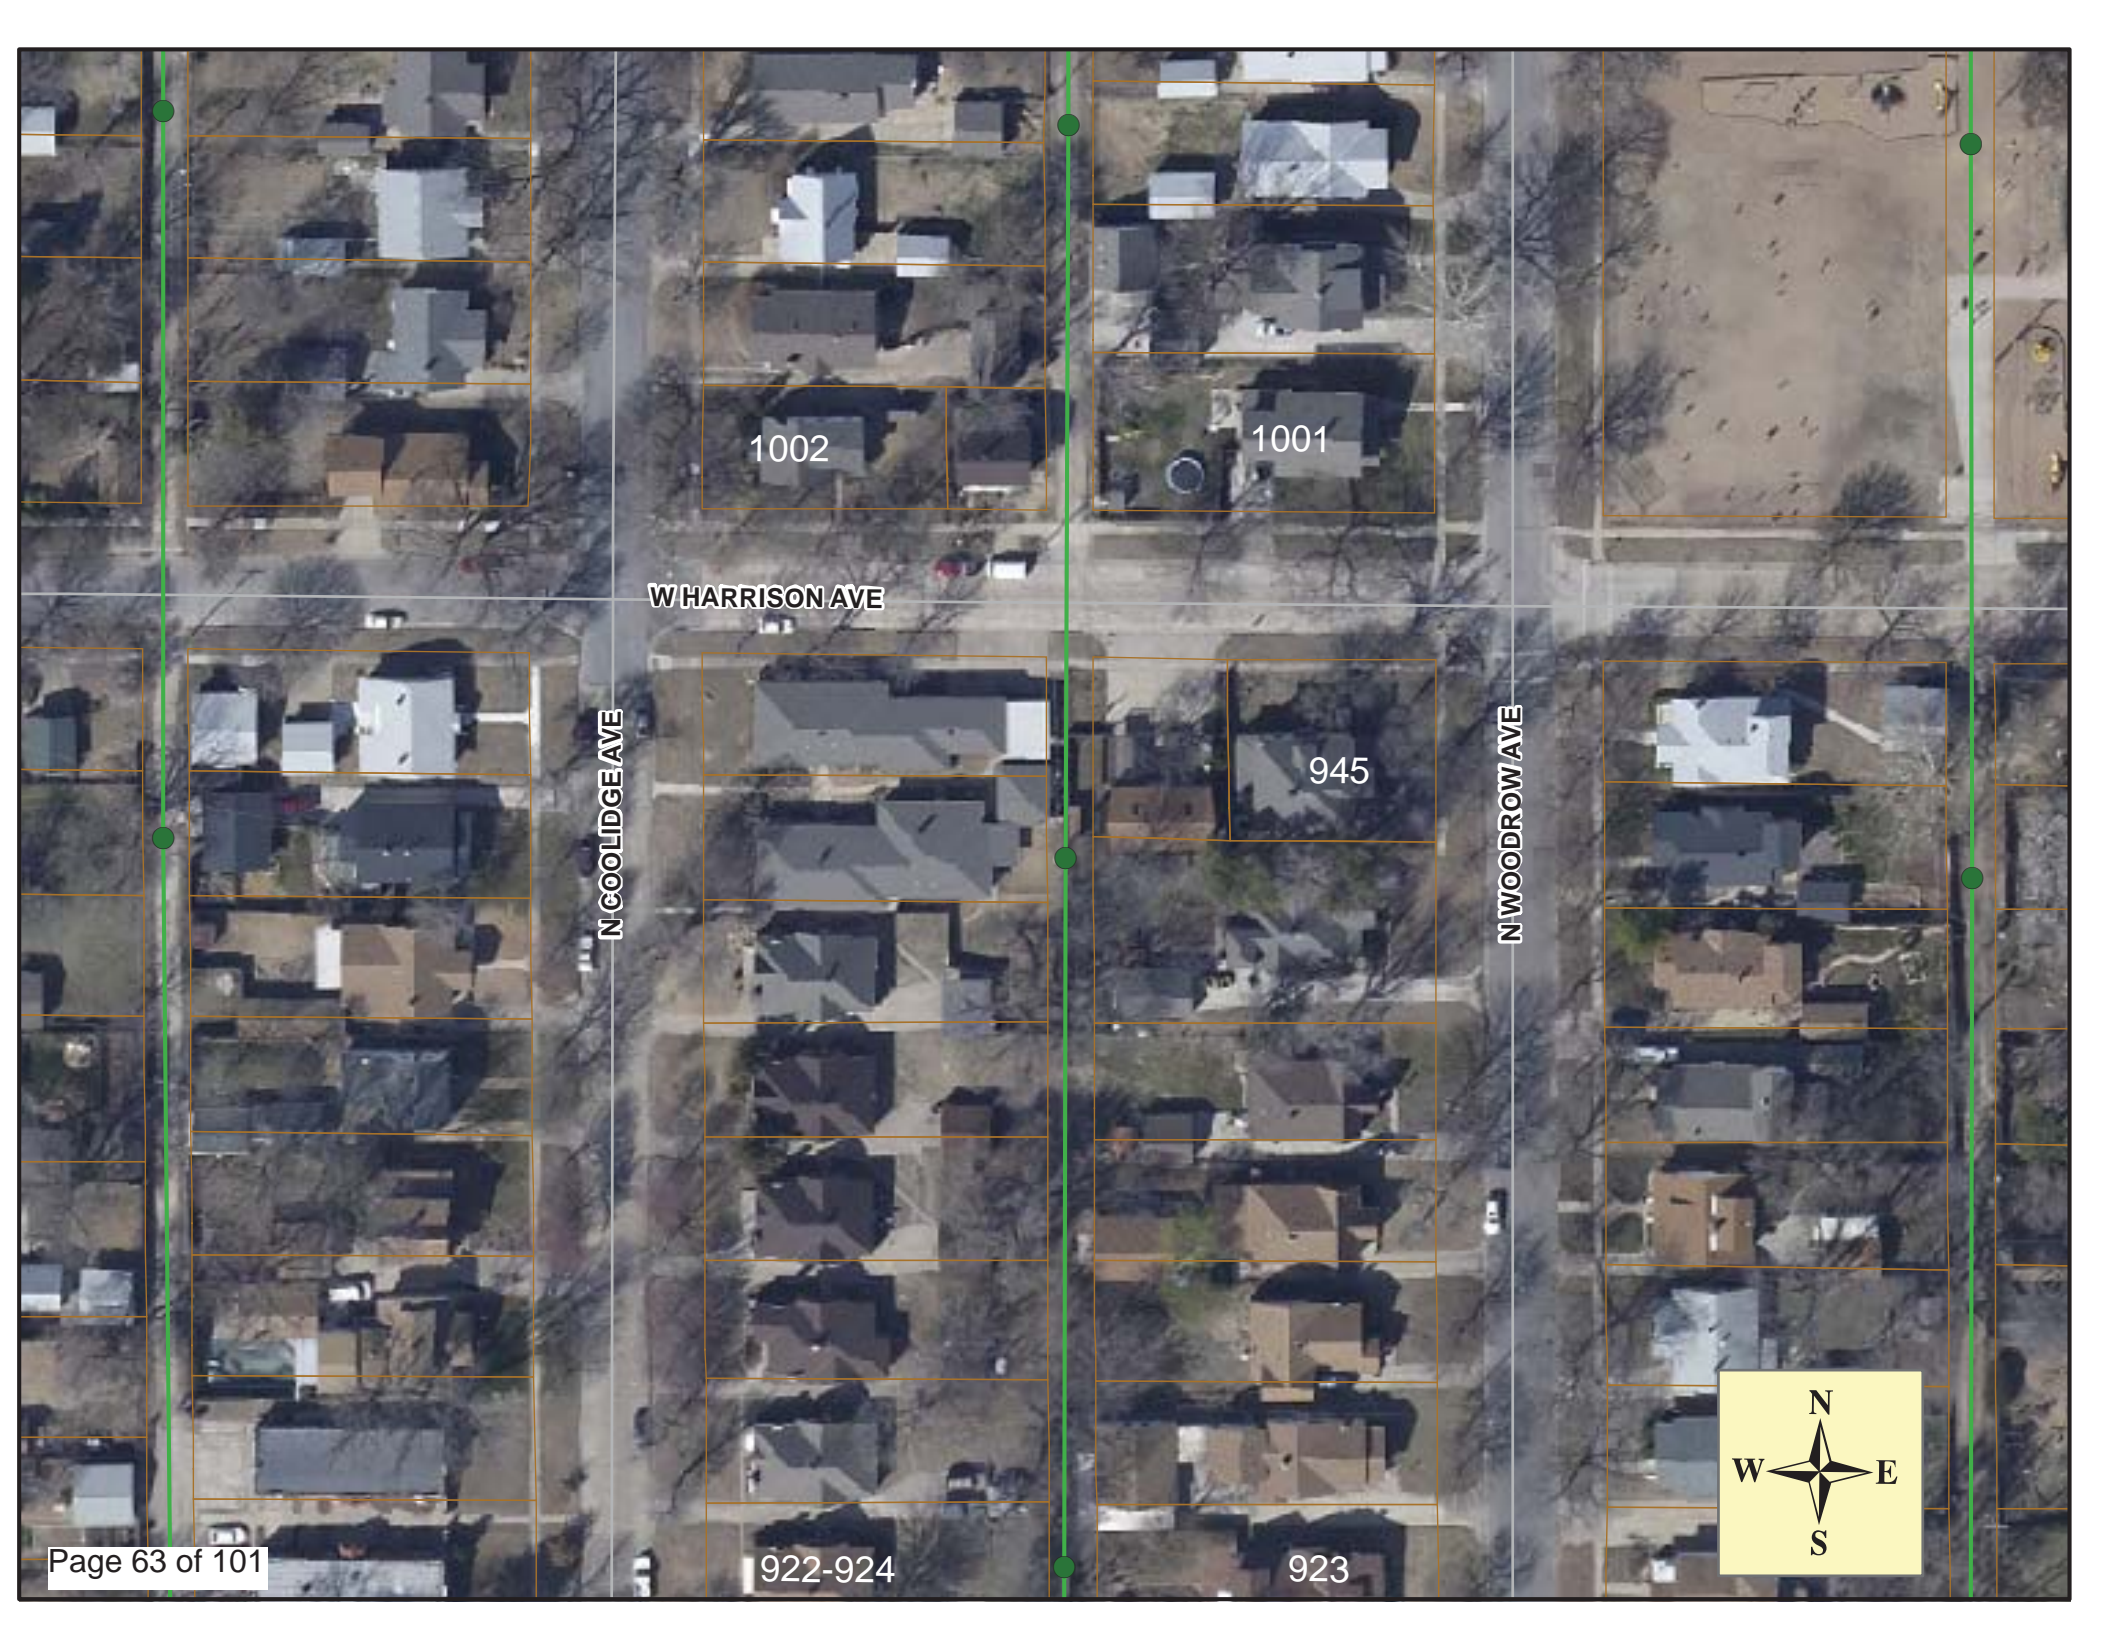
MH 5348-103
Approx. MH depth = 6.8 ft

MH 5348-100
Approx. MH depth = 7.4 ft

MH 5348-097
924 N Coolidge
Approx. MH depth = 7.5 ft
