Install 817 lf of 8" Cured-in-Place Liner  
 from MH 5948-087 to MH 5948-083

**SITE 1**

## Video Inspection Master Report

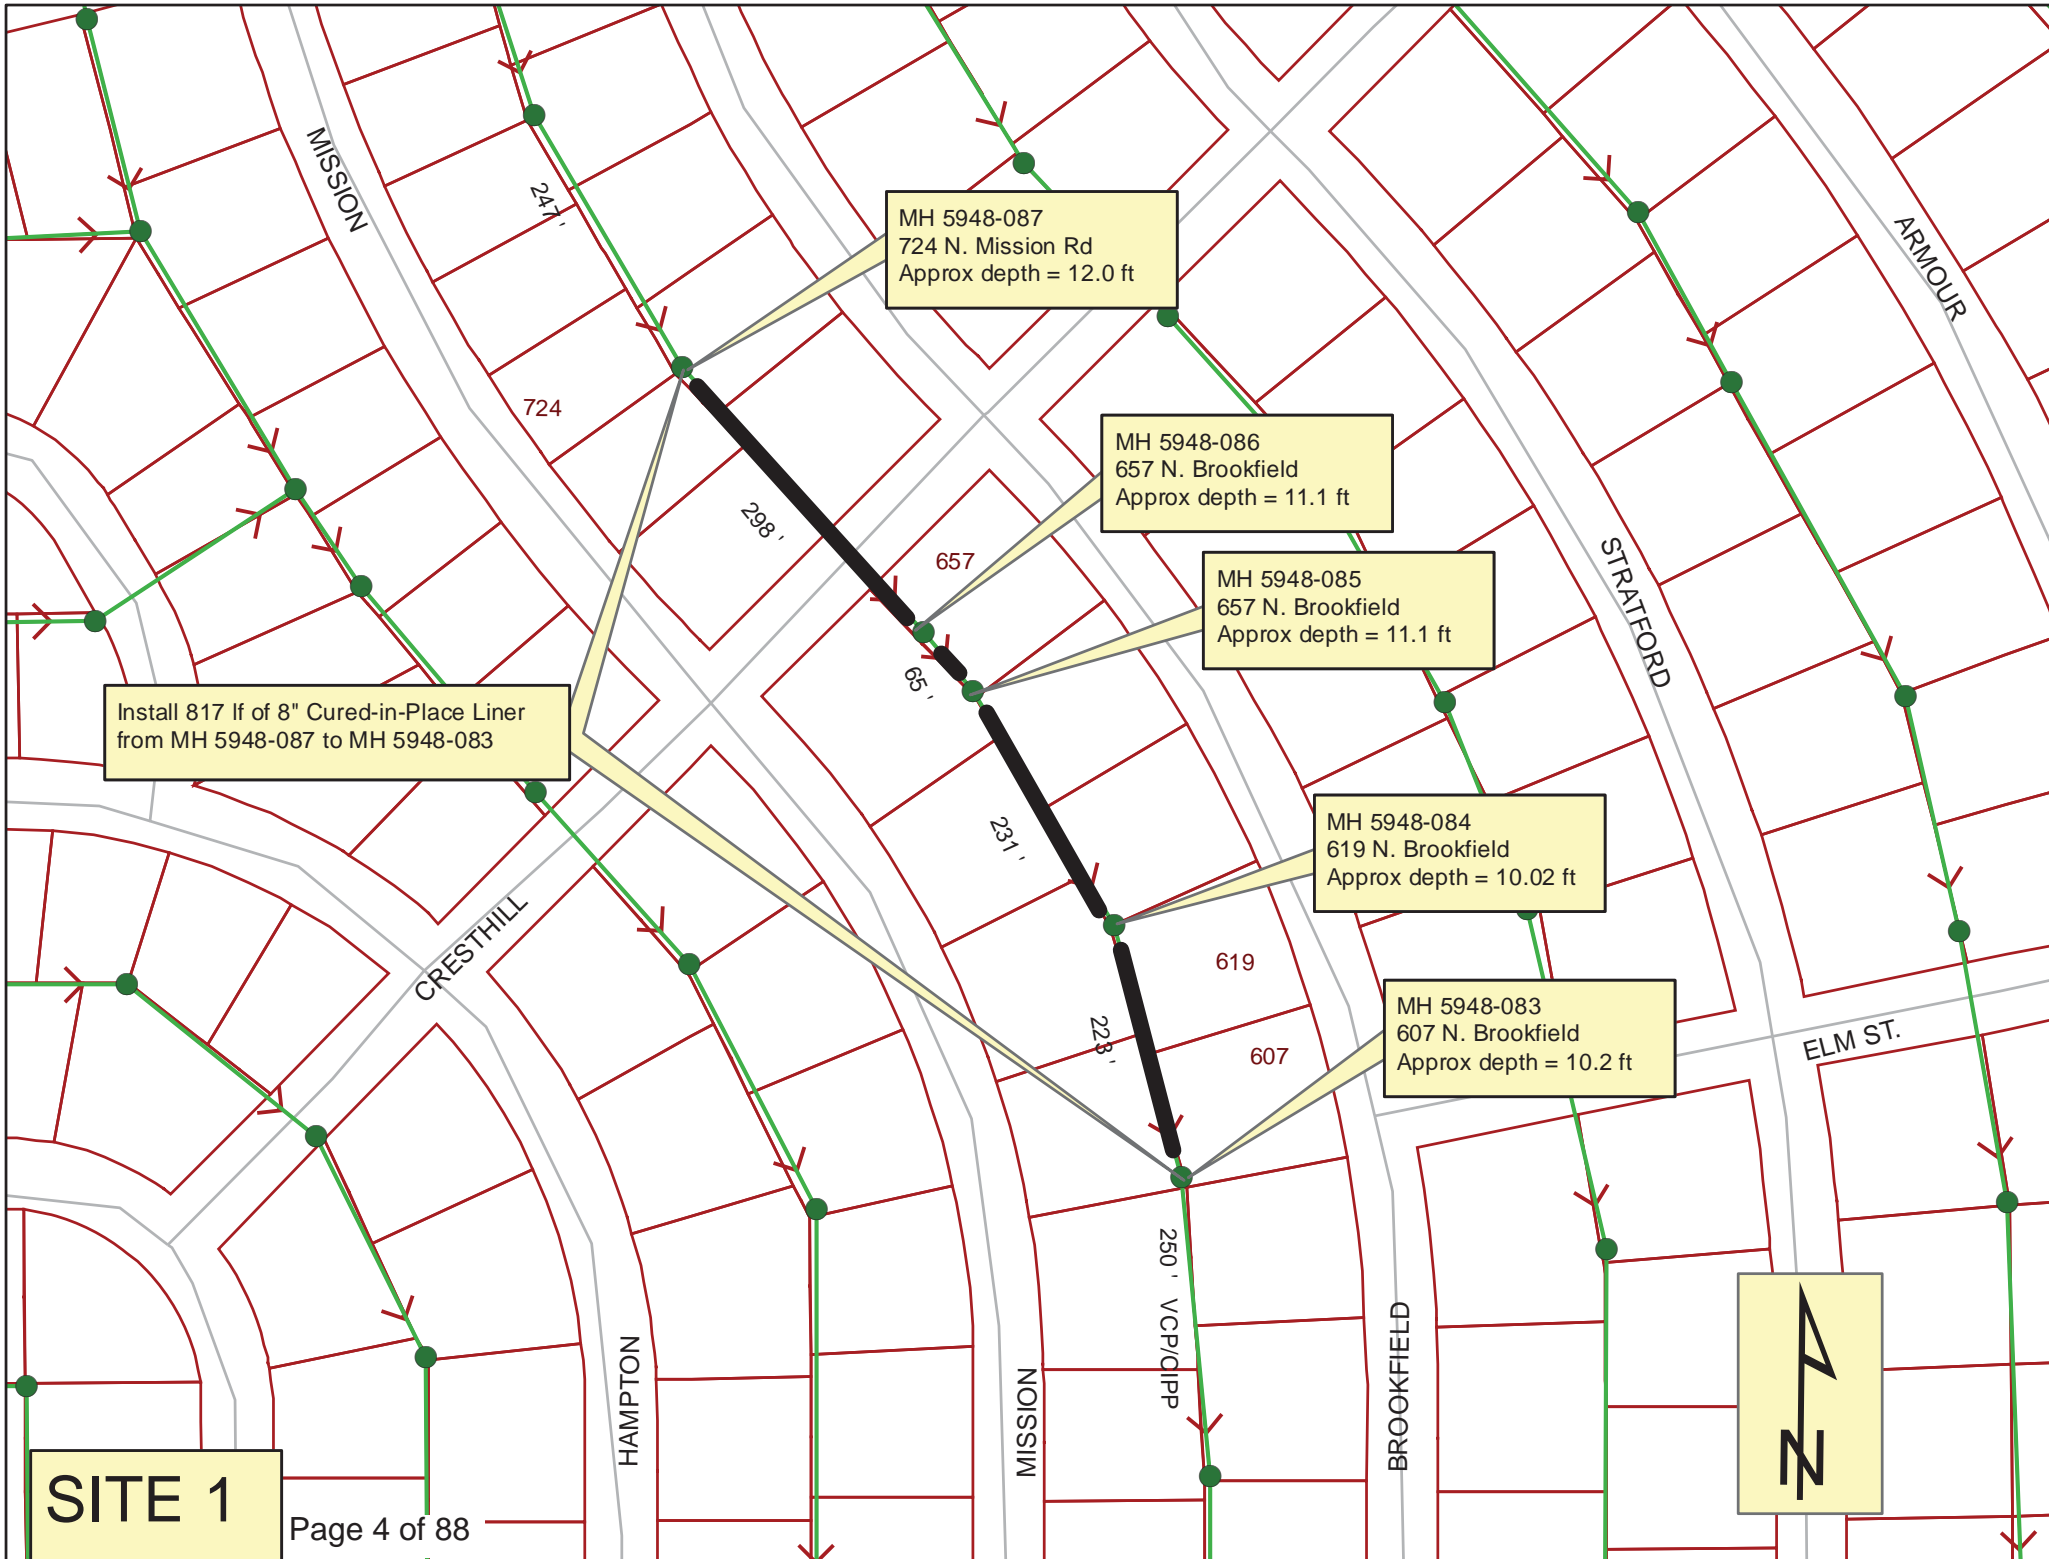
MH 5948-087  
 724 N. Mission Rd  
 Approx depth = 12.0 ft

MH 5948-086  
 657 N. Brookfield  
 Approx depth = 11.1 ft

MH 5948-085  
 657 N. Brookfield  
 Approx depth = 11.1 ft

MH 5948-084  
 619 N. Brookfield  
 Approx depth = 10.02 ft

MH 5948-083  
 607 N. Brookfield  
 Approx depth = 10.2 ft
