SITE 2

Video Inspection Master Report

US Structure: 5347-087 2136 W 2ND ST N **Date Insp:** 4/17/2012 **Basin:** C07B
DS Structure: 5347-086 2136 W 2ND ST **Dir Televised:** Upstream To Downstream

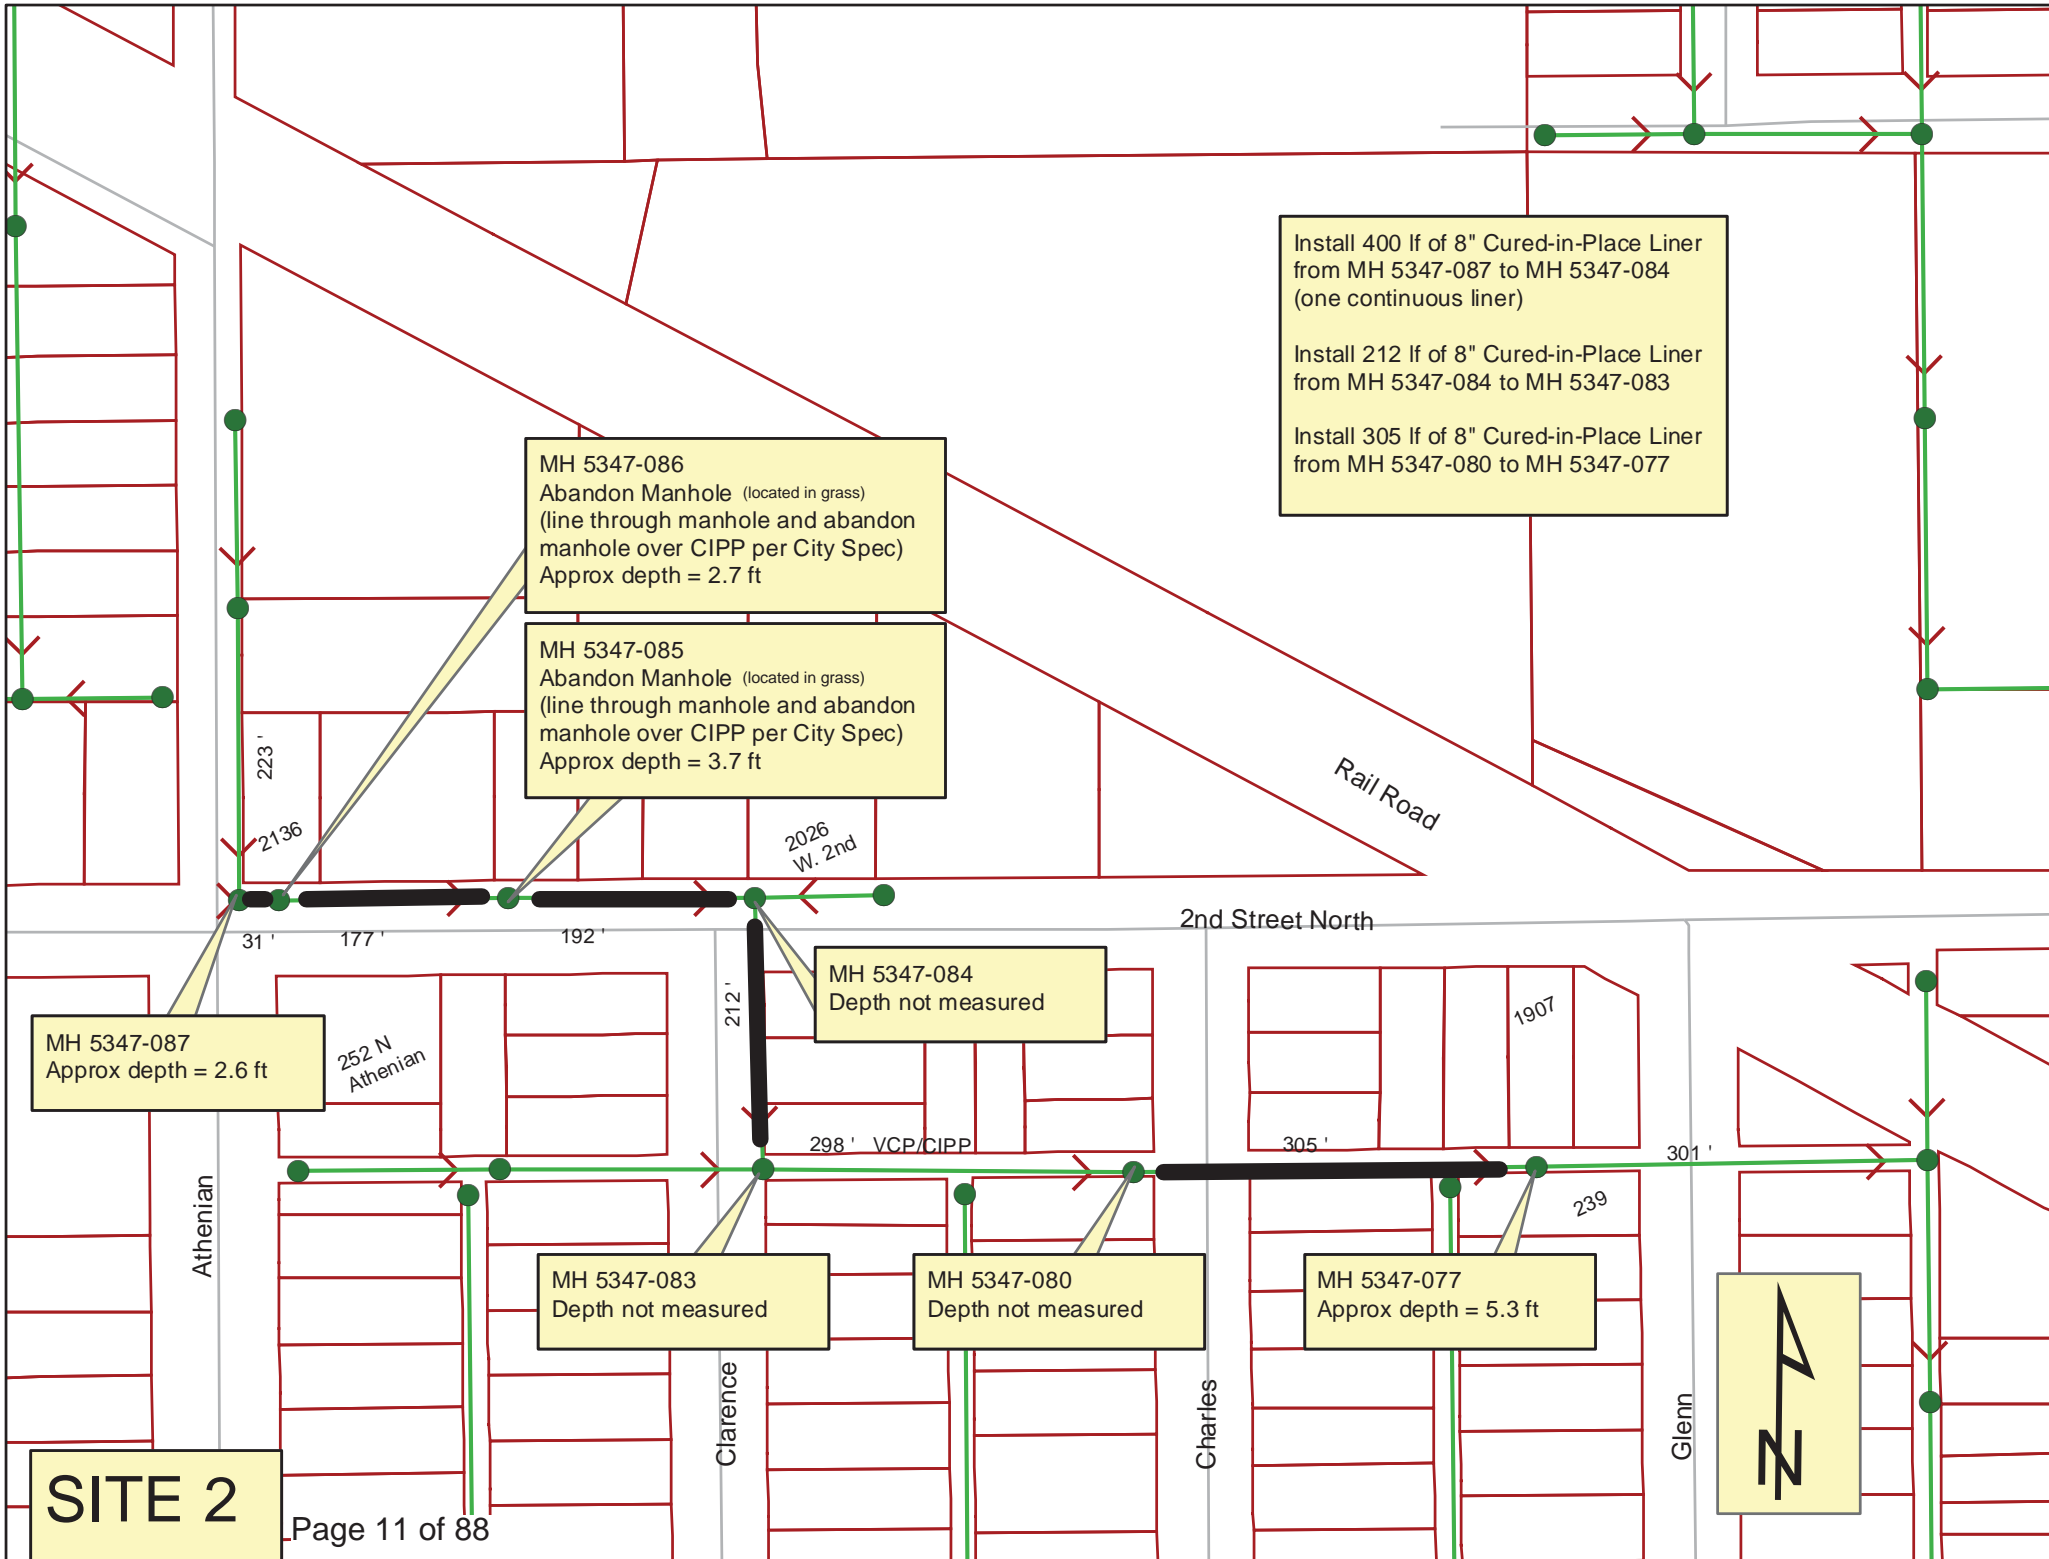
MH 5347-086
Abandon Manhole (located in grass)
(line through manhole and abandon manhole over CIPP per City Spec)
Approx depth = 2.7 ft

MH 5347-085
Abandon Manhole (located in grass)
(line through manhole and abandon manhole over CIPP per City Spec)
Approx depth = 3.7 ft

MH 5347-087
Approx depth = 2.6 ft

MH 5347-084
Depth not measured

MH 5347-083
Depth not measured

MH 5347-080
Depth not measured

MH 5347-077
Approx depth = 5.3 ft

Install 400 lf of 8" Cured-in-Place Liner from MH 5347-087 to MH 5347-084 (one continuous liner)

Install 212 lf of 8" Cured-in-Place Liner from MH 5347-084 to MH 5347-083

Install 305 lf of 8" Cured-in-Place Liner from MH 5347-080 to MH 5347-077
