Install 1305 lf of 10" Cured-in-Place Liner from MH 5448-512 to MH 5448-508

SITE 3

Television Inspection Master Report

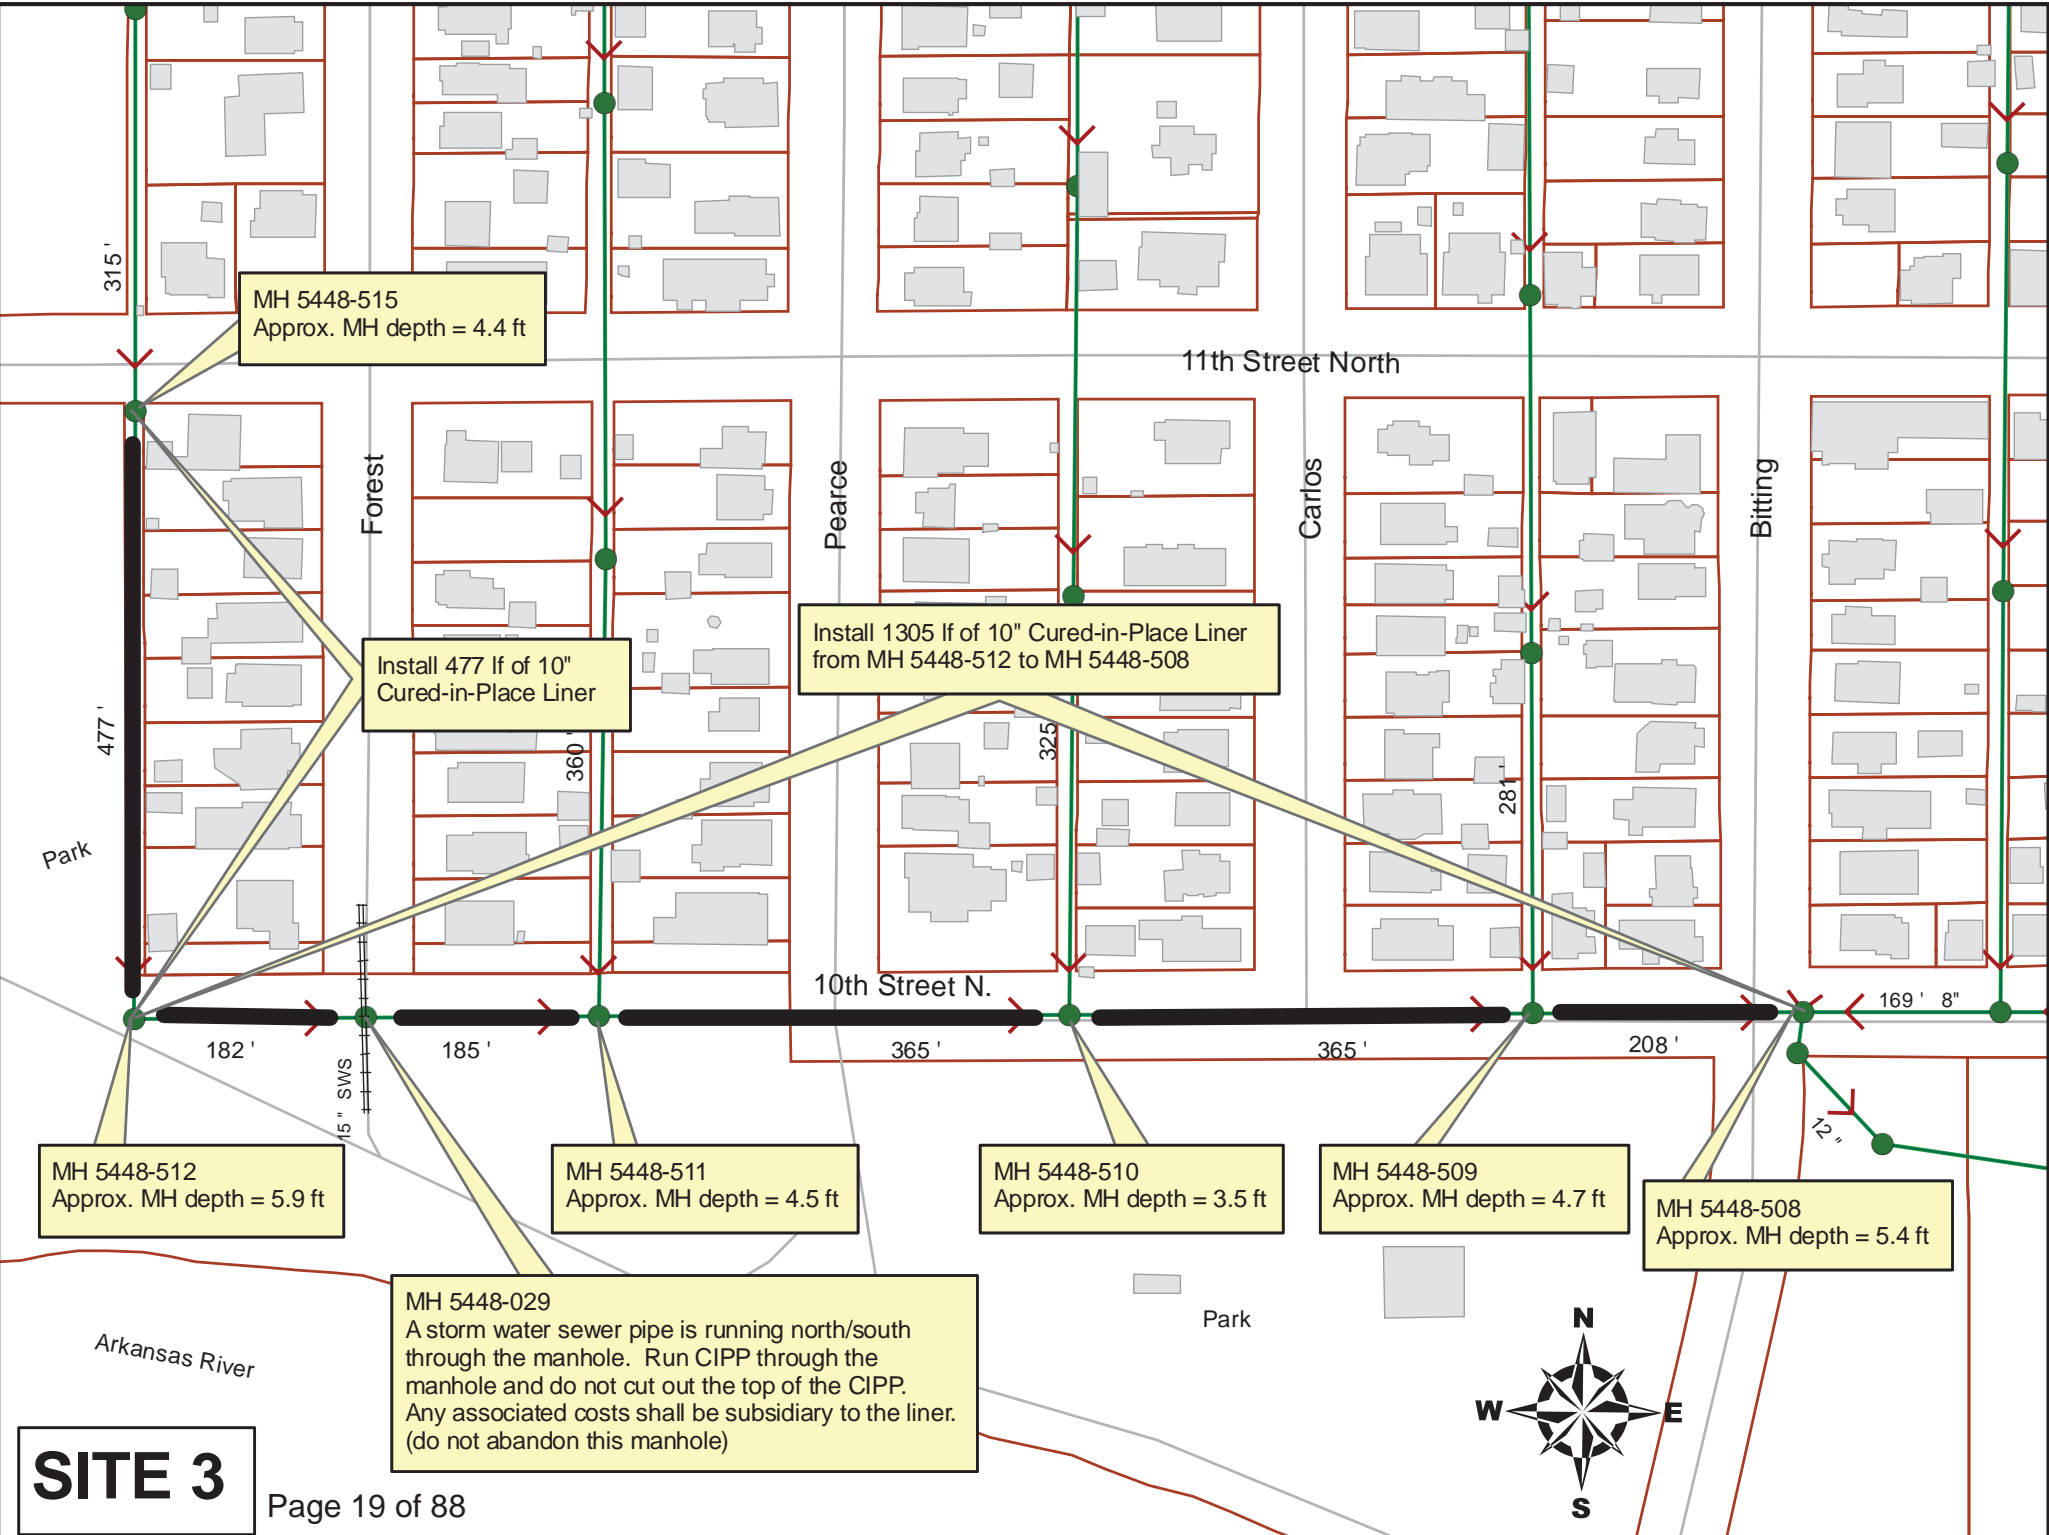
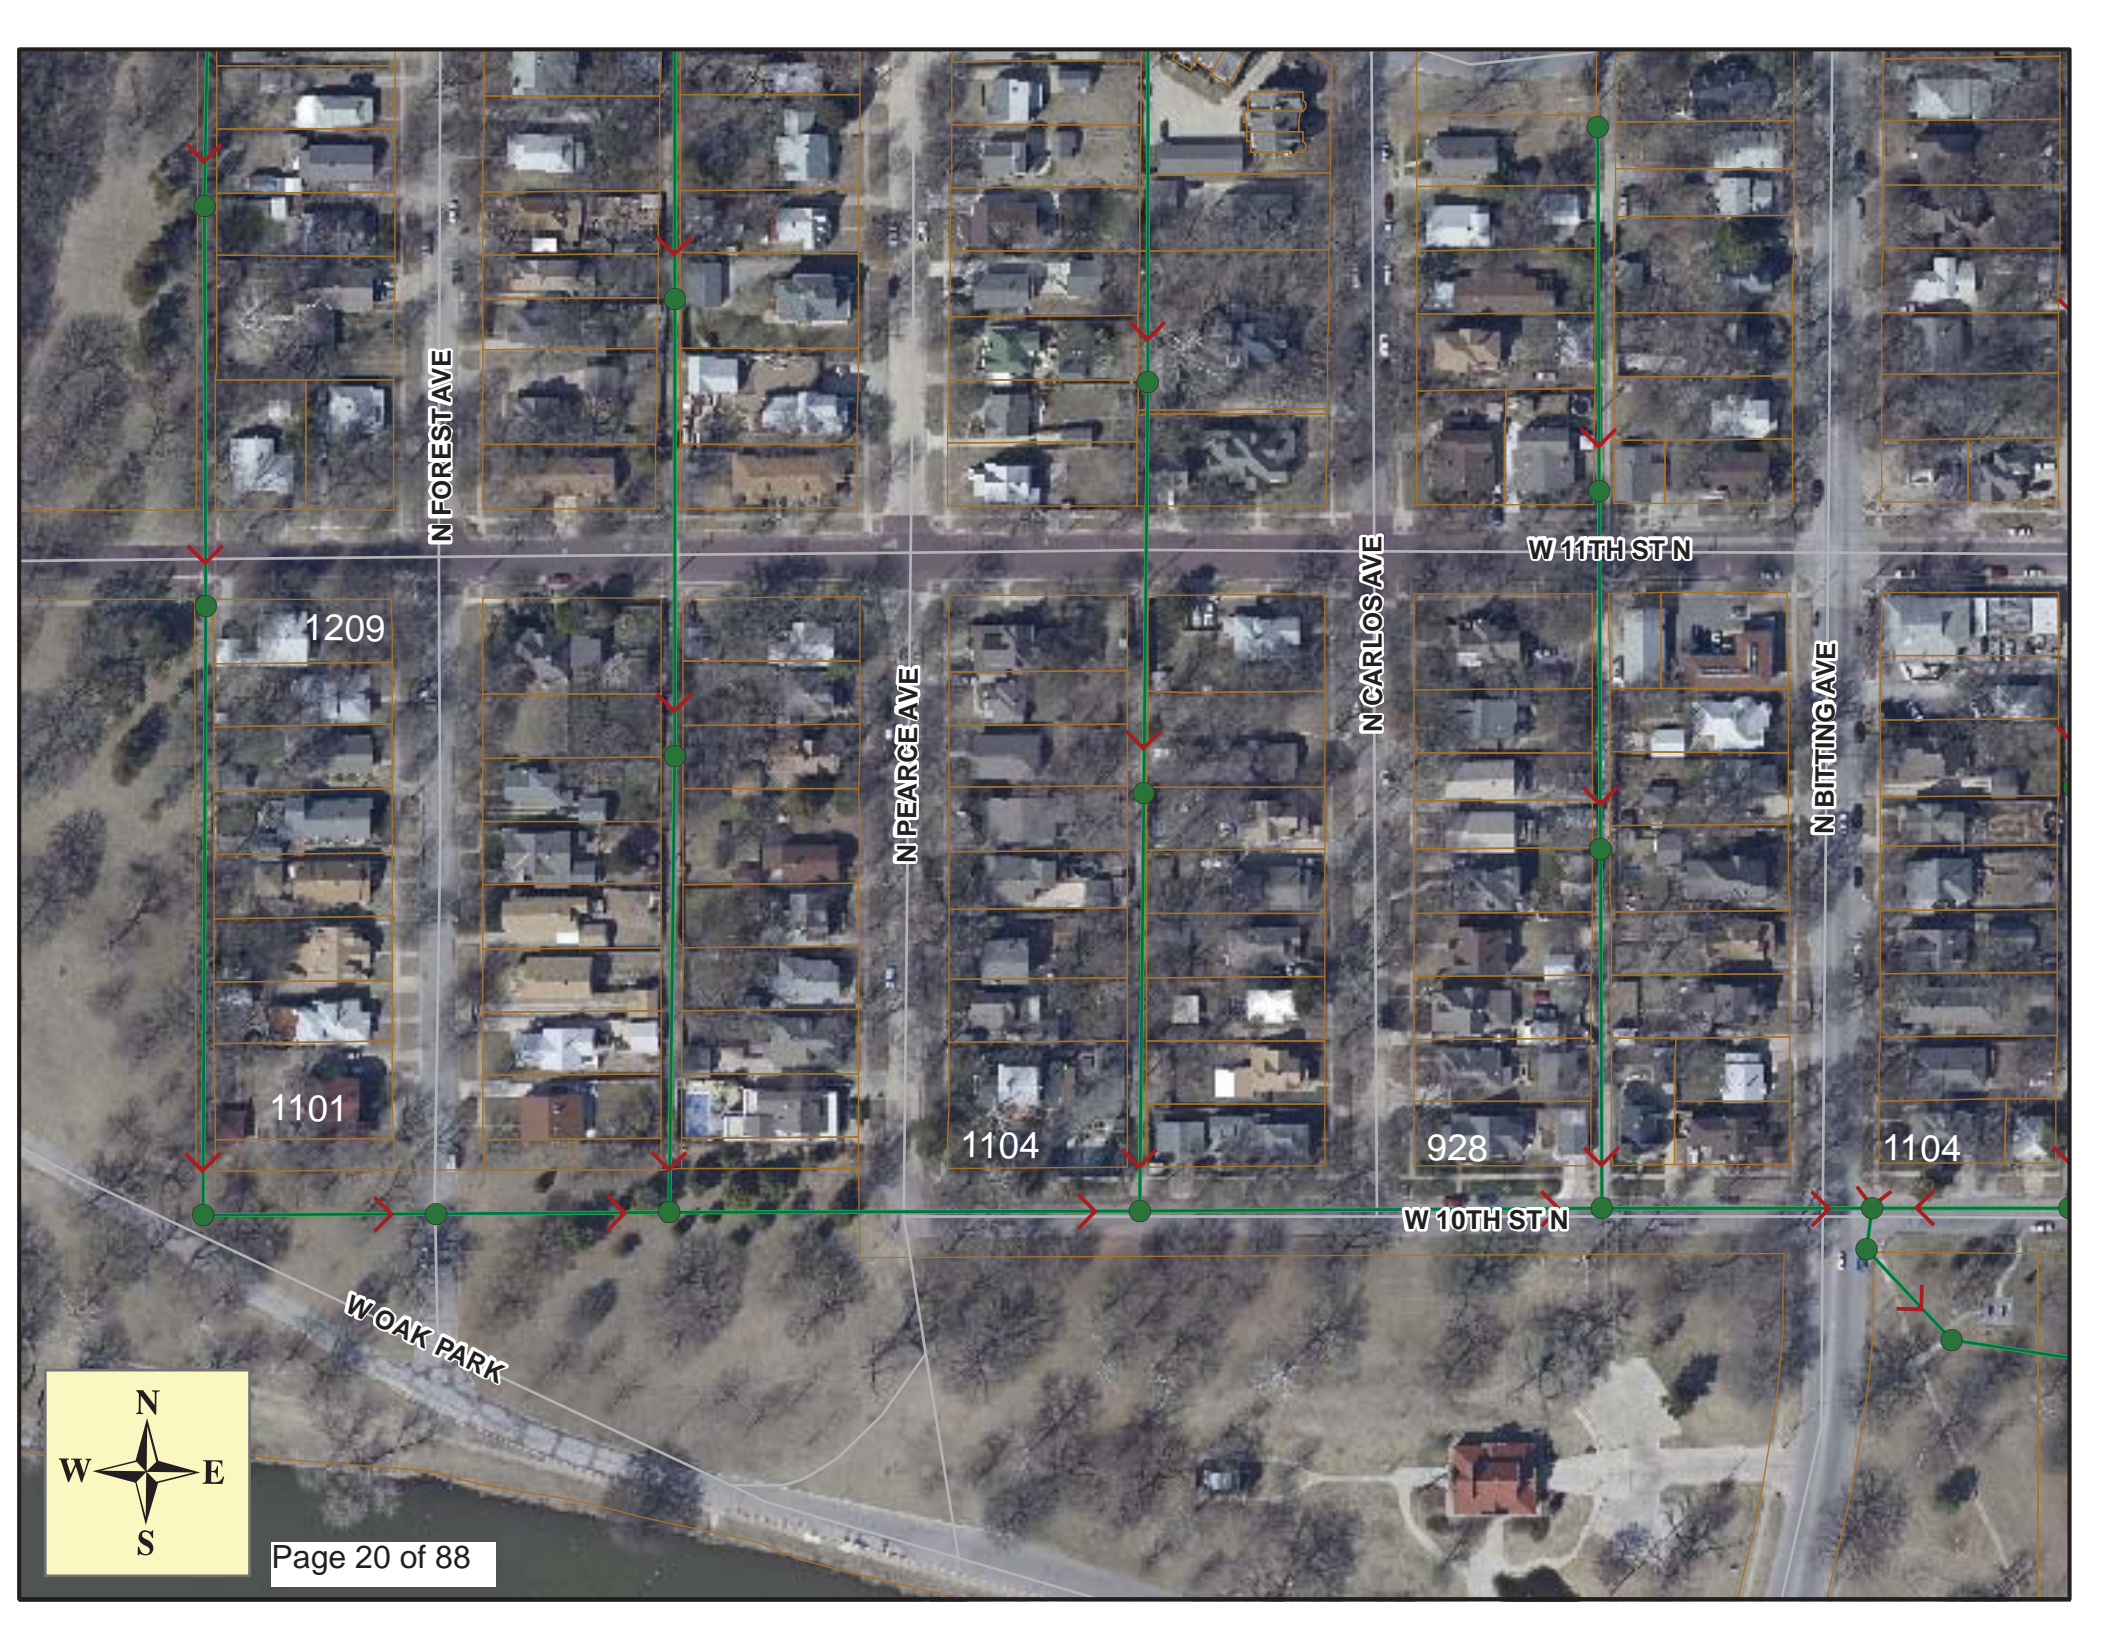
MH 5448-029
A storm water sewer pipe is running north/south through the manhole. Run CIPP through the manhole and do not cut out the top of the CIPP. Any associated costs shall be subsidiary to the liner. (do not abandon this manhole)

Install 477 lf of 10" Cured-in-Place Liner
