Install 500 lf of 8" Cured-in-Place Liner from MH 5647-024 to MH 5647-020

**SITE 7**

## Video Inspection Master Report

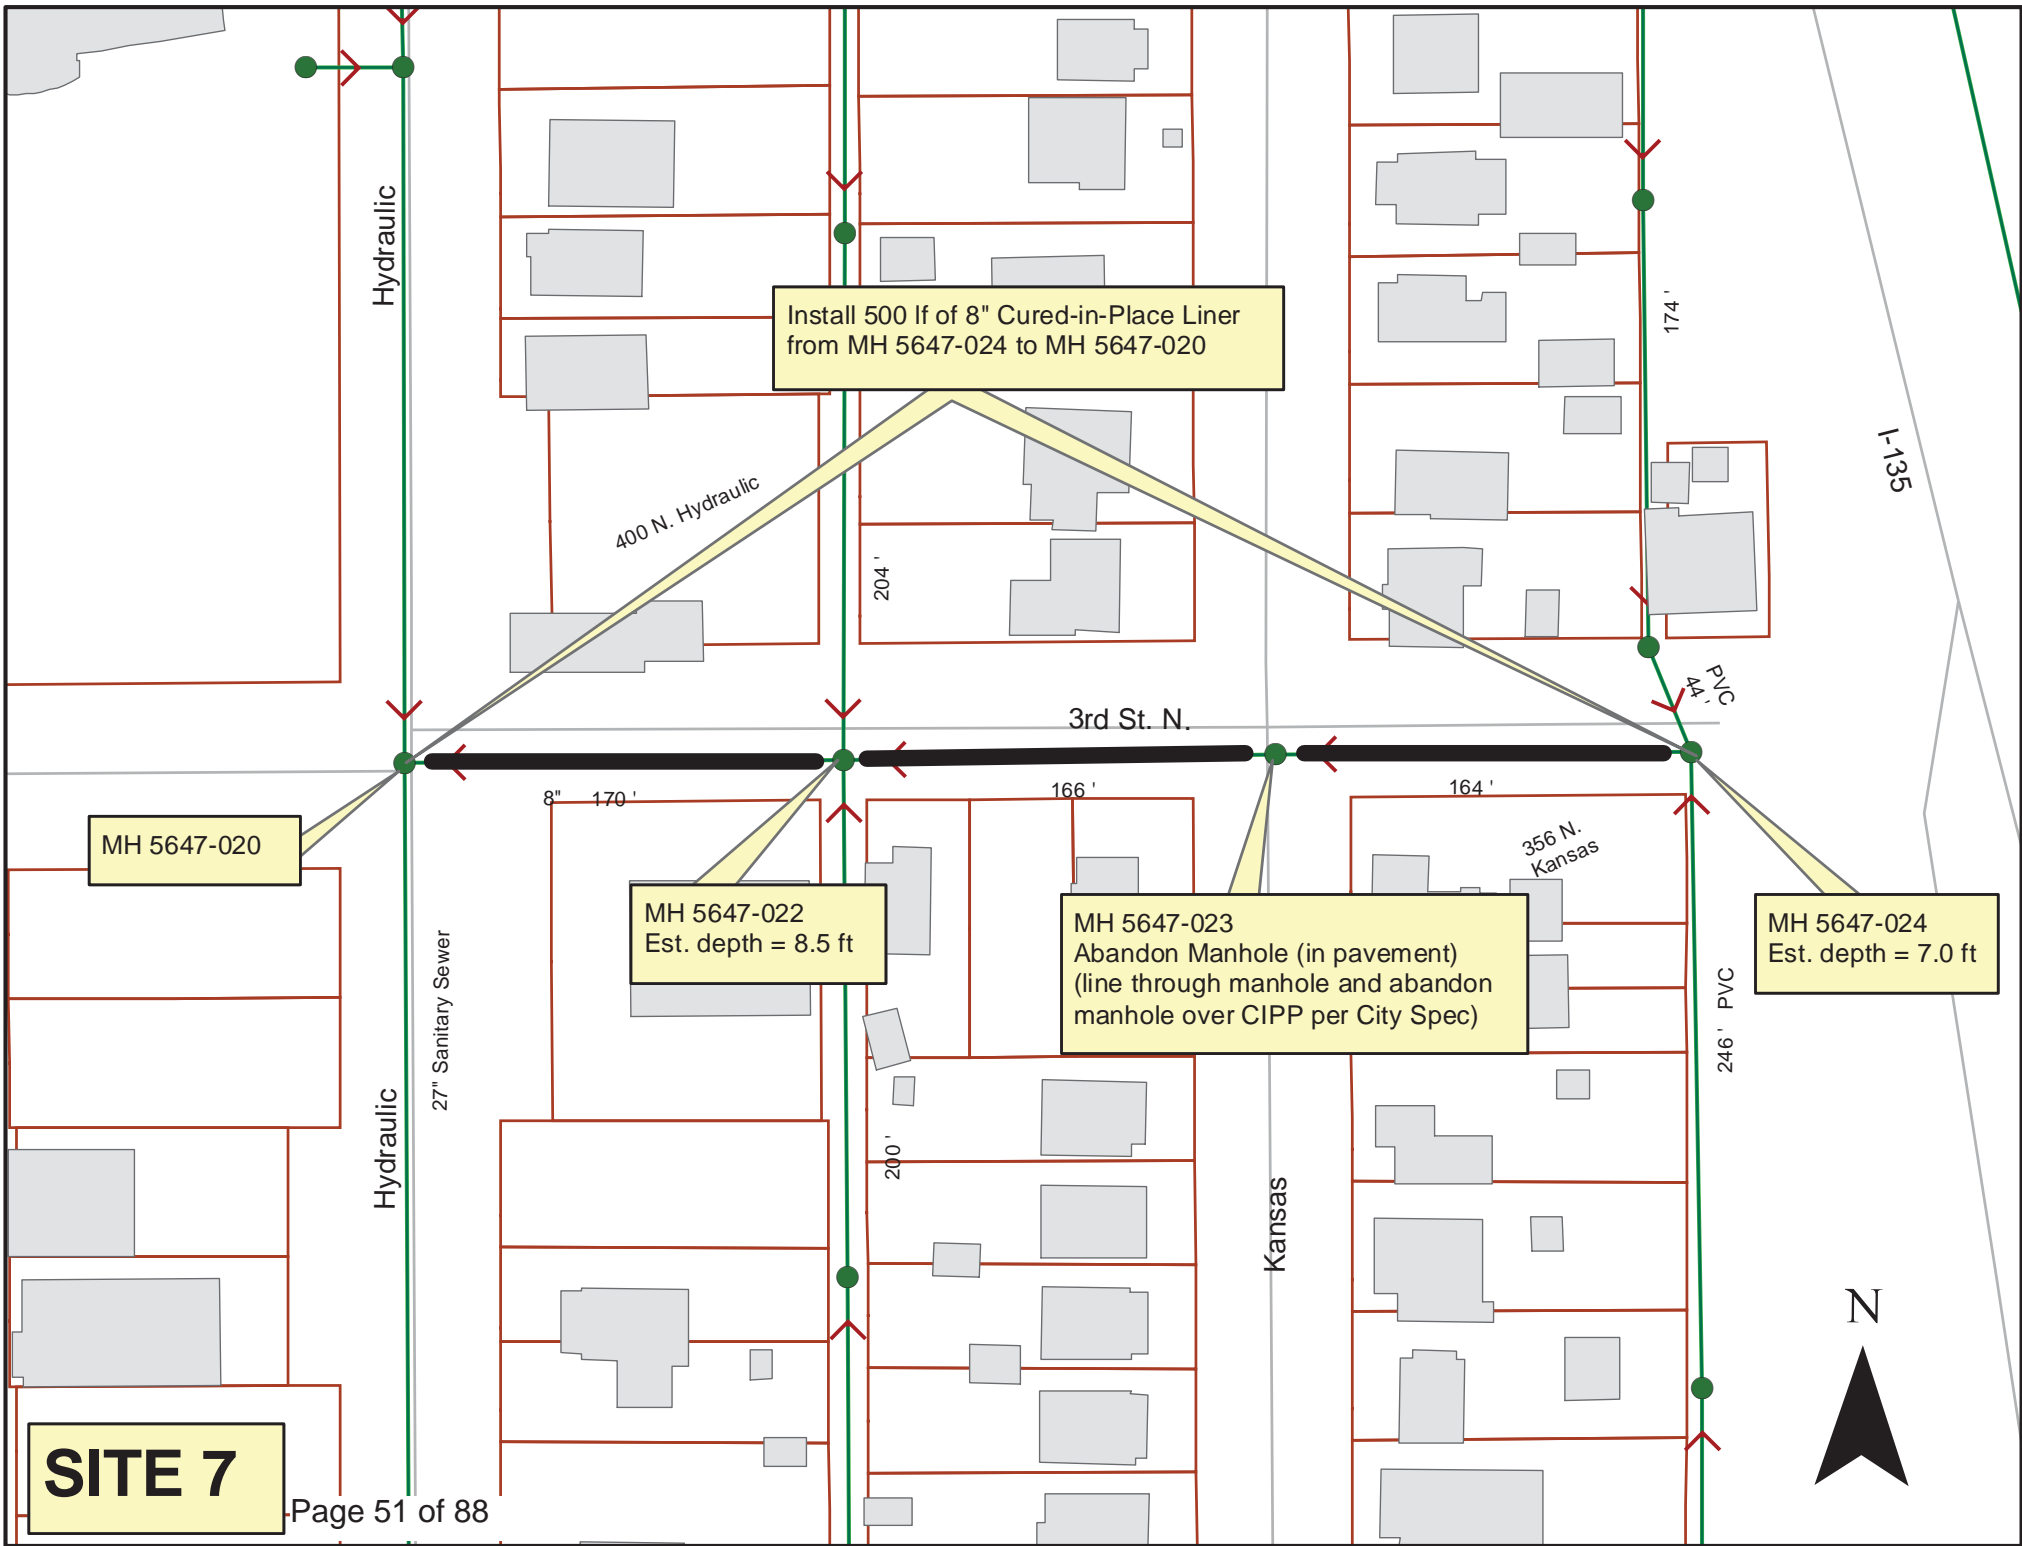
MH 5647-022  
Est. depth = 8.5 ft

MH 5647-023  
Abandon Manhole (in pavement)  
(line through manhole and abandon manhole over CIPP per City Spec)

MH 5647-024  
Est. depth = 7.0 ft
