Install 887 lf of 8" Cured-in-Place Liner
from MH 5744-390 to MH 5744-381

SITE 12

Video Inspection Master Report

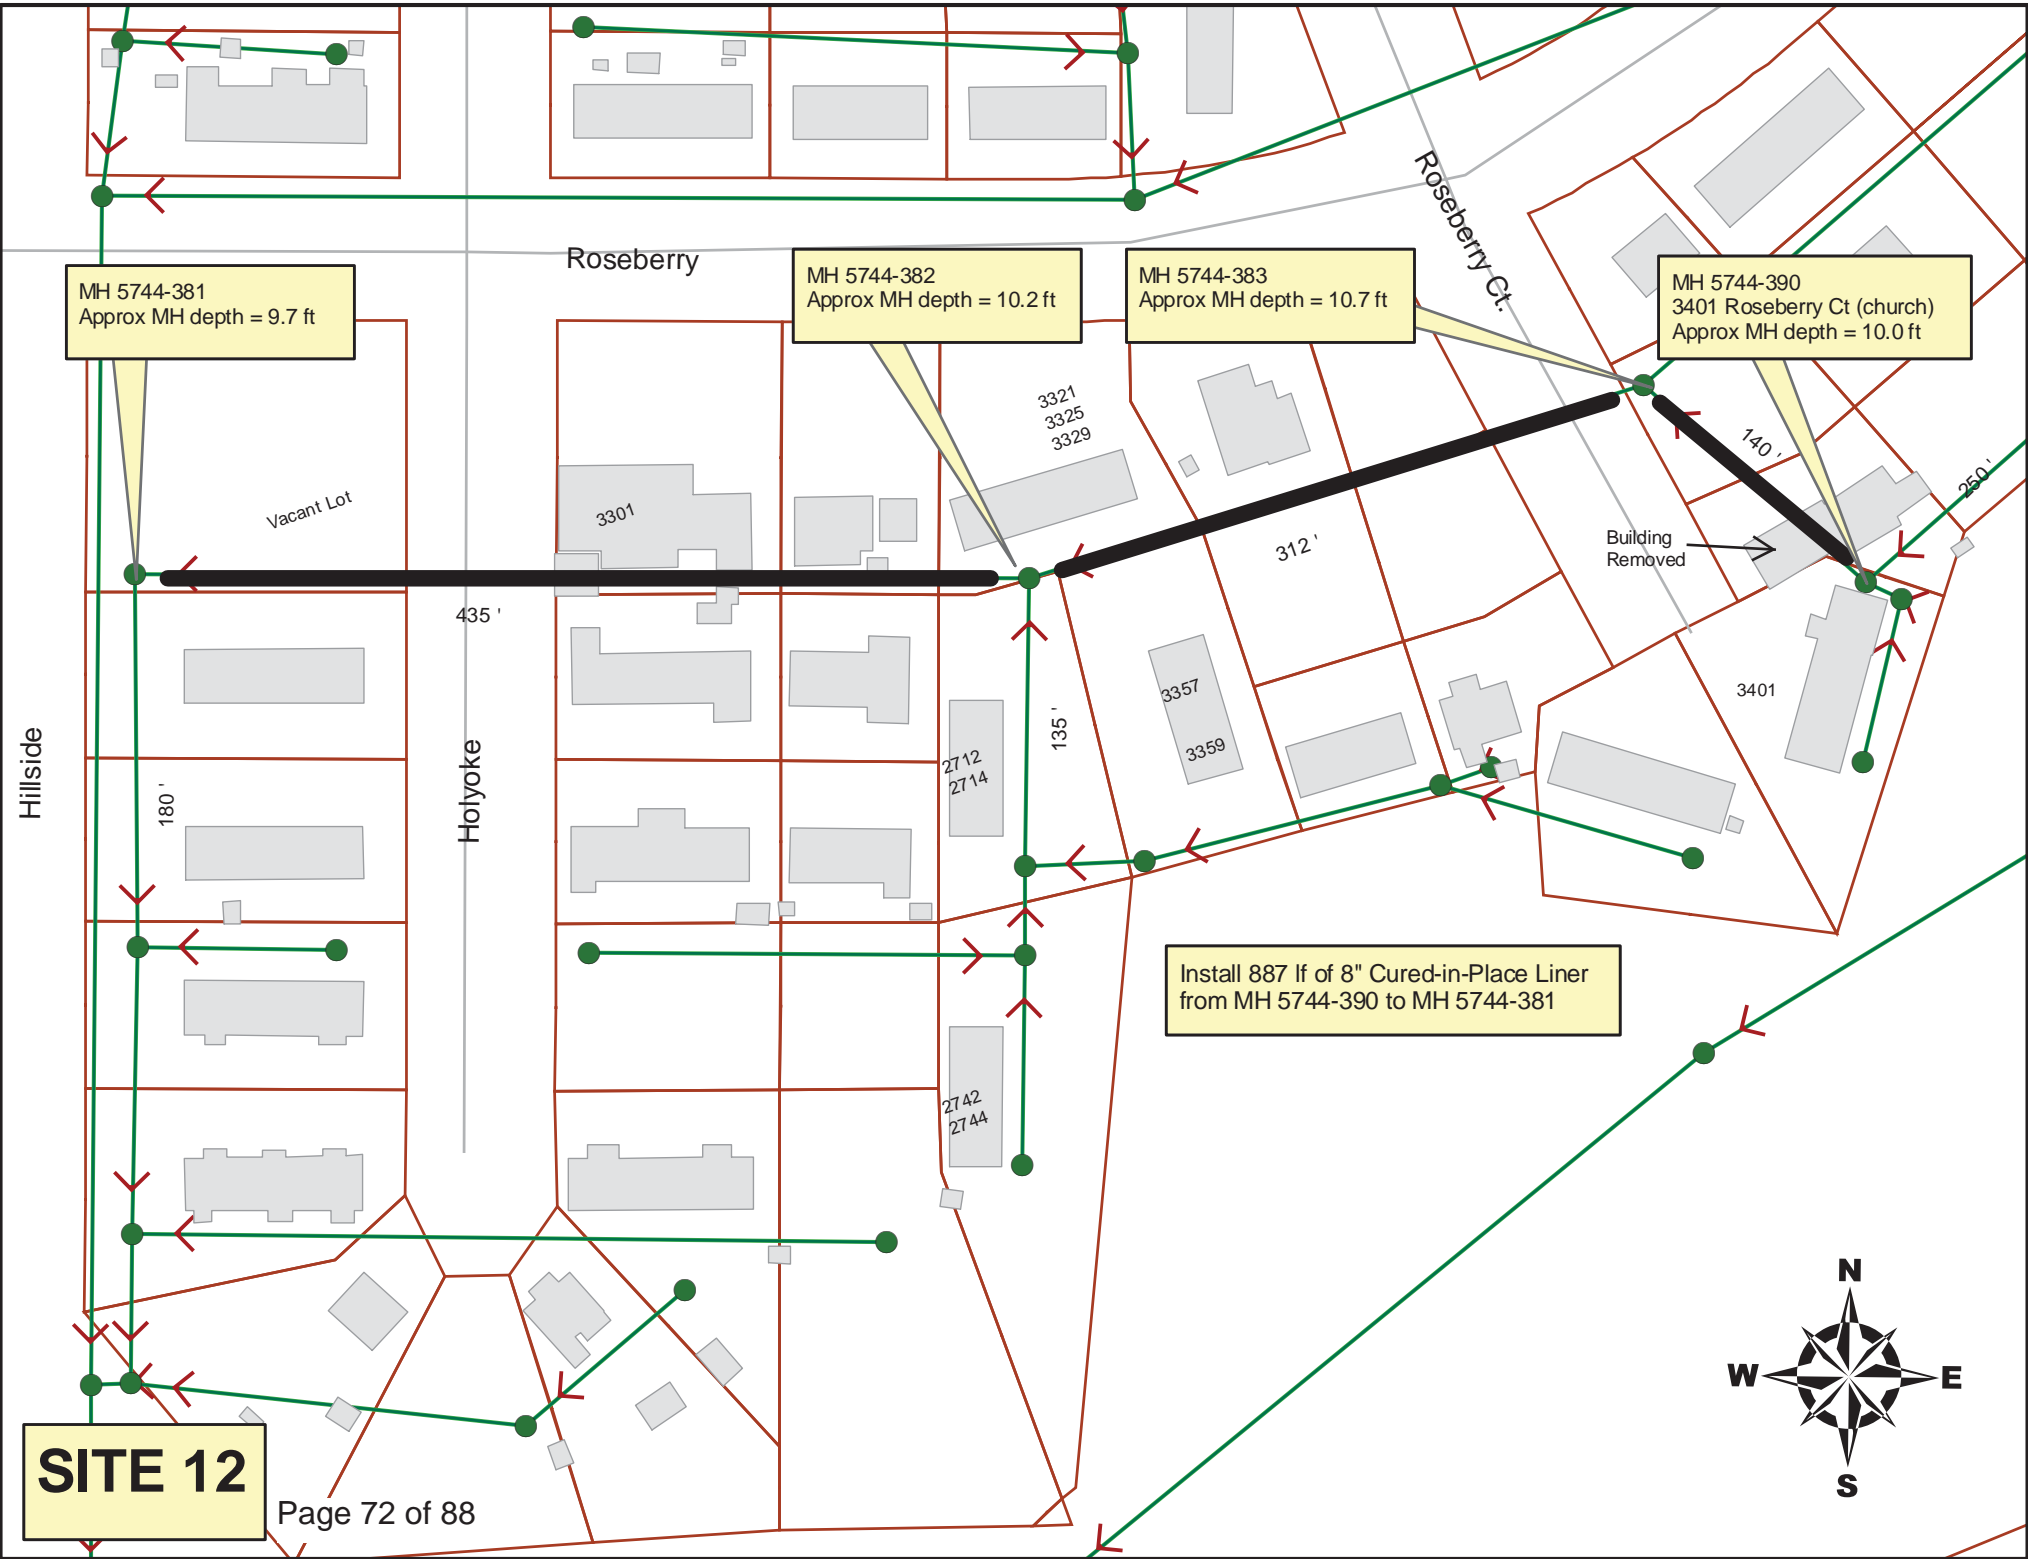
MH 5744-381
Approx MH depth = 9.7 ft

MH 5744-382
Approx MH depth = 10.2 ft

MH 5744-383
Approx MH depth = 10.7 ft

MH 5744-390
3401 Roseberry Ct (church)
Approx MH depth = 10.0 ft
