SITE 2

Video Inspection Master Report

US Structure: 5445-339 1733 S BROADWAY AVE Date Insp: 2/28/2007 Basin: C05D
 DS Structure: 5445-337 218 E FUNSTON ST Dir Televised: Upstream To Downstream

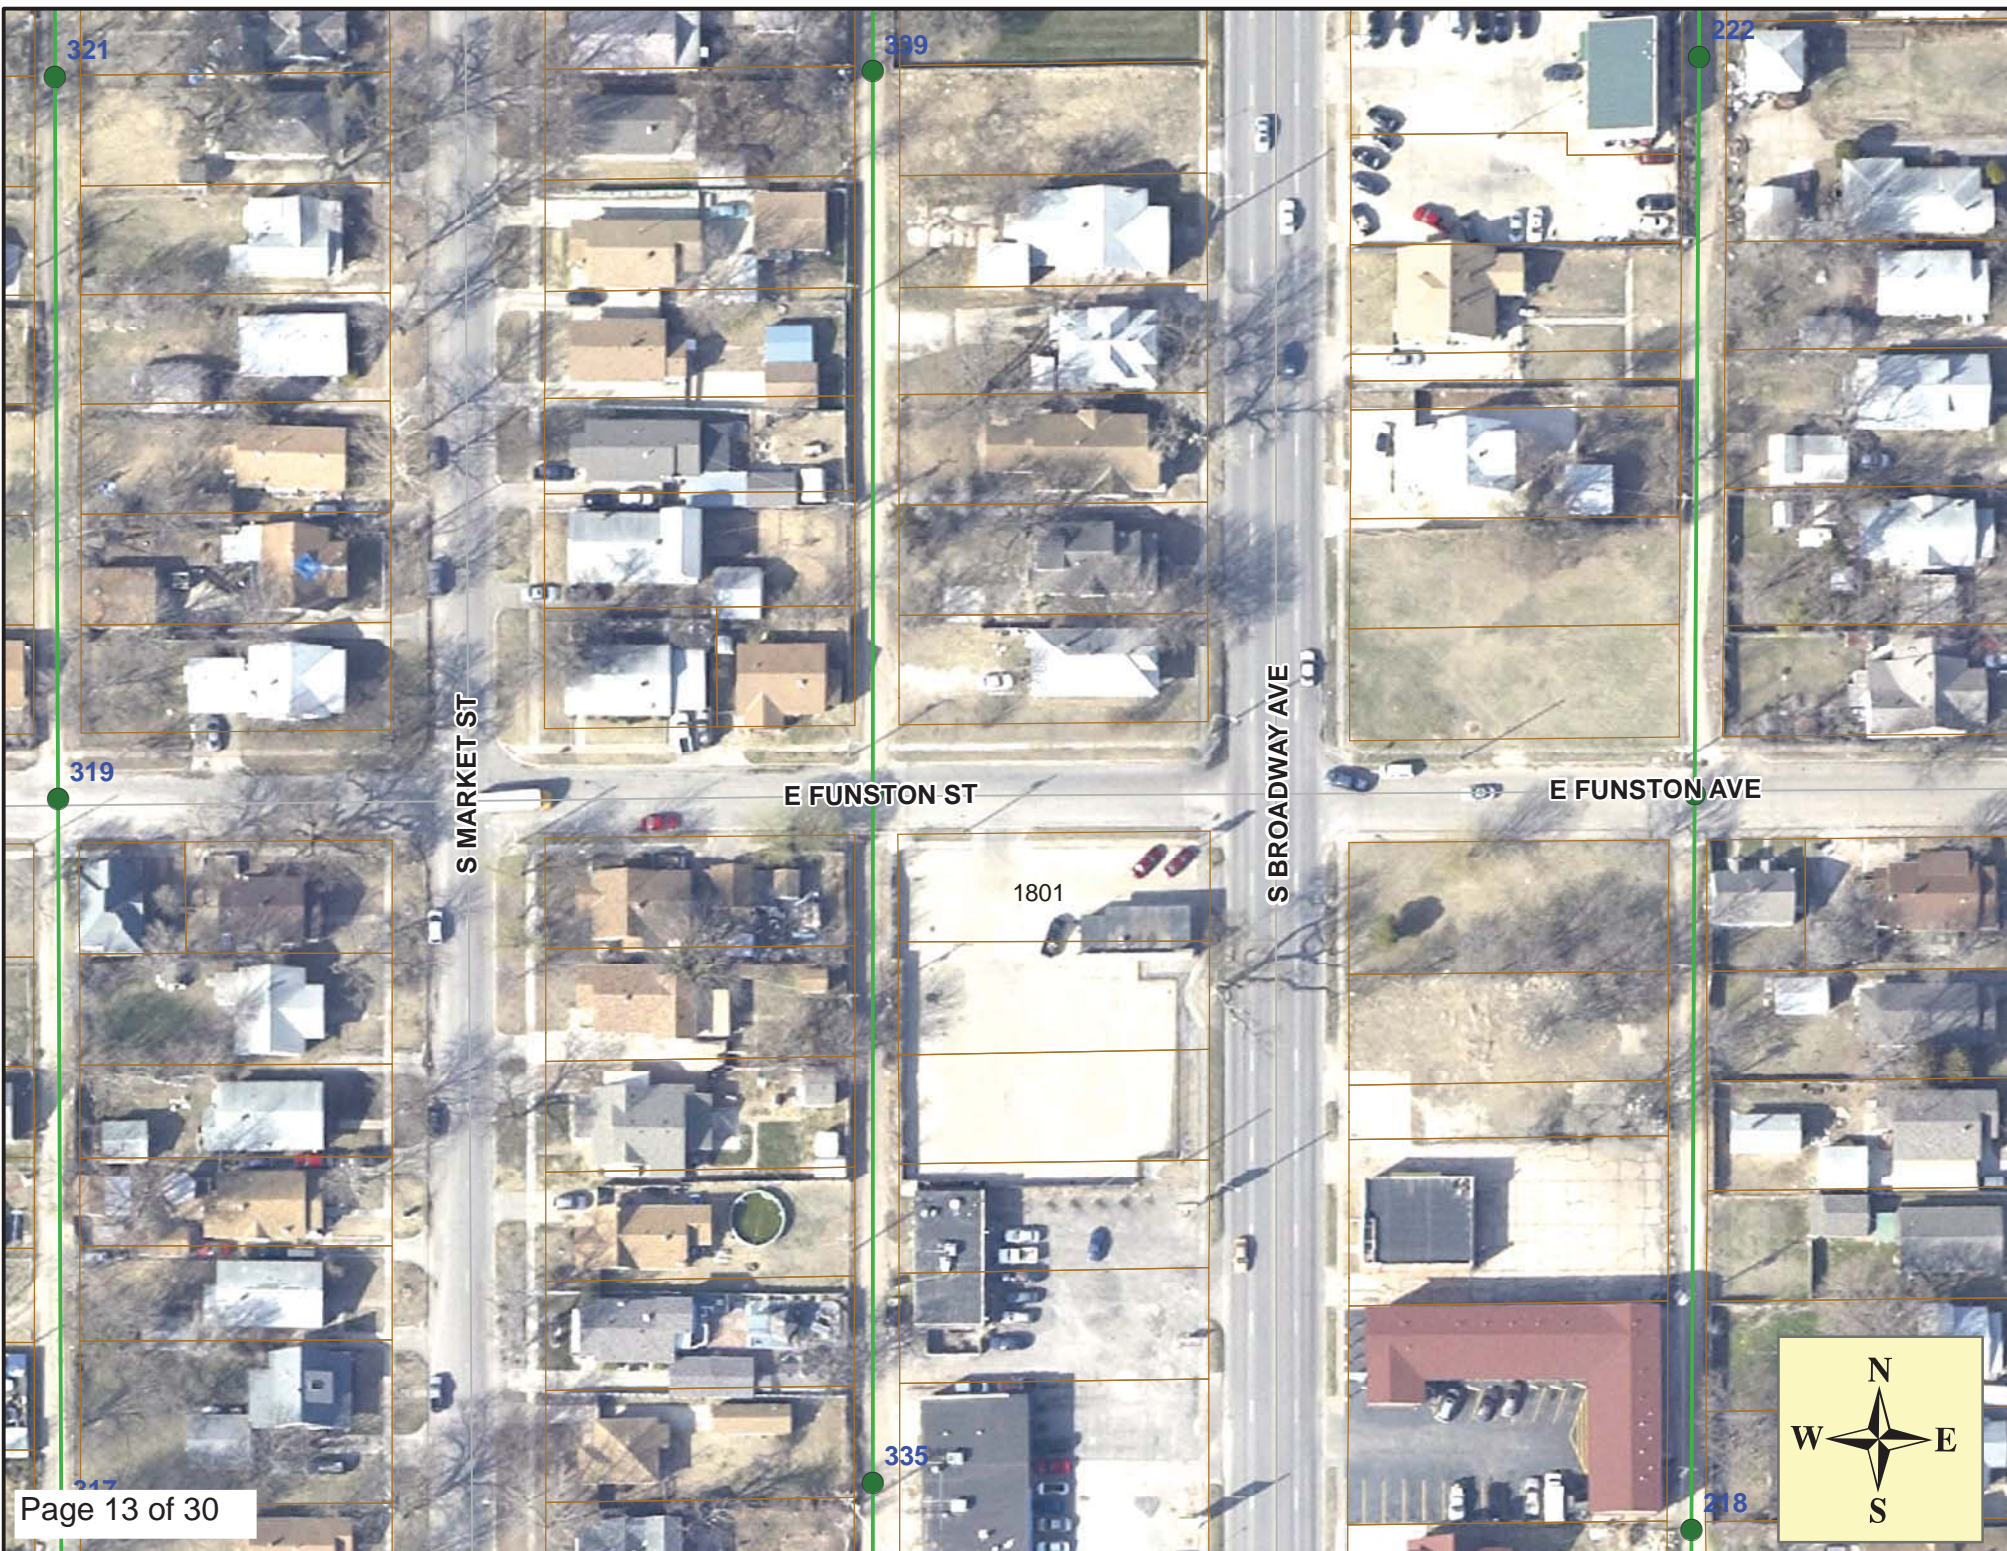
Comment: TILE MISSING IN BOTTOM OF MANHOLE

Comment: LINE IN POOR CONDITION, LINE NEEDS TO BE KNIFED AND VAPOR ROOTED
