**SITE 3**

# Video Inspection Master Report

US Structure: **5443-077**      701 W 33RD ST S      Date Insp: 8/10/2011      Basin: WC01G  
 DS Structure: **5443-076**      3356 S EXCHANGE ST      Dir Televised: Upstream To Downstream

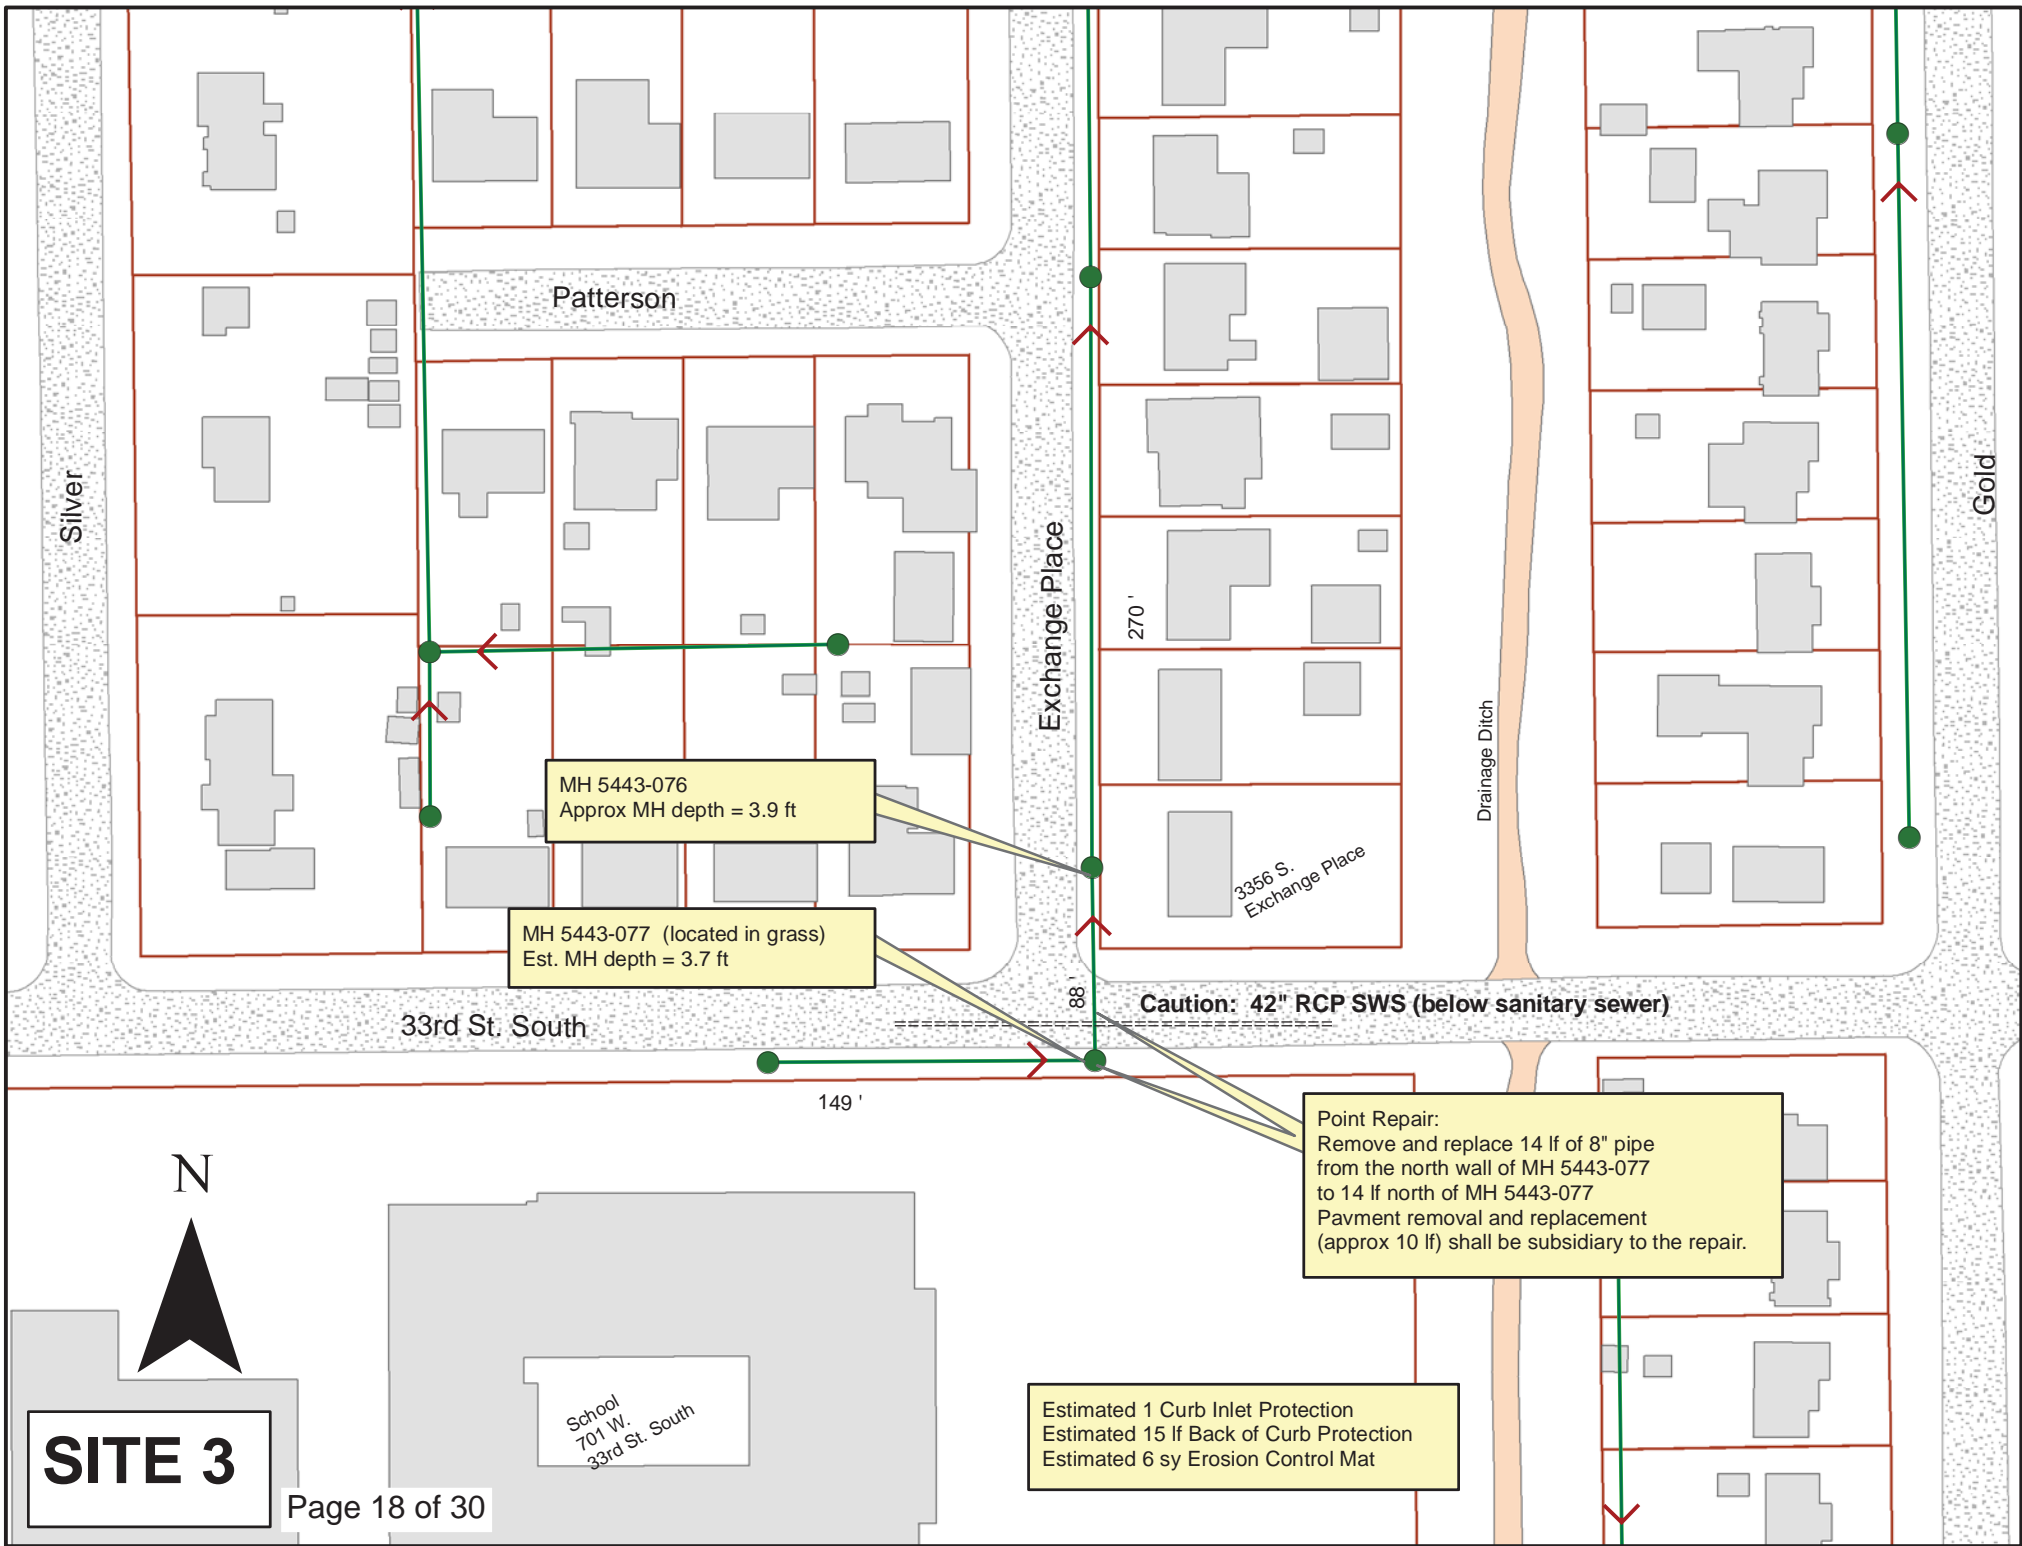
MH 5443-076  
Approx MH depth = 3.9 ft

MH 5443-077 (located in grass)  
Est. MH depth = 3.7 ft

Point Repair:  
Remove and replace 14 lf of 8" pipe  
from the north wall of MH 5443-077  
to 14 lf north of MH 5443-077  
Pavment removal and replacement  
(approx 10 lf) shall be subsidiary to the repair.

Estimated 1 Curb Inlet Protection  
Estimated 15 lf Back of Curb Protection  
Estimated 6 sy Erosion Control Mat

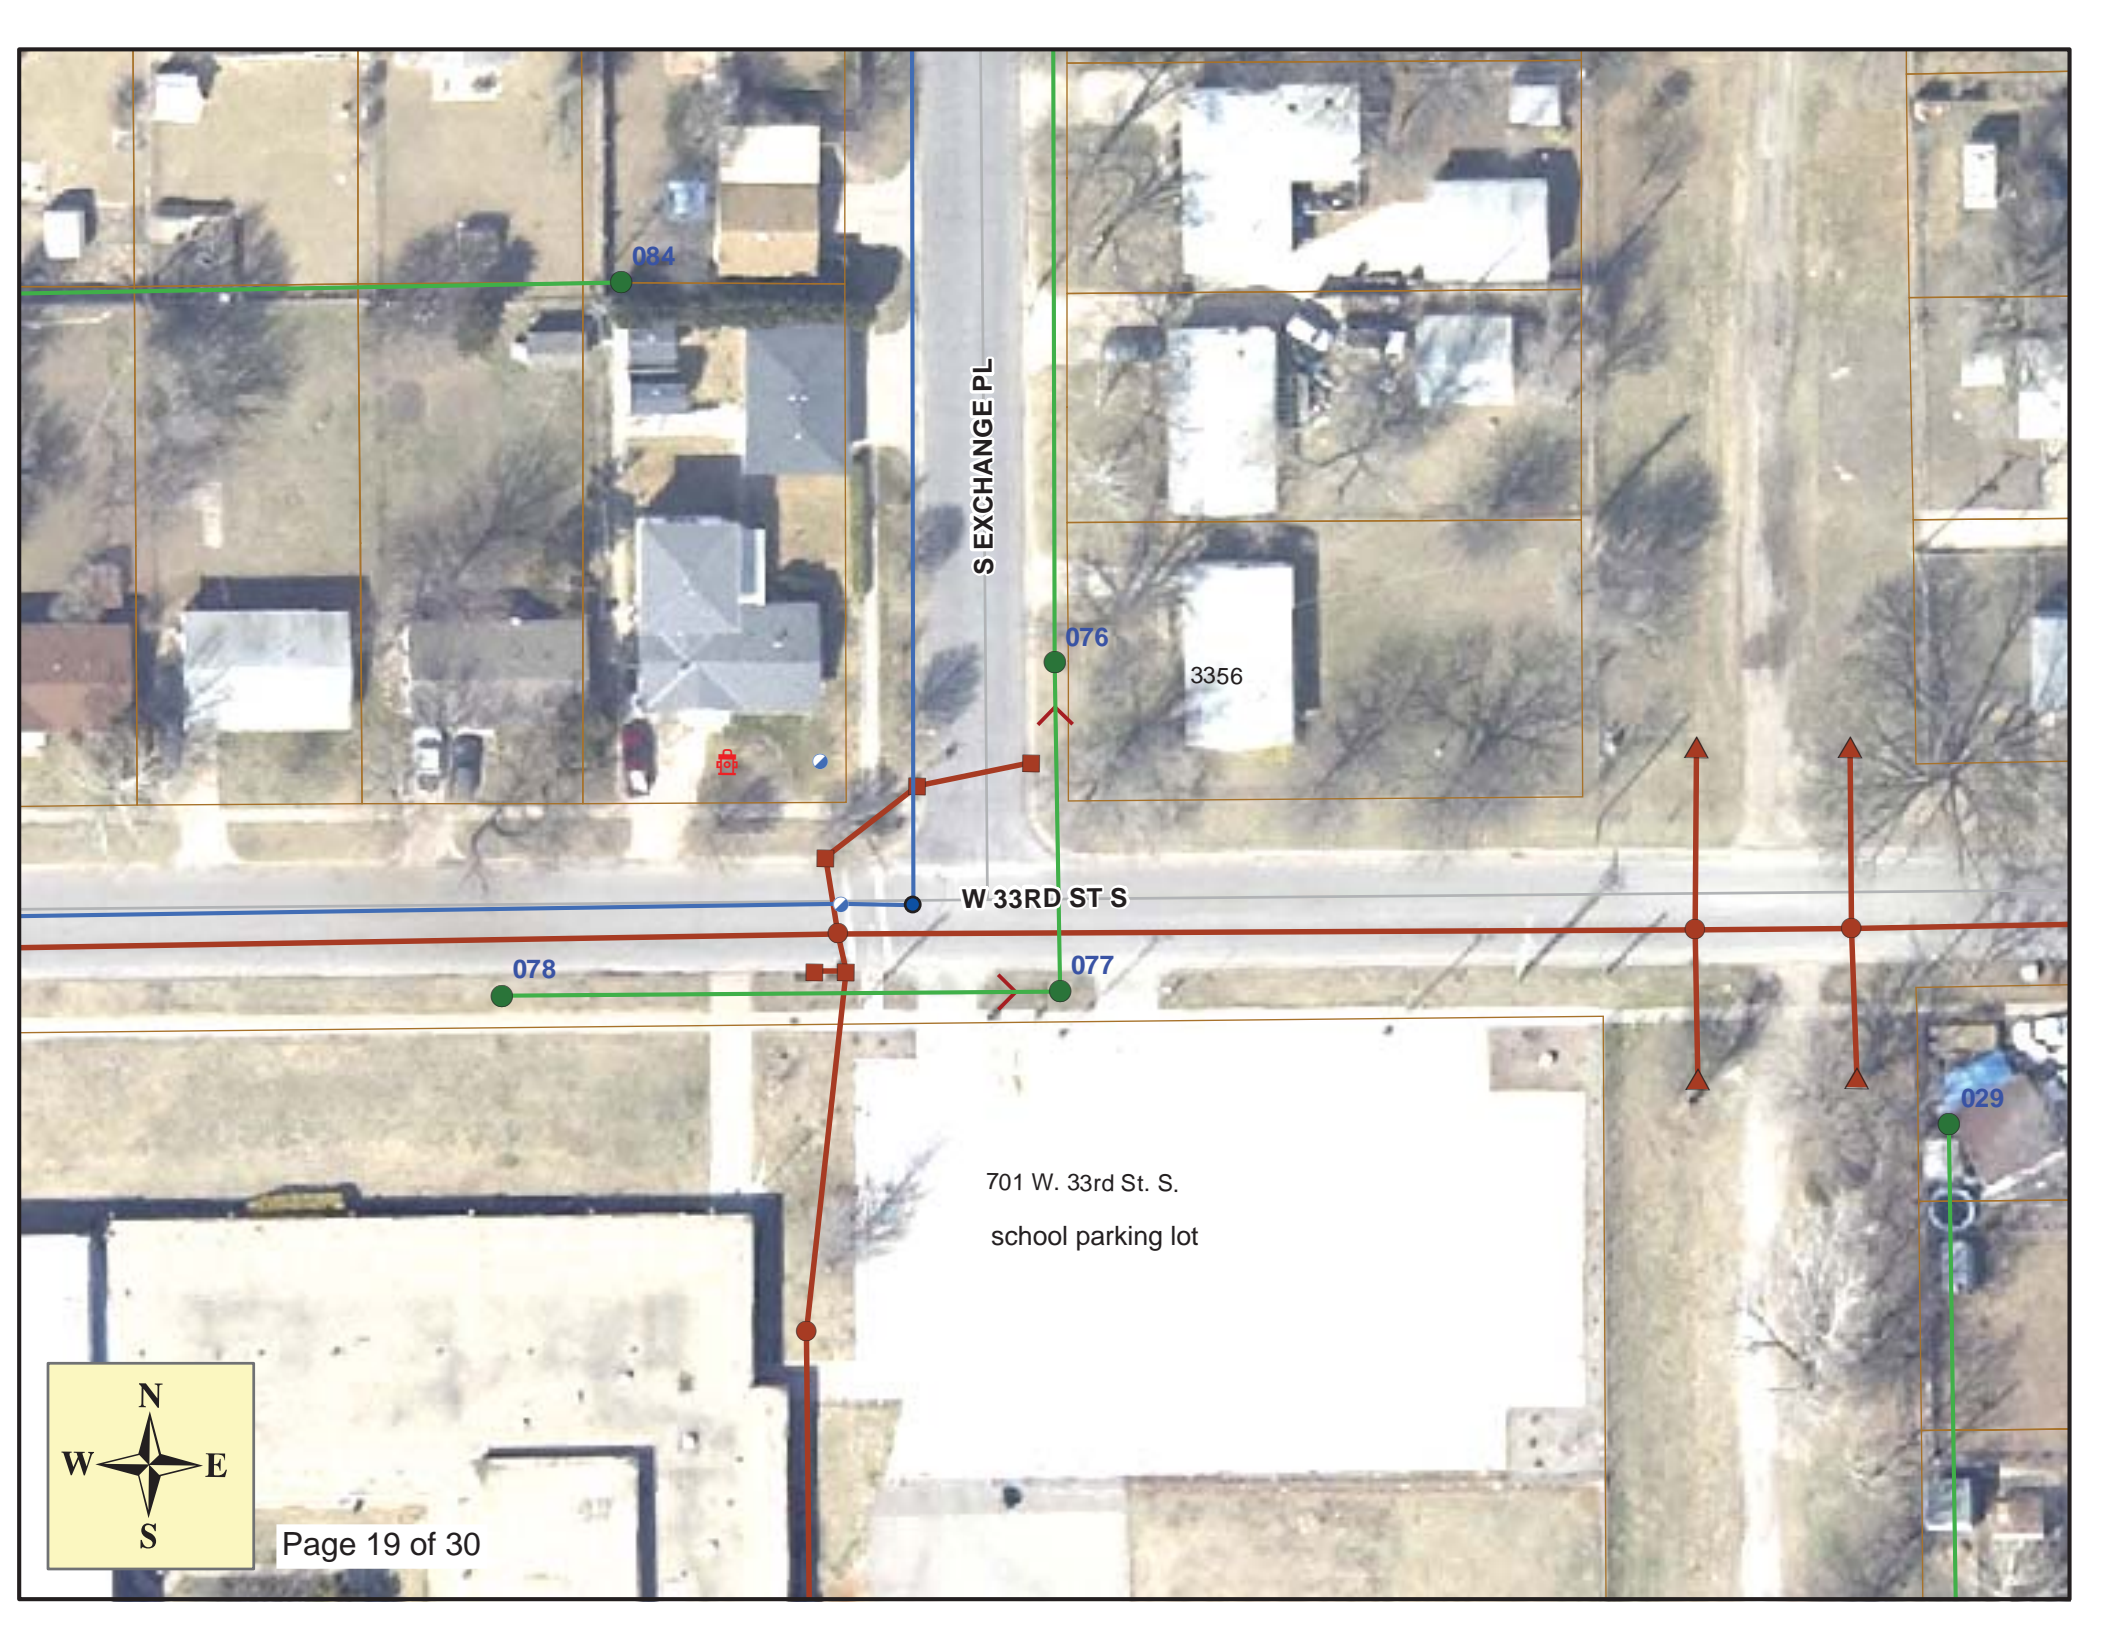
701 W. 33rd St. S.  
school parking lot
