SITE 4

Video Inspection Master Report

US Structure: 5347-077 239 N GLENN AVE Date Insp: 4/18/2012 Basin: C07B
 DS Structure: 5347-074 248 N GLENN AVE Dir Televised: Upstream To Downstream

Project No. : B-046 Dia: 8 Material: VCP Length: 301.0

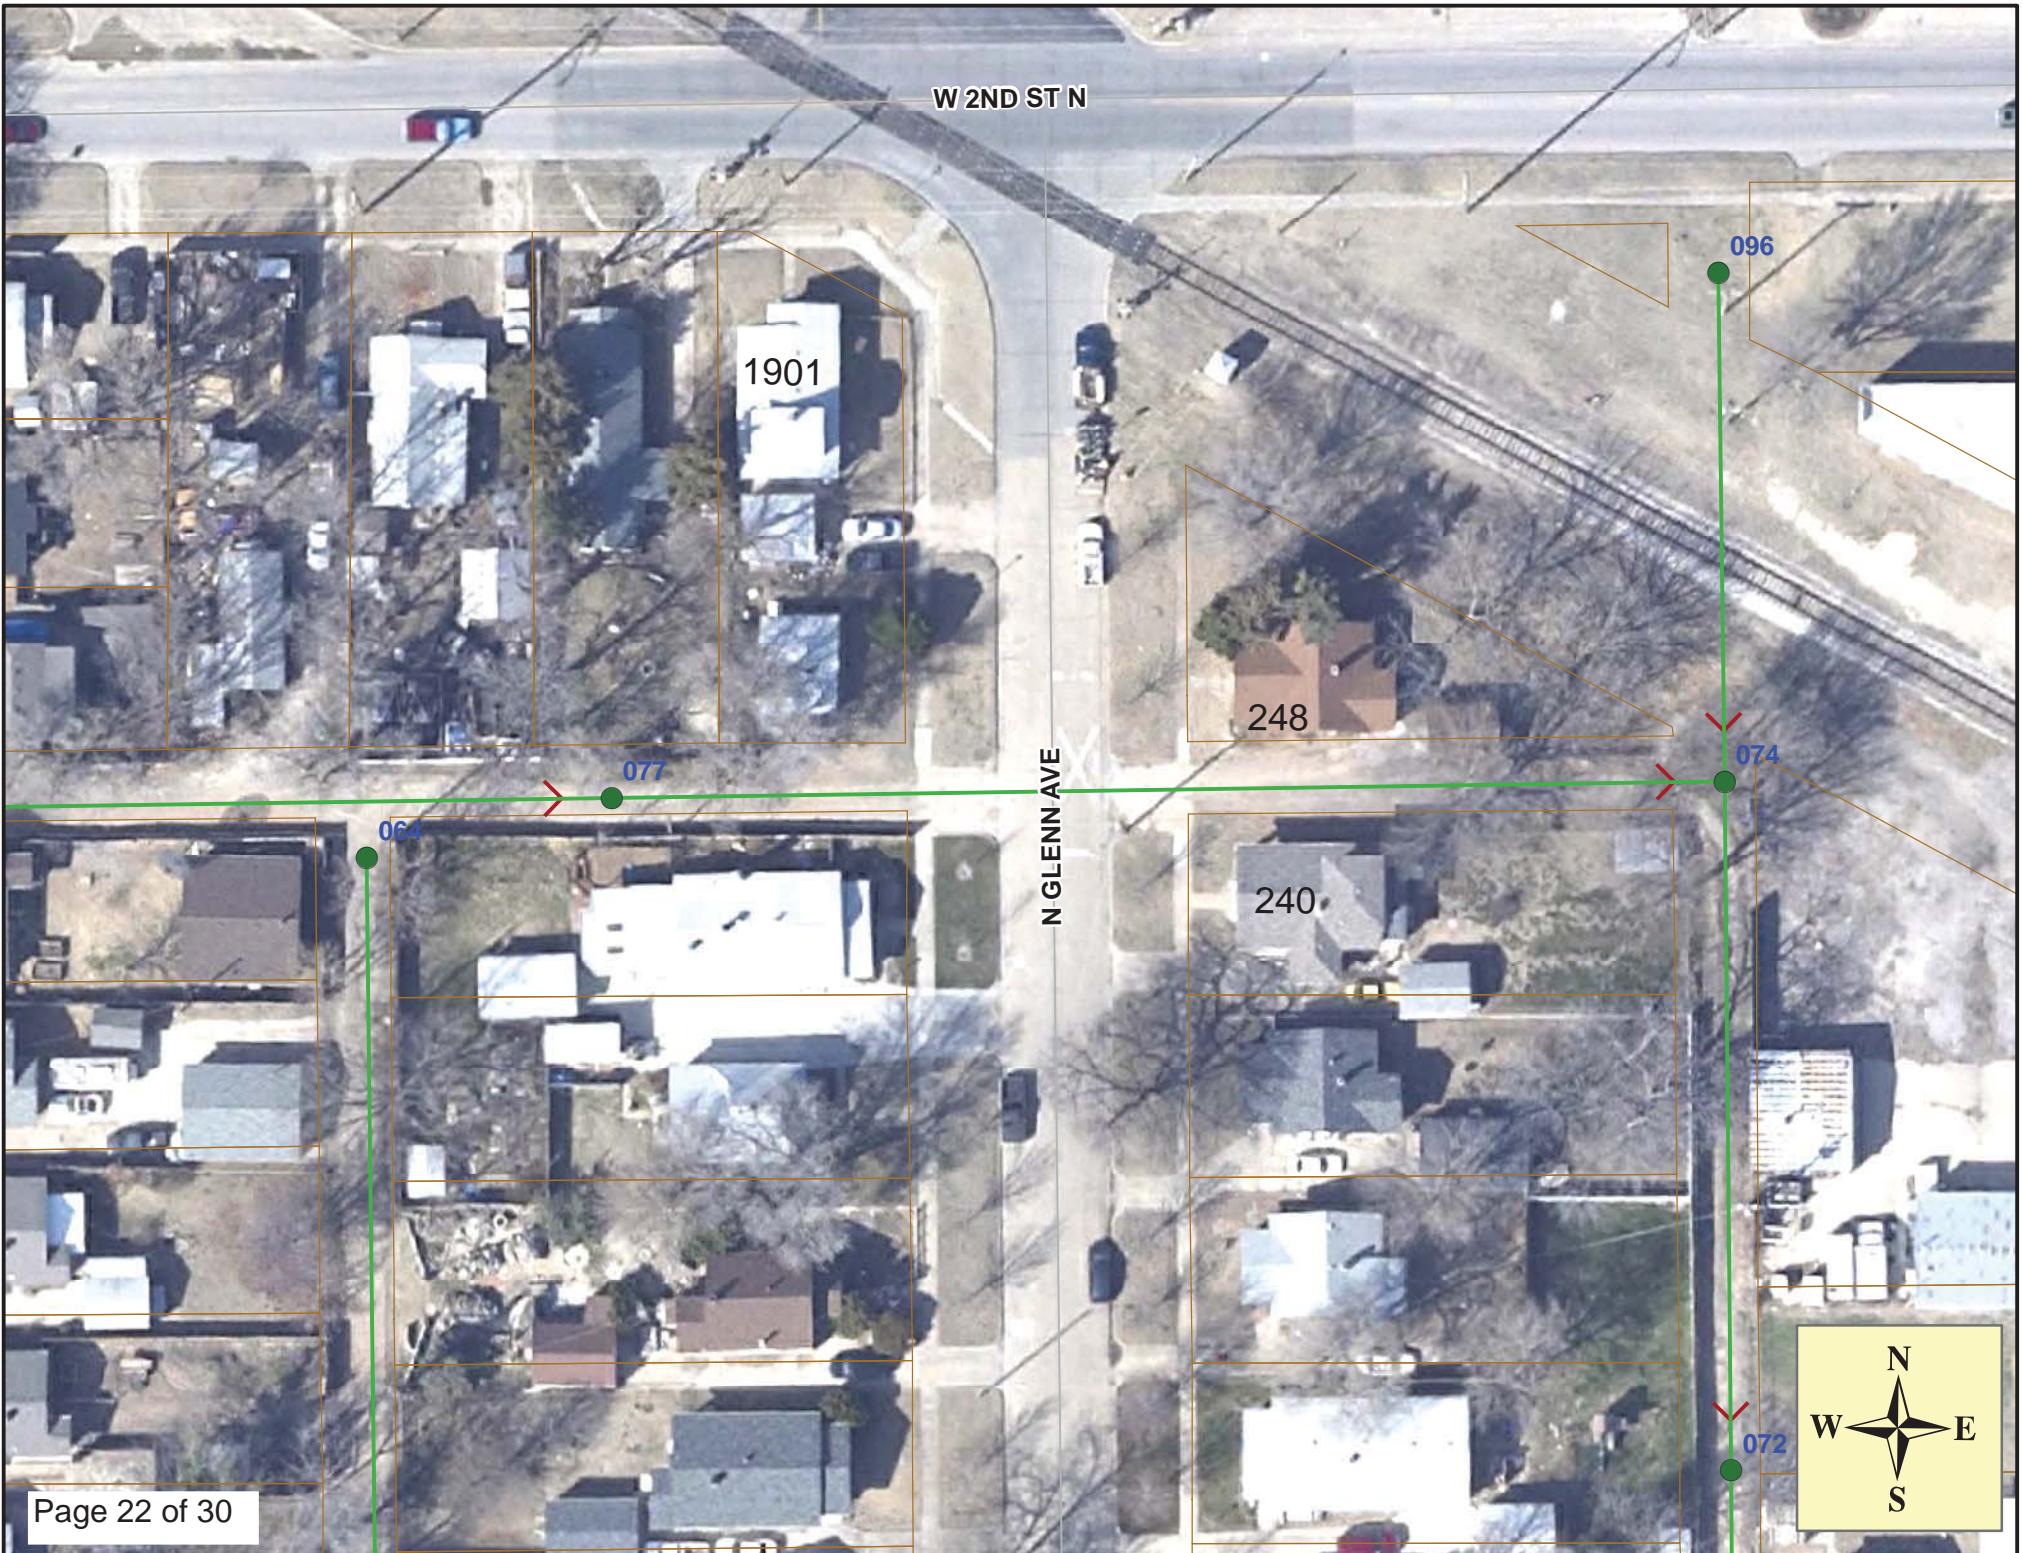
Remove and replace 25 lf of Concrete Approach (incl gutter) (west side)
Remove and replace 26 lf of Concrete Pavement
Remove and replace 25 lf of Concrete Approach (incl gutter) (east side)
Fill Sand, 51 lf (flushed & vibrated)

Remove 20 lf of Concrete Encasement
on 8" VCP Sanitary Sewer
Install 20 lf of Concrete Encasement
on 8" PVC Sanitary Sewer

(There is an 8" PVC water main in Glenn,
at approx. 5 ft east of the east curb line of
Glenn, located below the sanitary sewer.)

MH 5347-074
Approx MH depth = 6.5 ft

MH 5347-077
Remove Manhole
Construct Shallow Manhole
Approx MH depth = 5.3 ft

Estimated 2 Service Reconnections (4")
Restoration of unpaved alleys shall be subsidiary to Site Restoration

This segment is scheduled to have CIPP installed. Check with the Field Engineer to coordinate the work schedules.

Remove and replace 301 lf of 8" pipe
