**SITE 3**

# Video Inspection Master Report

**SITE 4**

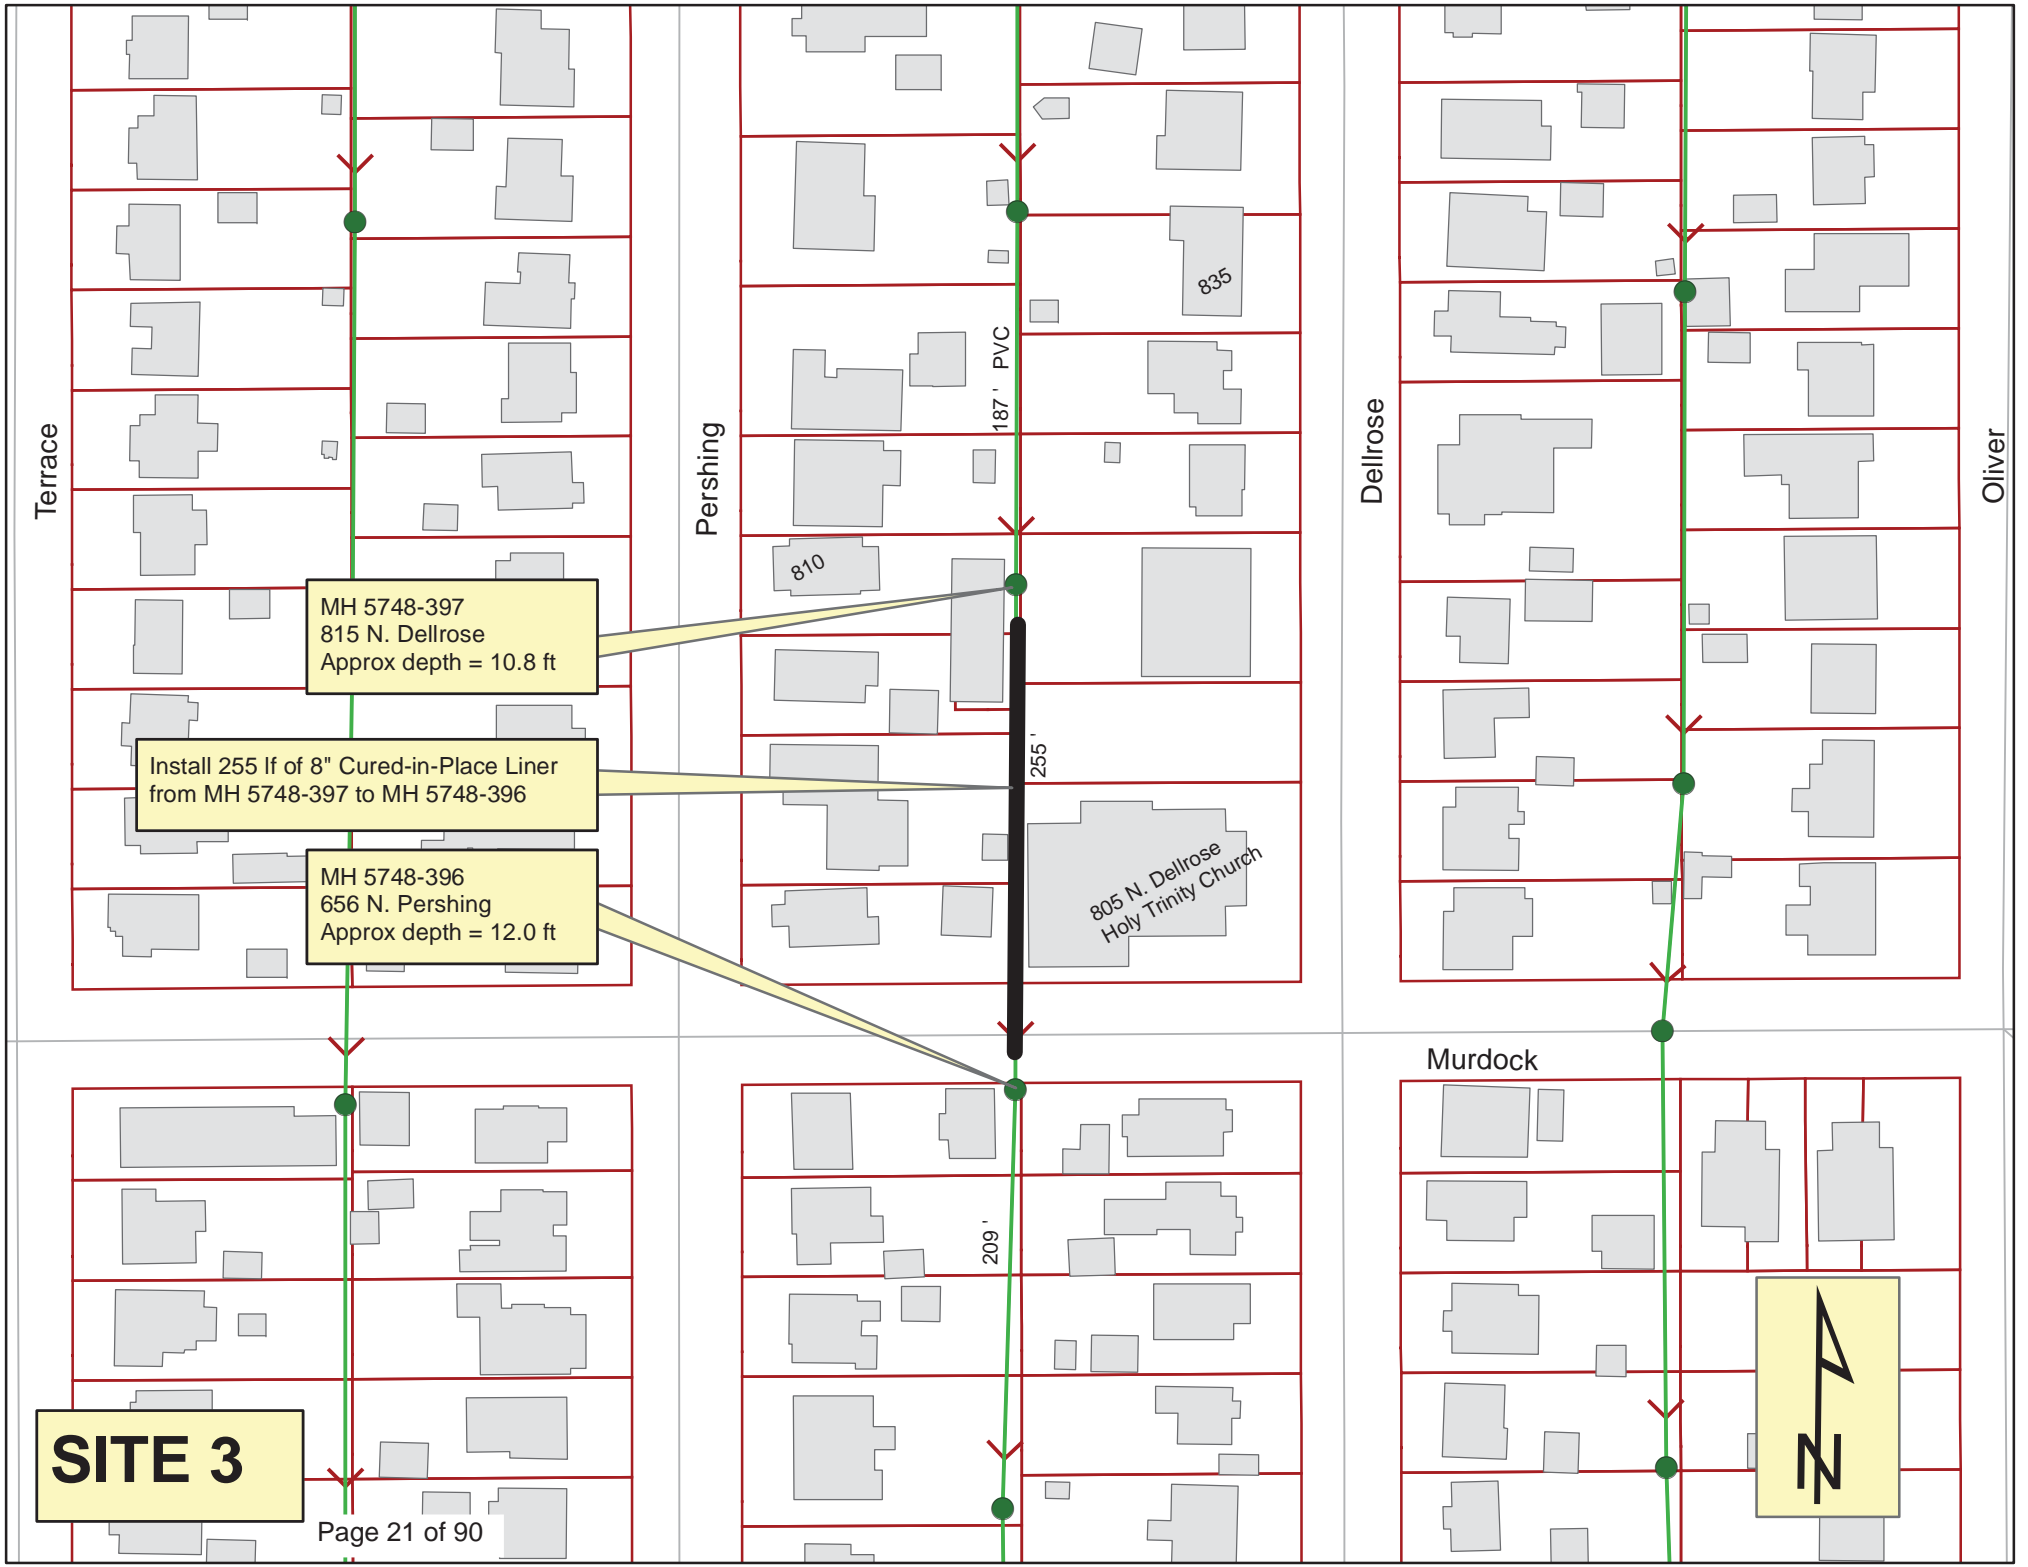
MH 5748-397  
815 N. Dellrose  
Approx depth = 10.8 ft

MH 5748-396  
656 N. Pershing  
Approx depth = 12.0 ft

805 N. Dellrose  
Holy Trinity Church

Roots at the joints are not called out on this log. Pipe has infiltration at joints & broken wye seals. -LML

Install 255 lf of 8" Cured-in-Place Liner  
from MH 5748-397 to MH 5748-396

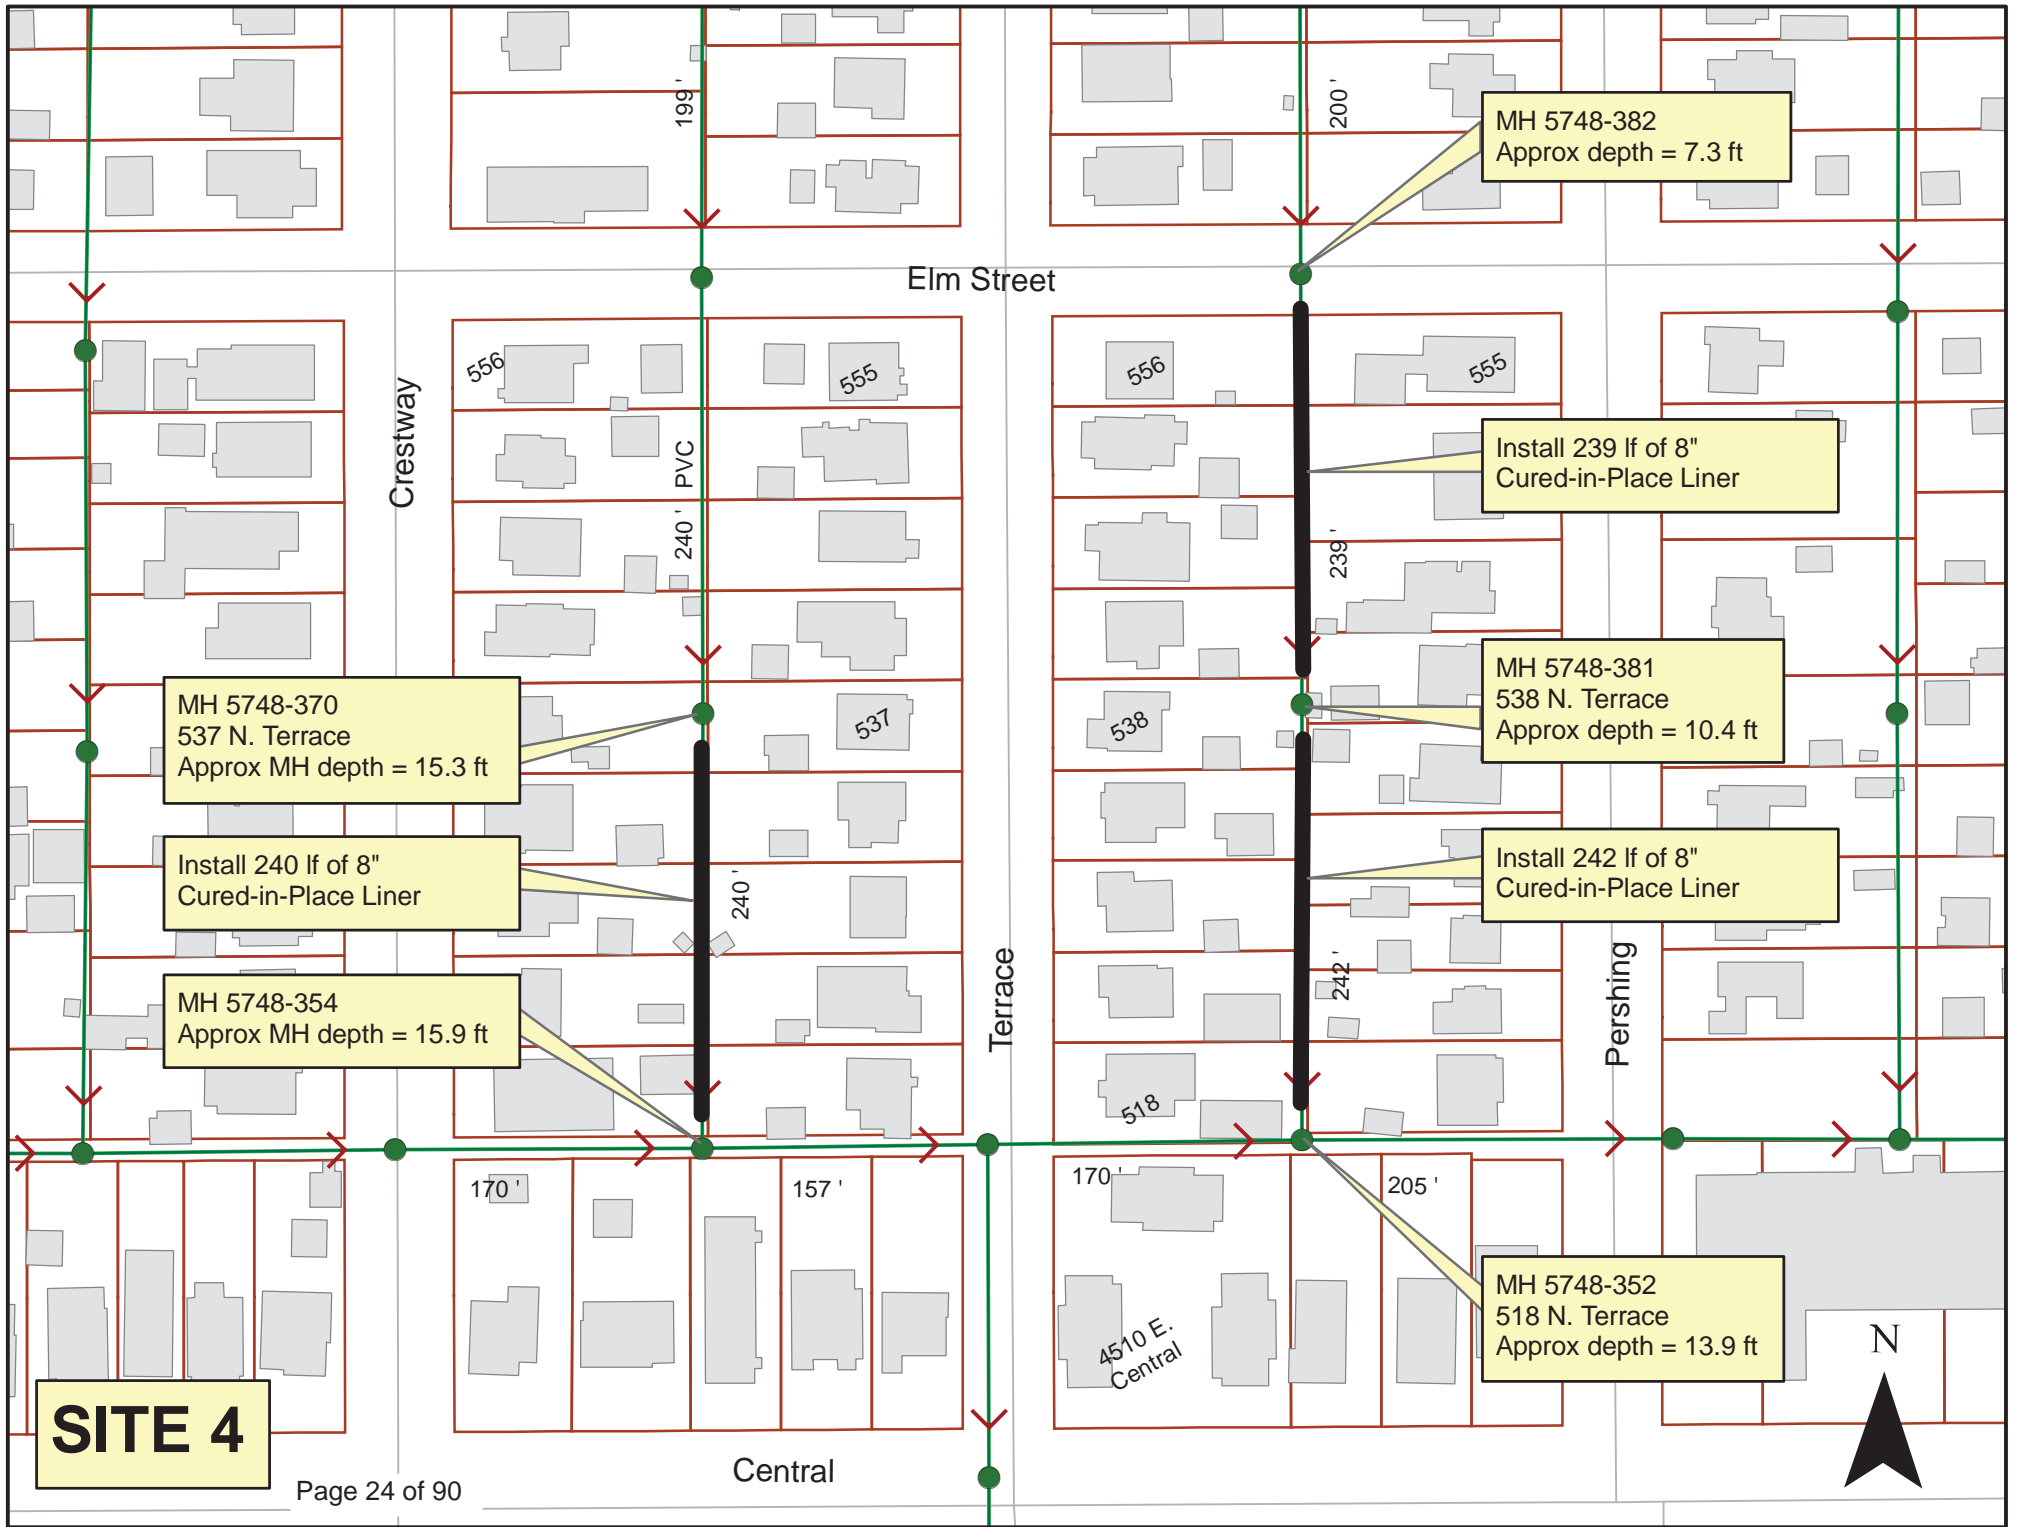
MH 5748-370  
537 N. Terrace  
Approx MH depth = 15.3 ft

MH 5748-354  
Approx MH depth = 15.9 ft

MH 5748-382  
Approx depth = 7.3 ft

MH 5748-381  
538 N. Terrace  
Approx depth = 10.4 ft

MH 5748-352  
518 N. Terrace  
Approx depth = 13.9 ft

There are other smaller sags in the line but not as extreme as the upstream 70 lf. -LML

Roots at joints not called out on the log. Taps are in poor condition. Line has a maintenance history. -LML

Install 240 lf of 8"  
Cured-in-Place Liner

Install 239 lf of 8"  
Cured-in-Place Liner

Install 242 lf of 8"  
Cured-in-Place Liner
