Install 441 lf of 8" Cured-in-Place Liner
from MH 5748-363 to MH 5748-356

SITE 5

Video Inspection Master Report

US Structure: 5748-363 554 N BELMONT AVE Date Insp: 6/7/2012 Basin: E04E
 DS Structure: 5748-362 531 CRESTWAY ST Dir Televised: Upstream To Downstream

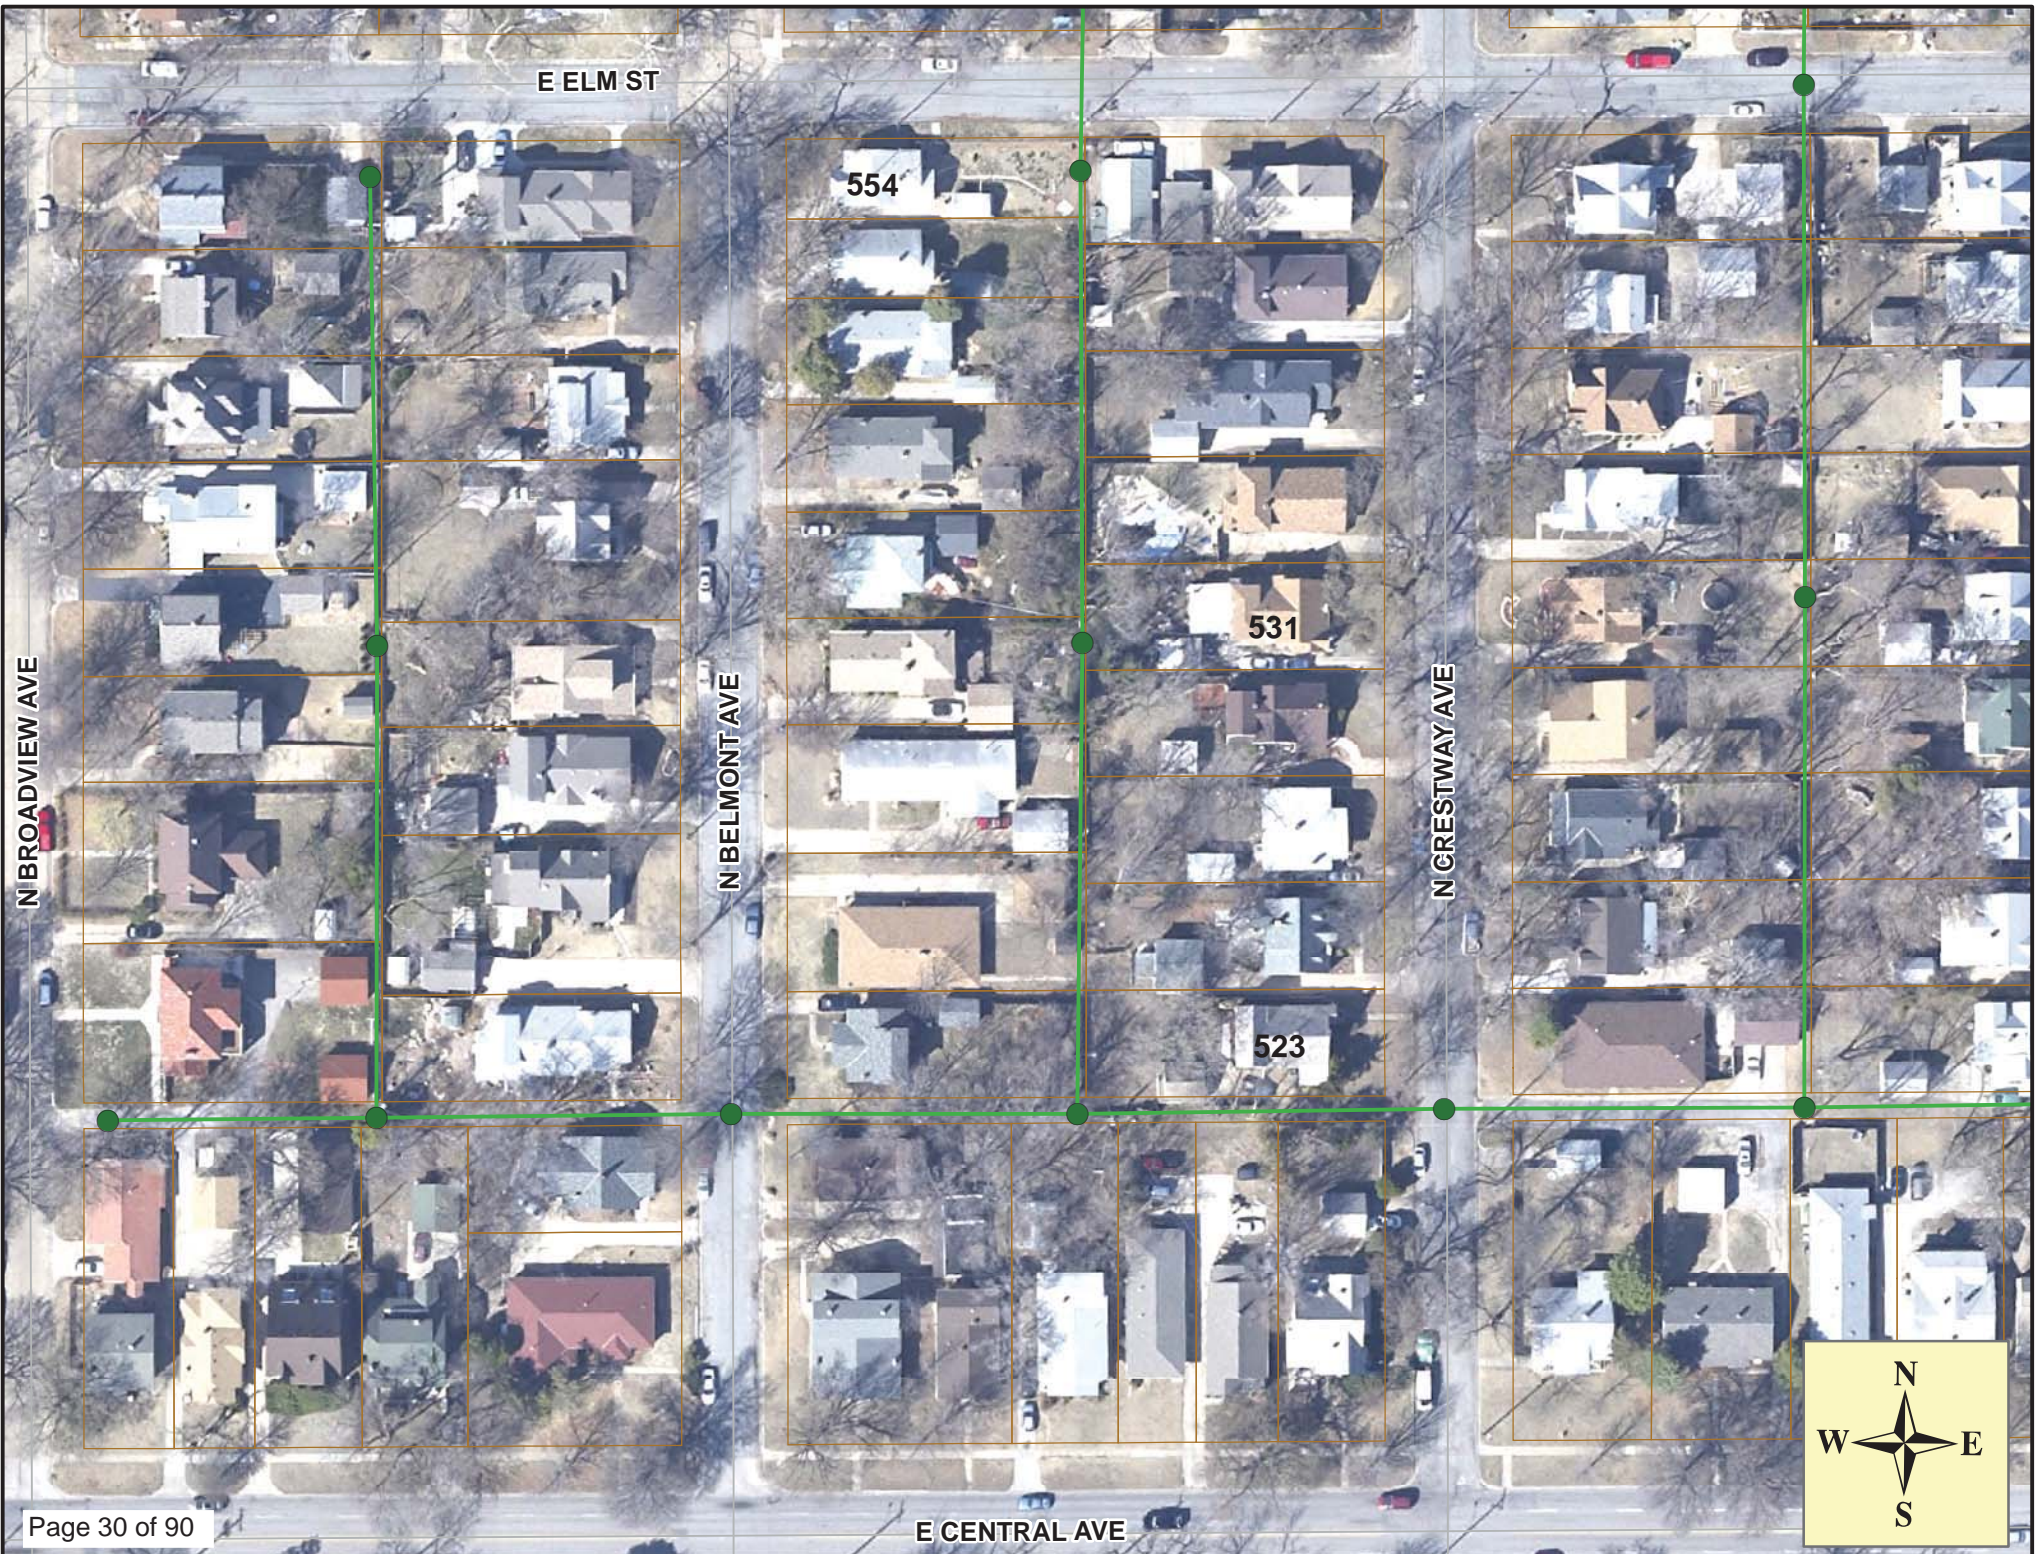
MH 5748-363
554 N. Belmont
Approx MH depth = 10.3 ft

MH 5748-362
531 N. Crestway
Approx MH depth = 10.0 ft

MH 5748-356
523 N. Crestway
Approx MH depth = 12.4 ft
