Install 141 lf of 8" Cured-in-Place Liner from MH 5748-113 to MH 5748-110

SITE 9

Video Inspection Master Report

US Structure: 5748-113 601 N FOUNTAIN AVE Date Insp: 6/7/2012 Basin: EC02A
 DS Structure: 5748-110 605 N FOUNTAIN AVE Dir Televised: Downstream To Upstream

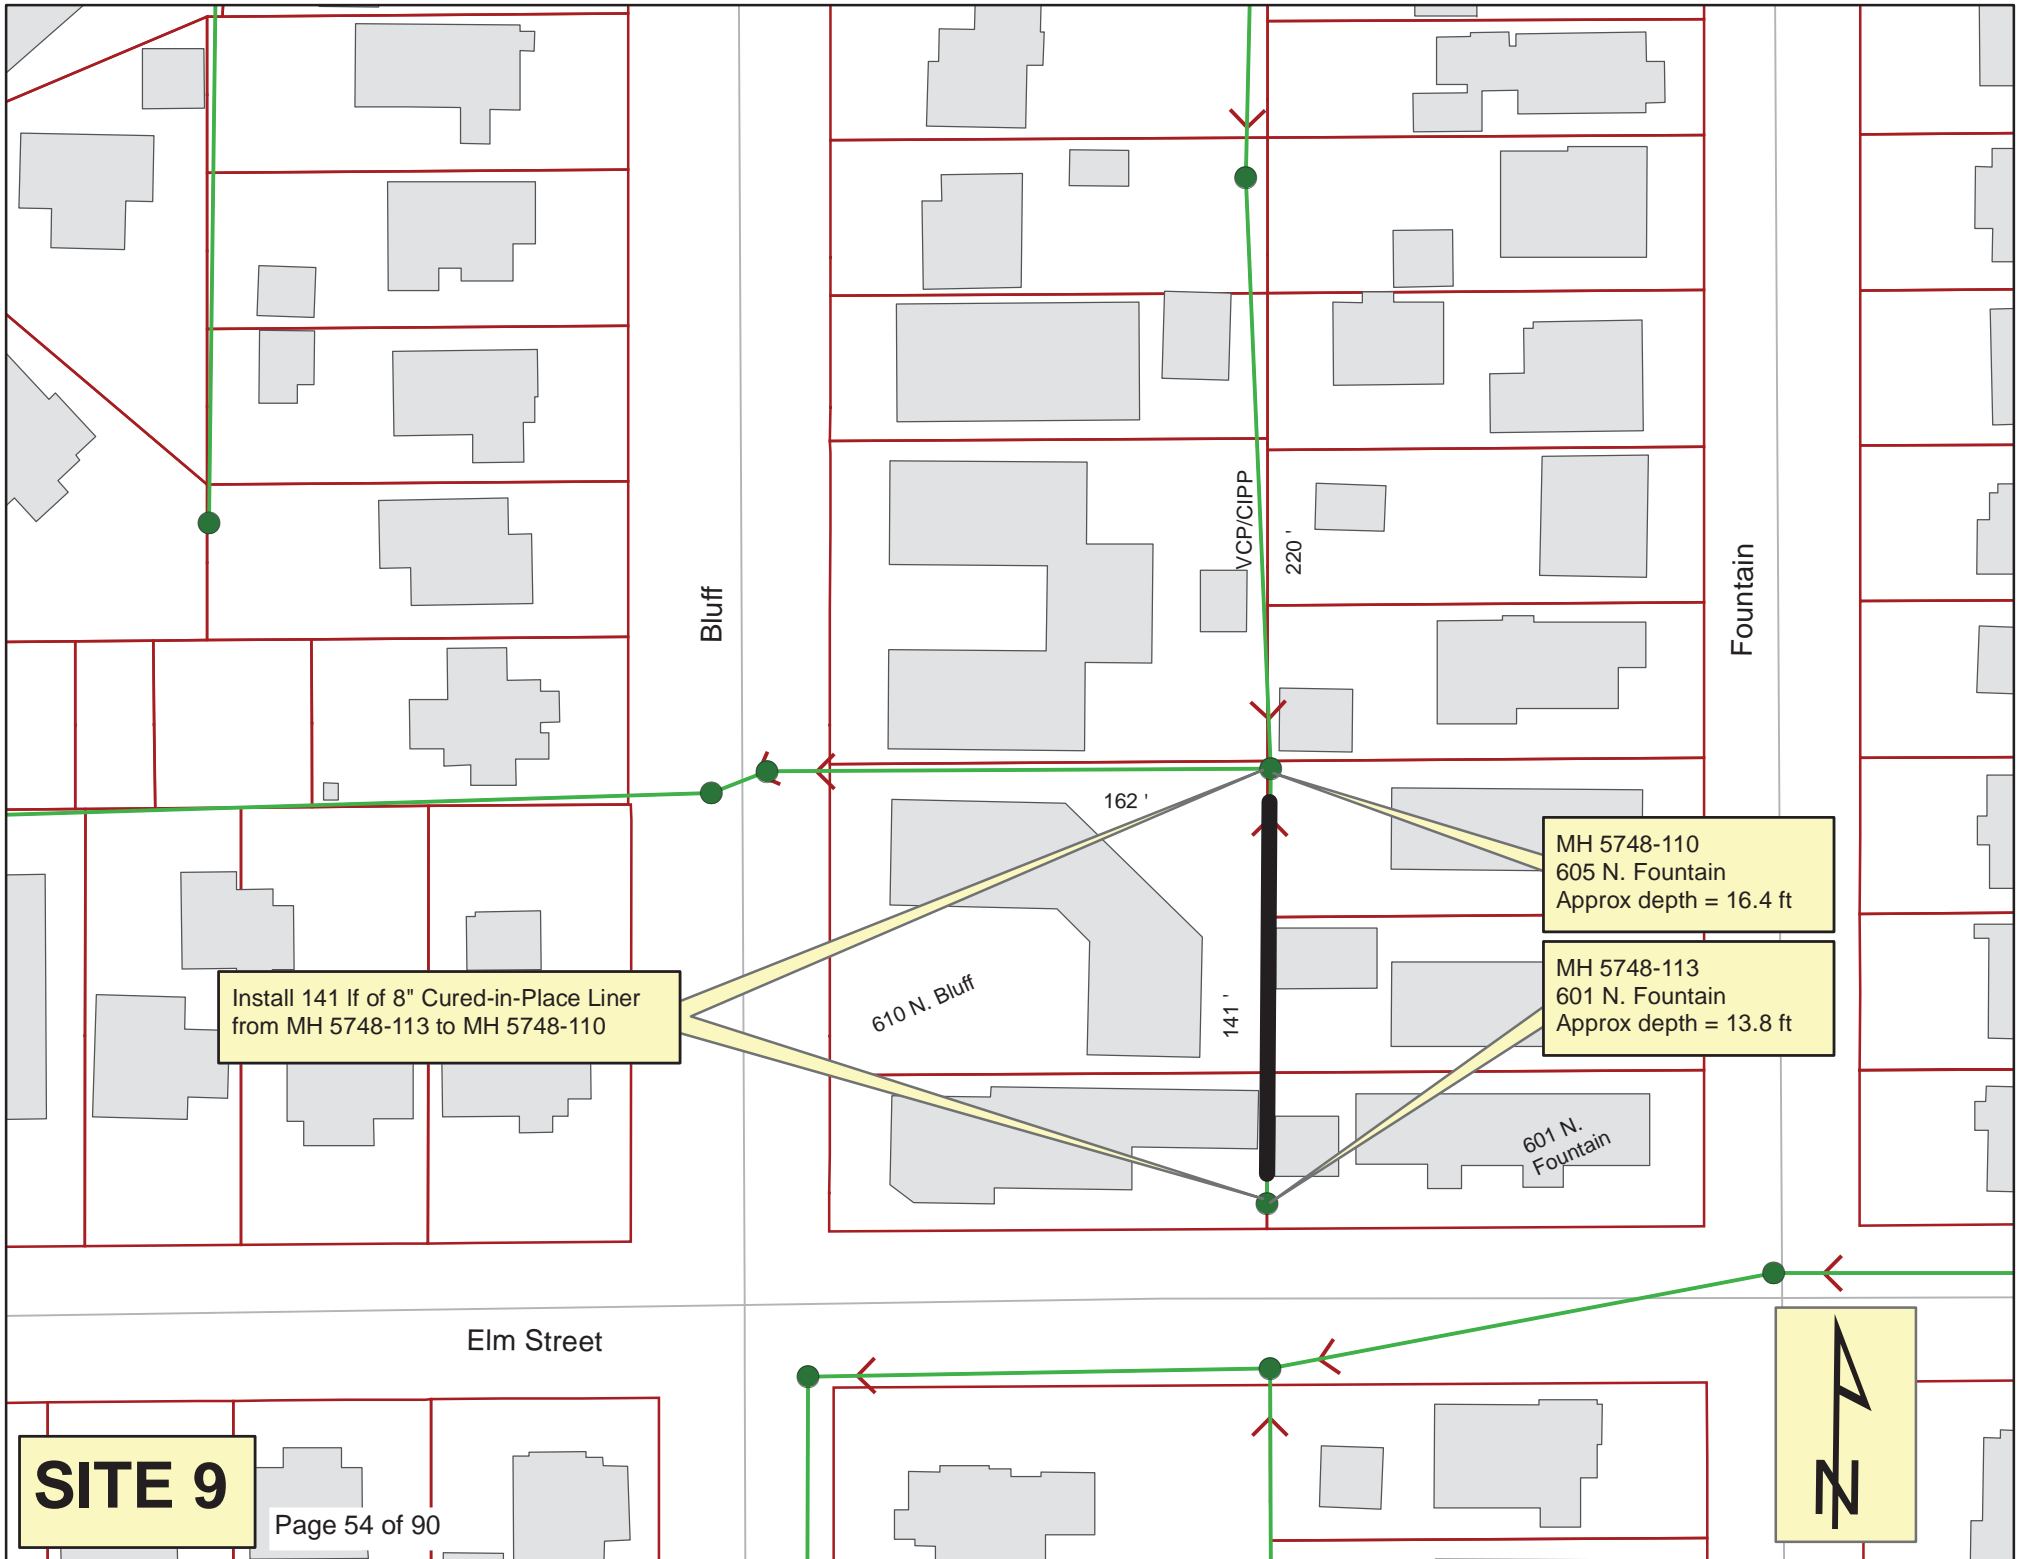
MH 5748-110
605 N. Fountain
Approx depth = 16.4 ft

MH 5748-113
601 N. Fountain
Approx depth = 13.8 ft
